# FEBRUARY 2023 SUBJECT MATTER EXPERT PUBLIC REPORT

RE: UNITED STATES V. HARRIS COUNTY, TEXAS, NO. 4:16-CV-02331 (S.D. TEX.)

United States Dept. of Justice  
Civil Rights Division

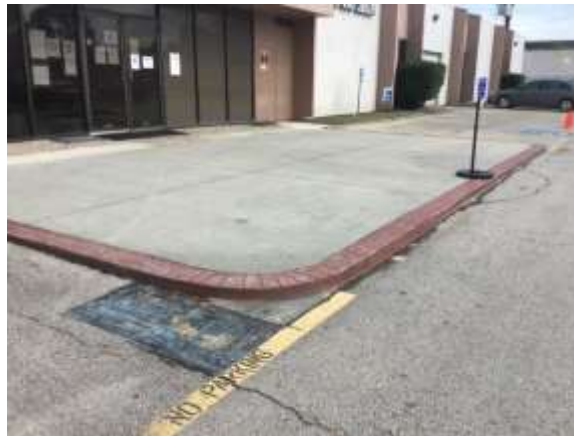
**Figure 3 - Chinese Civic Center Missing Ramp**

During early voting, one of the ramps the SME anticipated observing was not installed. This occurred at the Chinese Civic Center, whose checklist was submitted and approved after early voting began.

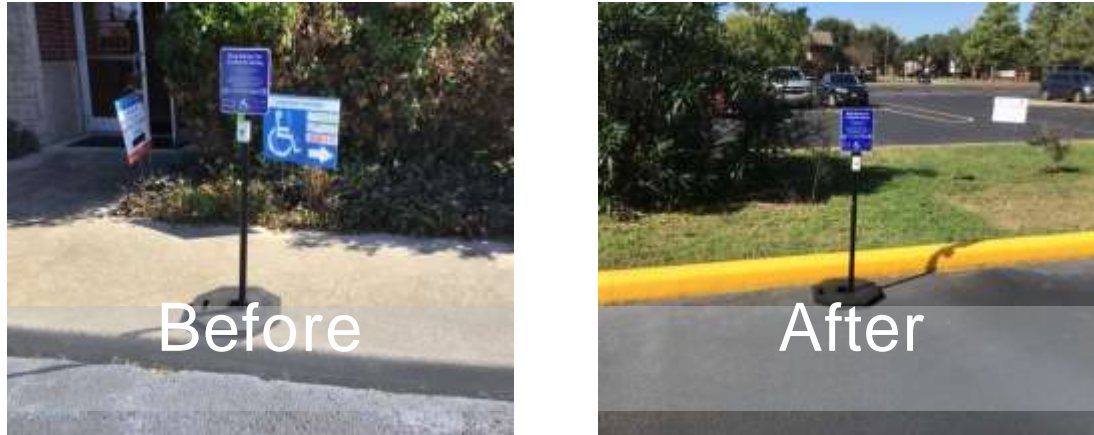
**Figure 5 - Korean Christian Church of Houston Curbside Bell**

At Korean Christian Church of Houston, the bell was located on a curb out of reach of someone in a car. The SME team moved the bell to a location more easily reached from a car.

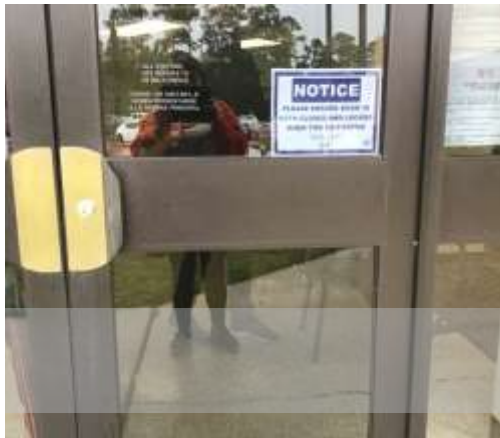
Item #	Proposed Remedy	SME Results	HCEAD Results
12265	Judge must prop facility entrance open during voting hours.	Not Implemented	Implemented Properly

Harris County noted that a poll worker opened the door for everyone. SME observed that the poll worker opened the door for some, but not all, voters, and explained to the poll worker and presiding judge the obligation to open it for everyone. SME believes that HCEAD analyzed this element appropriately.

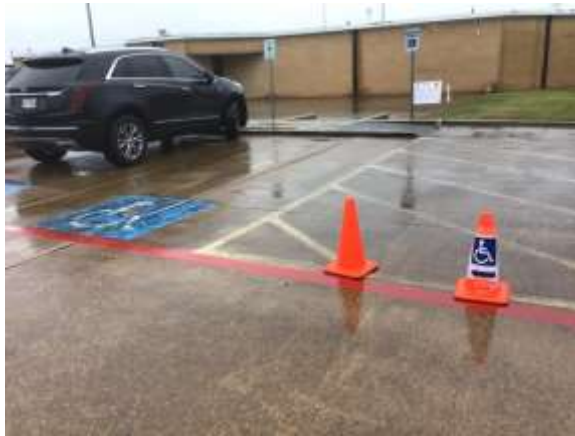
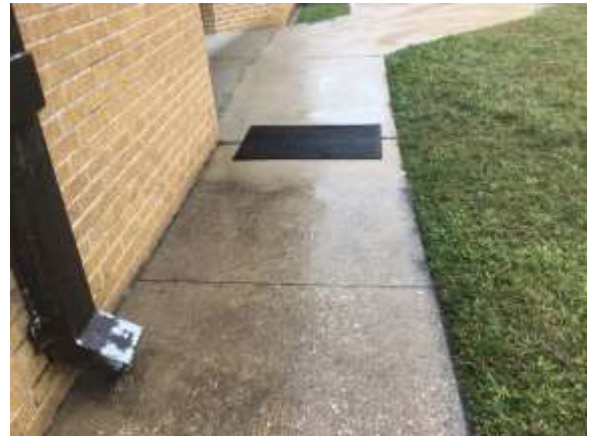
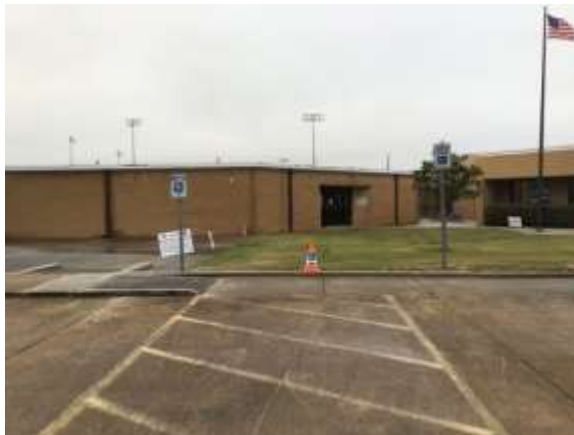
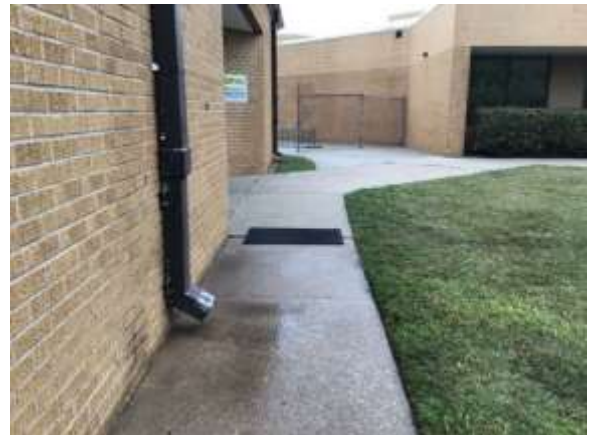
Item #	Proposed Remedy	SME Results	HCEAD Results
12262	Judge must create an alternate route by placing one cone with a left directional sign across the top of the access aisle and another right directional sign at pole in front of the curb ramp to direct voters to accessible entrance. Judge must also place a mat over the last expansion joint before turning into the accessible entrance and also ensure there is 36" clearance by removing the gutter concrete splash block.	Not Implemented Properly	Not Implemented

SME noted that the signage was not pointed in the correct direction. Harris County noted that the mat was not placed correctly and that the issue was fixed in the field. The discrepancy between the results could be caused by a cone being moved between the SME and Harris County visits. SME believes that HCEAD analyzed this element appropriately.

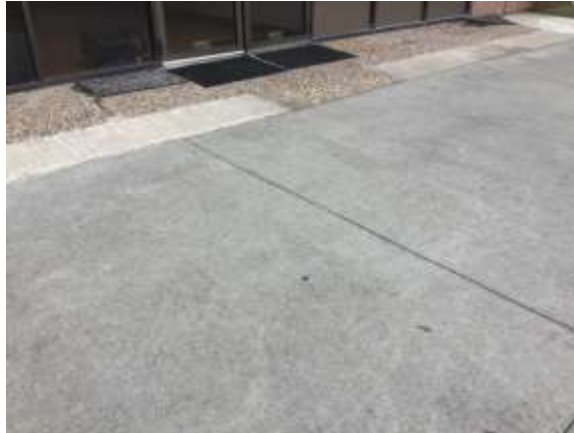
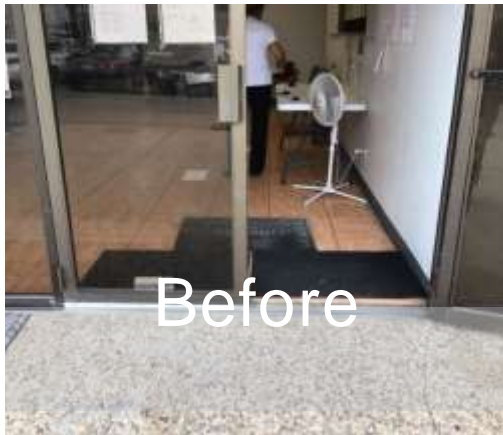
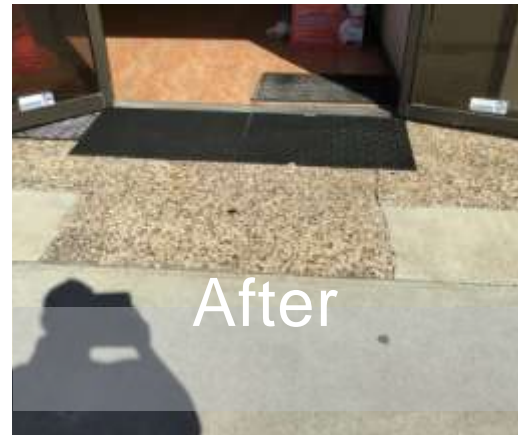
Item #	Proposed Remedy	SME Results	HCEAD Results
12678	Judge must place 1 mats over 1 plate next to each other as shown in pictures. (2)	Implemented Properly	Not Implemented Properly

Harris County noted that the mats and plates were placed on the interior of the door and that the issue was fixed in the field. This accounts for the discrepancy between the SME and HCEAD results. SME believes that HCEAD analyzed this element appropriately.

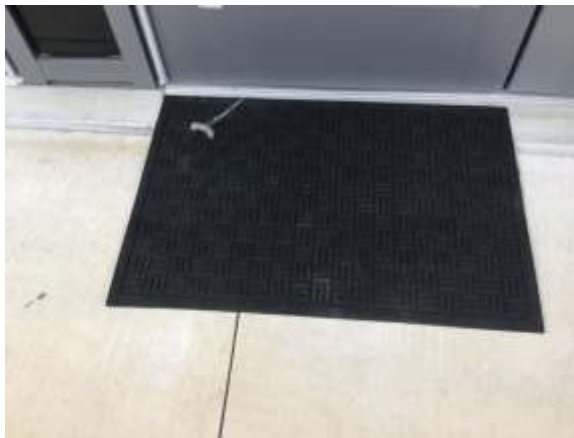
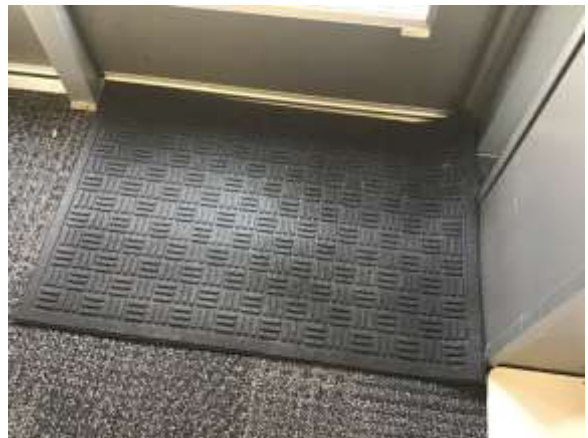
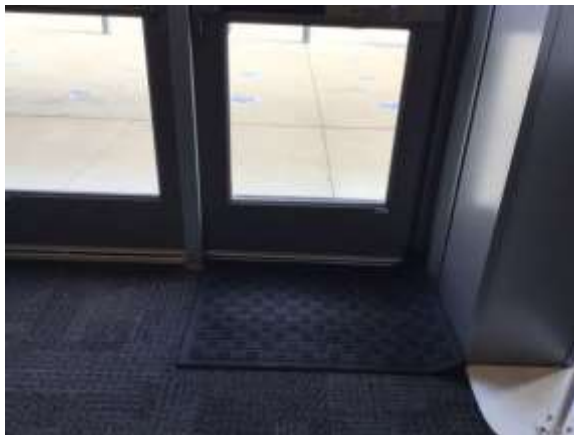
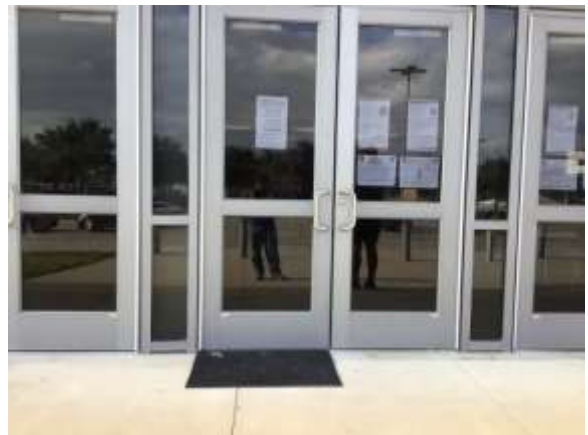
Item #	Proposed Remedy	SME Results	HCEAD Results
13036	Judge must place a plate over concrete gap in front door, and also place one mat over plate but pushed up against the exterior threshold of accessible entrance into building. Judge must a mat pushed up against the interior threshold of accessible entrance as well. Judge must also place a poll worker at accessible entrance to open door for all voters during voting hours. Facility does not allow exterior doors to be propped open for long periods of time.	Not Implemented Properly	Implemented Properly

The SME noted that a poll worker was stationed but did not open the door for everyone when it was approached. The SME explained to the poll workers that the door must be opened for everyone entering and exiting. This accounts for the discrepancy between the SME and HCEAD results. SME believes that HCEAD analyzed this element appropriately.

SME noted that the interior mat should be cut down to fit into the doorframe.

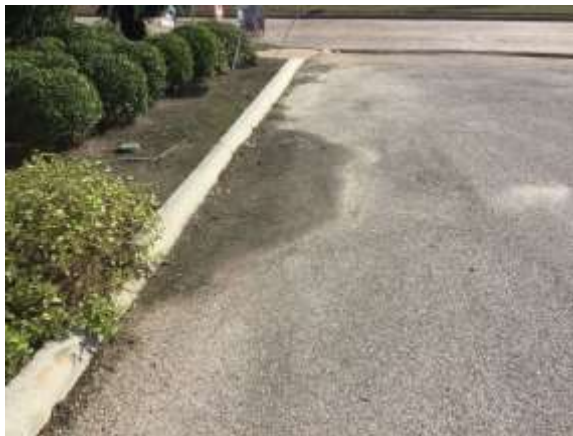
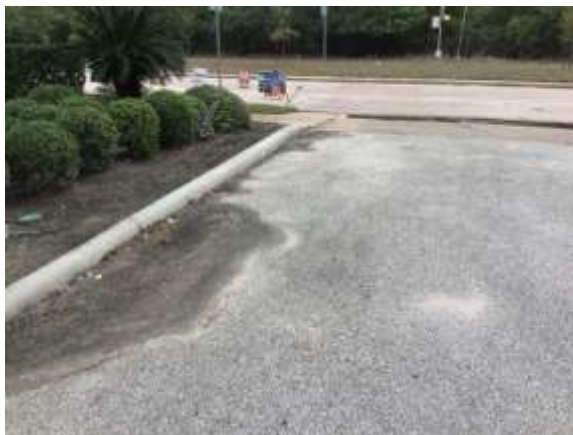
Item #	Proposed Remedy	SME Results	HCEAD Results
12476	Judge must ensure that facility clears mud in the drive aisle along the route from the public sidewalk before elections start.	Not Implemented	Implemented Properly

The mud and debris were present during the SME visit. HCEAD's notes state that it was not cleaned, yet the item was marked Implemented Properly. SME believes that the HCEAD Results were marked in error.

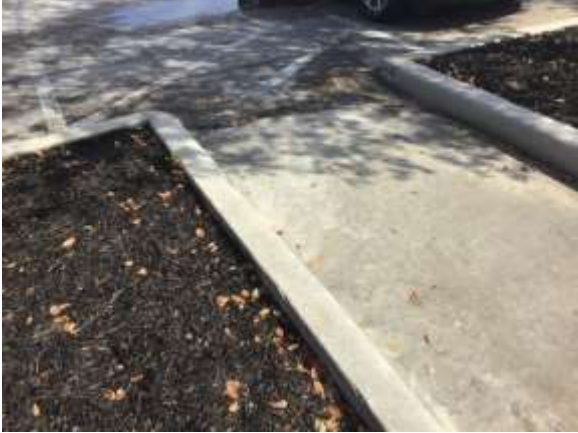
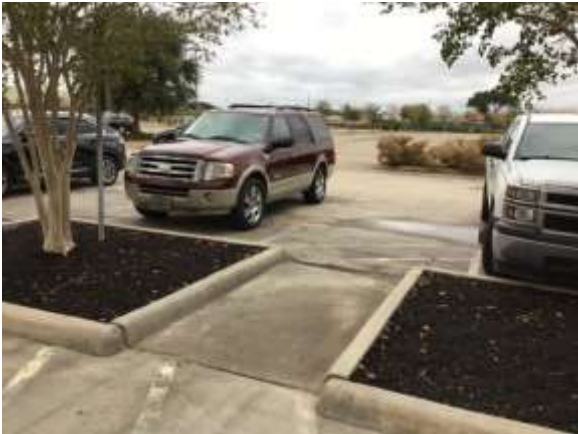
Item #	Proposed Remedy	SME Results	HCEAD Results
12475	Judge must ensure that the facility clears the mud from the route in front of the van accessible parking space access aisle before voting starts.	Not Implemented	Implemented Properly
<hr/>			
SME Photos

The mud and debris were present during the SME visit. HCEAD photos show similar conditions. SME believes that the HCEAD Results were marked in error.

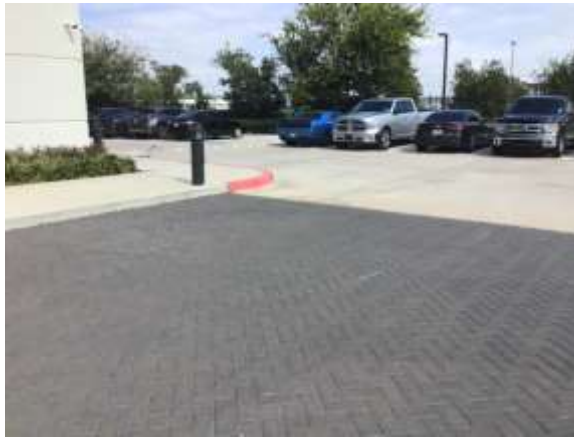
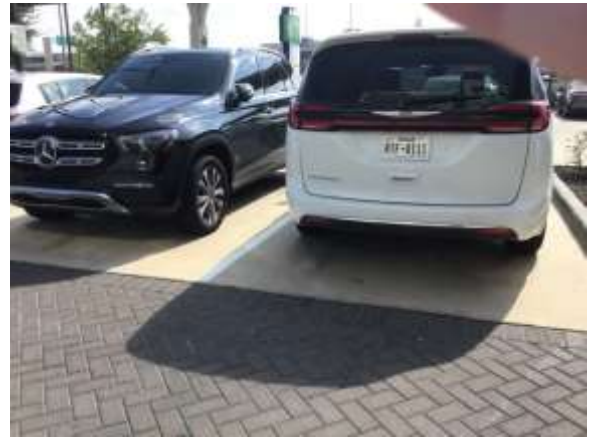
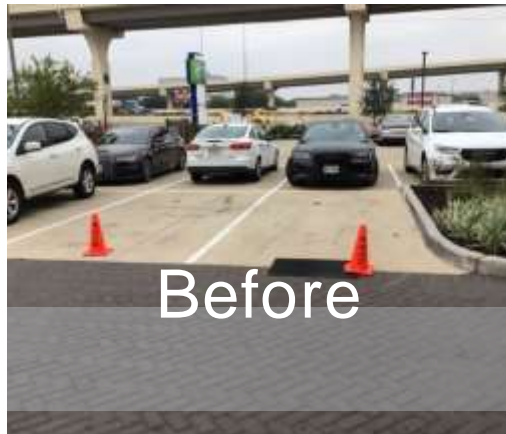
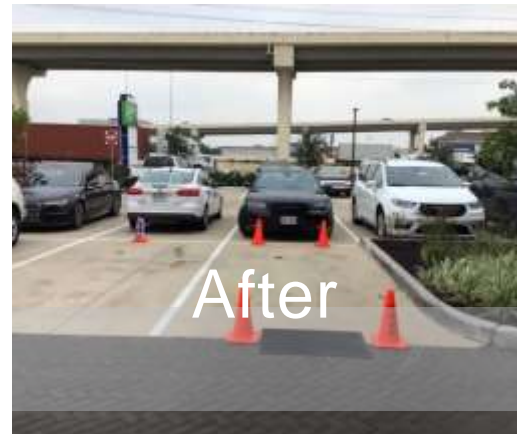
Item #	Proposed Remedy	SME Results	HCEAD Results
13023	Judge must place a temporary Van accessible parking and access aisle on the left hand side of drop off when facing I10 freeway on the first and second parking from first row closest to drop off. Judge must place two cones at the bottom and two cones at the top of the temporary access aisle on the first parking from passenger drop off. Judge must place one cone with ISA Van accessible sign on top of second parking from drop off.	Not Implemented	Not Implemented Properly

SME noted that none of the instructions were implemented. When questioned about it, HCEAD stated that the property manager would not allow them to use the front entrance for voting nor block any parking spaces in the front. HCEAD stated that the manager removed their implemented remedial measures. SME explained to the manager that this was required for Harris County to be able to use the location as a polling place. The manager did not budge. SME recommends not using this location for future elections unless the property agrees in writing to allow the implementation of all temporary remedial measures throughout the election.

HCEAD photos reflect their results. SME believes that HCEAD analyzed this element appropriately.

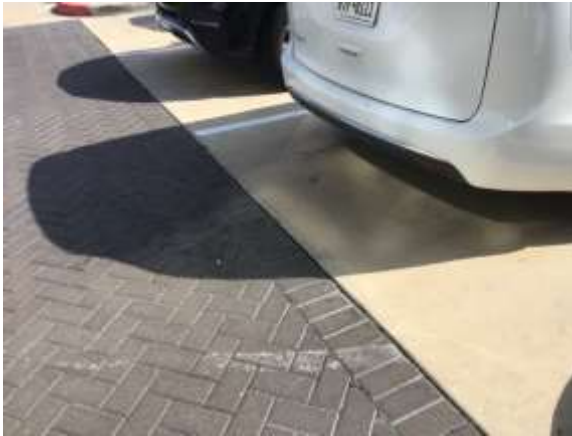
Item #	Proposed Remedy	SME Results	HCEAD Results
13026	New route from temporary van accessible parking and access aisle. Judge must place a mat and plate at the end of the first parking standard parking space diagonal to the main entrance. Judge must ensure automatic door is working during elections.	Not Implemented	Not Implemented Properly

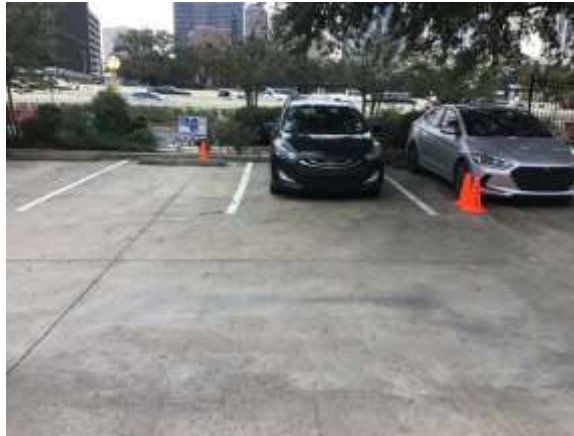
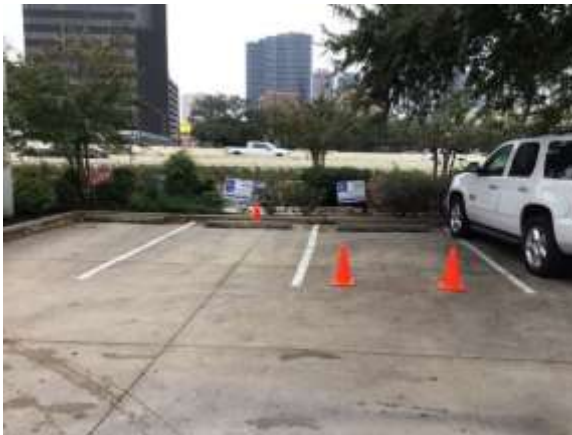
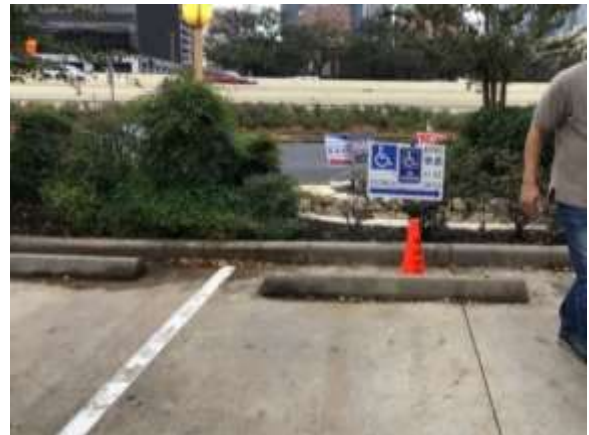
Item #	Proposed Remedy	SME Results	HCEAD Results
12554	Judge must place one cone with van accessible at the third parking spot from where the la Quinta sign is at. Judge must place two cones at the bottom parking next to the van accessible temporary parking.	Not Implemented Properly	Implemented Properly

When SME visited the polling place, it appeared as though the cones placed at the bottom of the access aisle were moved and a car was parked in the parking space. The sign was also not placed on the cone as directed by the remedial measure. SME was unable to fix the issue prior to leaving the polling place.

HCEAD's photos show the van accessible parking sign at two different locations on the directional signage at the top of the parking space, but not on the cone as directed by the remedial measure. SME believes that HCEAD analyzed this element appropriately.

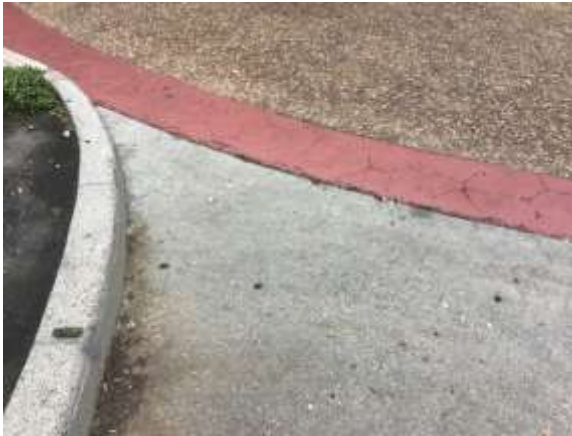
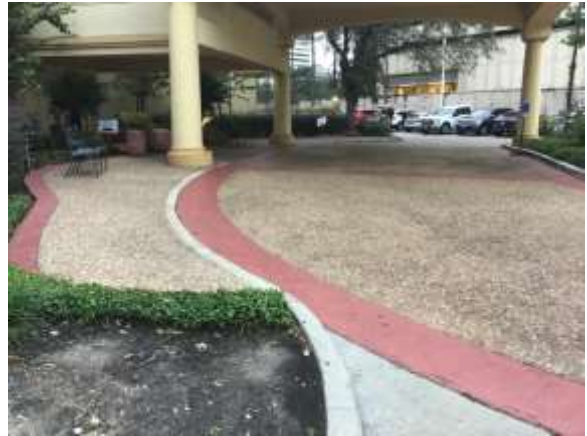
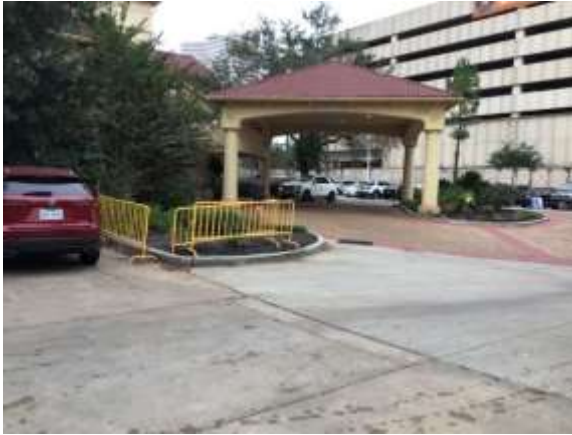
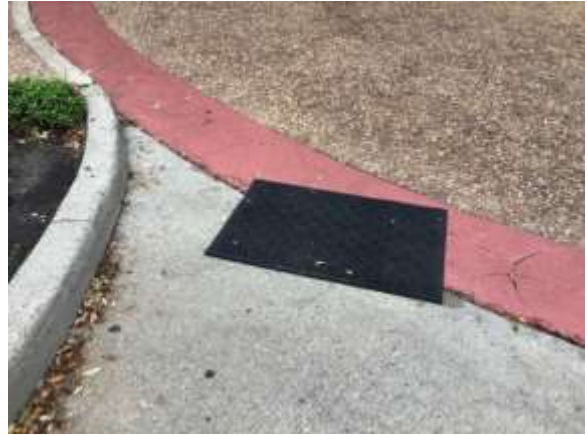
Item #	Proposed Remedy	SME Results	HCEAD Results
12555	Judge must place one thick mat on the joint aligned with the curb right on the red color pavement	Not Implemented	Implemented Properly

SME was informed by the Presiding Judge that the mat was stolen and a new one was requested but had not arrived. HCEAD photos show the mat placed as directed. SME believes that HCEAD analyzed this element appropriately.

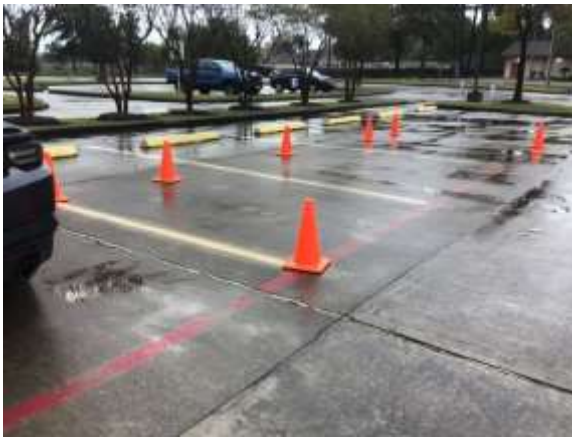
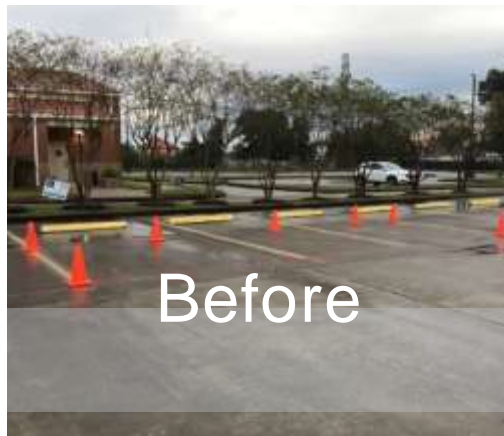
Item #	Proposed Remedy	SME Results	HCEAD Results
12314	Judge will create a temporary passenger drop off zone by placing 2 cones between the 3rd and 4th parking spaces from the right of the accessible aisle and 2 cones between the 6th and 7th parking spaces from the right of the accessible aisle and 1 cone in the center of the 5th parking space to the right of the accessible aisle.	Implemented Properly	Not Implemented Properly

SME noted that a car was parked in the location where the temporary passenger drop off was directed to be placed, so it appears that the judge shifted the drop off a few parking spaces over to accommodate. SME verified that the relocated location met the requirements and was compliant. HCEAD noted that a drop off sign was not provided, and they fixed it in the field. The signage is a voluntary element provided by HCEAD but is not required by the ADA. Because it wasn't called for in the remedial measure, SME was not checking for signage. This accounts for the discrepancy between the SME and HCEAD results. SME believes that HCEAD analyzed this element appropriately.

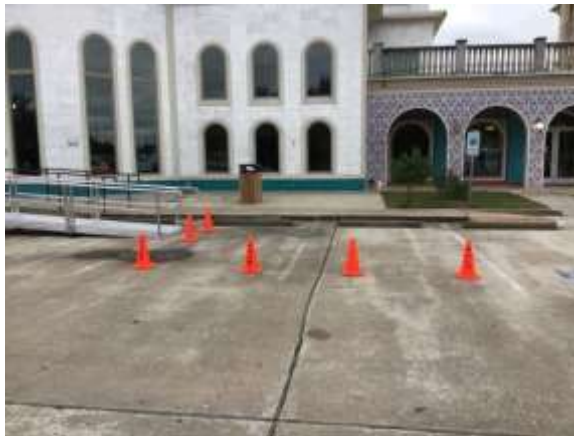
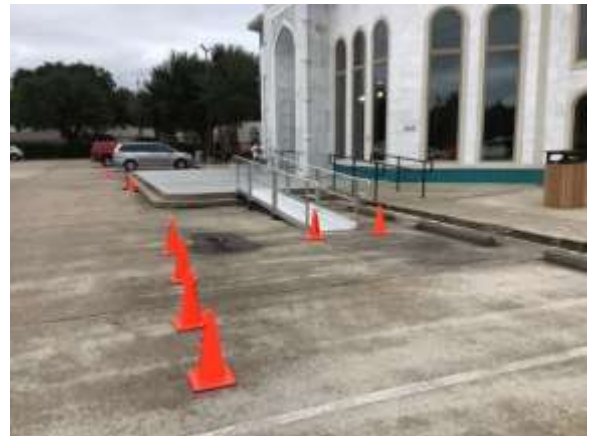
SME noted that the cones were moved by the facility when they arrived, but SME moved them back. Unfortunately, no before photo was taken before the issue was fixed. HCEAD noted that everything was implemented properly, which aligns with the photographs. This accounts for the discrepancy between the SME and HCEAD results. SME believes that HCEAD analyzed this element appropriately.

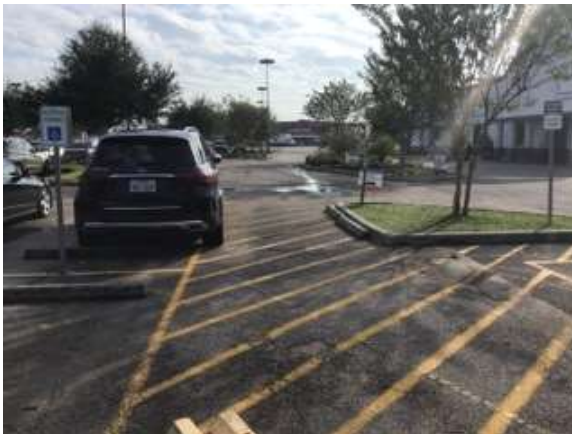
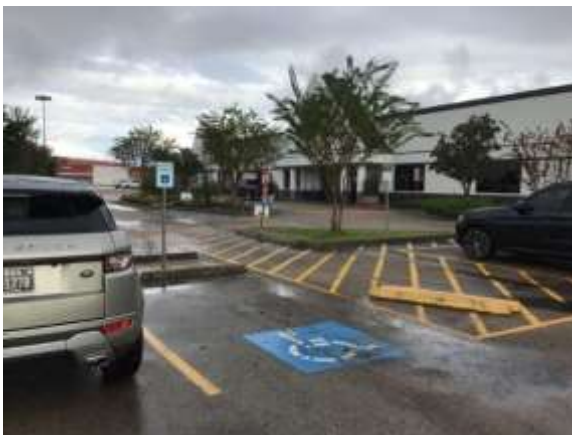
Item #	Proposed Remedy	SME Results	HCEAD Results
12410	Judge must place van accessible sign on the second accessible parking space to the left of the light post when facing the facility	Not Implemented	Not Implemented Properly

SME noted that no sign was posted at the parking space. Because a wheel stop was located in the access aisle, blocking its use, SME did not fix the issue in the field. HCEAD marked the item Not Implemented Properly and noted the wheel stop in the access aisle. Because no effort was undertaken to implement the remedial measure, HCEAD should have marked the remedial measure as Not Implemented.

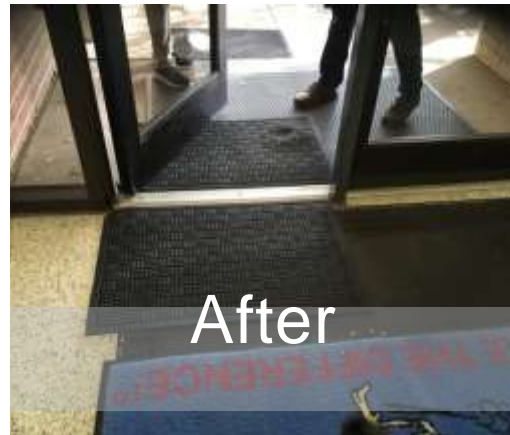
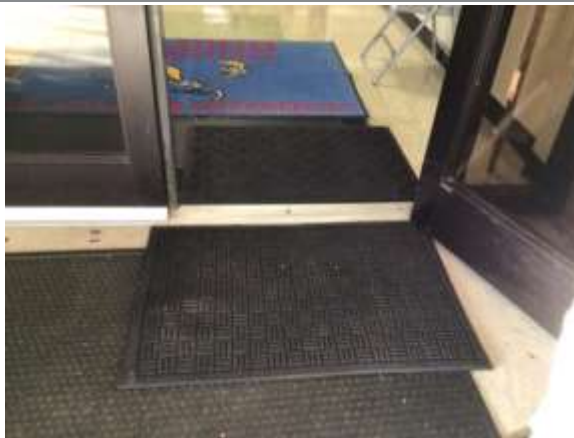
Item #	Proposed Remedy	SME Results	HCEAD Results
15197	Judge must place one mat on the interior and exterior against threshold on accessible entrance. Judge must put one extra mat on the interior left hand side of accessible entrance. Judge must ensure that facility tapes down mats on accessible entrance. Total of 3 mats.	Not Implemented	Implemented Properly

SME fixed the issues they saw in the field, which accounts for the discrepancy between the SME and HCEAD results. The mat on the interior left-hand side of the threshold is not needed as the center post of the door was not removed. SME believes that HCEAD analyzed this element appropriately.

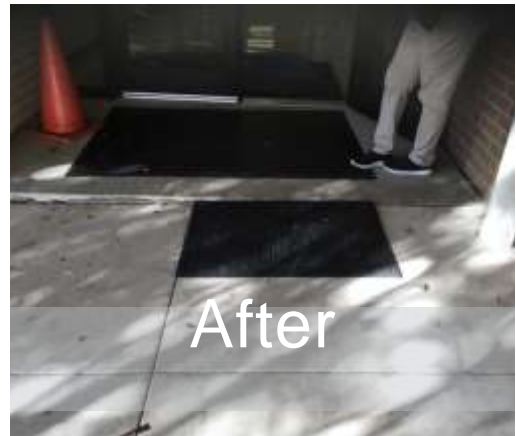
Item #	Proposed Remedy	SME Results	HCEAD Results
15189	Judge must place one mat and one plate on the level change in front of accessible entrance.	Not Implemented Properly	Implemented Properly

SME observed the mat placed over the level change, not abutting it, and fixed the issue in the field. This accounts for the discrepancy between the SME and HCEAD results. SME believes that HCEAD analyzed this element appropriately.

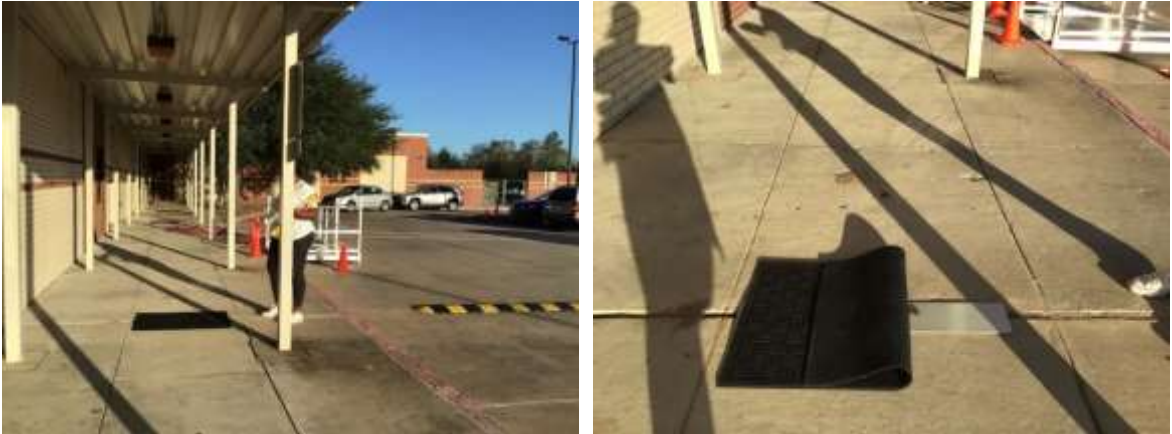
Item #	Proposed Remedy	SME Results	HCEAD Results
15194	Judge must place one mat and one plate adjacent to the speed bumps	Not Implemented	Implemented Properly
SME Photos	Unable to take photos due to presence of children at school dismissal.		
HCEAD Photos

SME observed no mat or plate placed along this route and fixed the issue in the field. This accounts for the discrepancy between the SME and HCEAD results. SME believes that HCEAD analyzed this element appropriately.

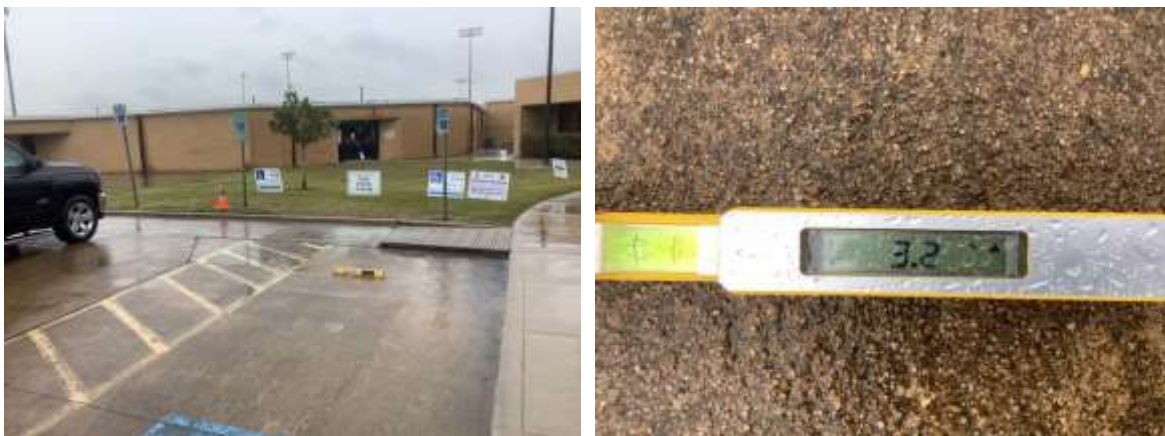
SME observed excessive openings at the top of the access aisle and along the accessible route to the entrance. The excessive openings were not measured in the survey.

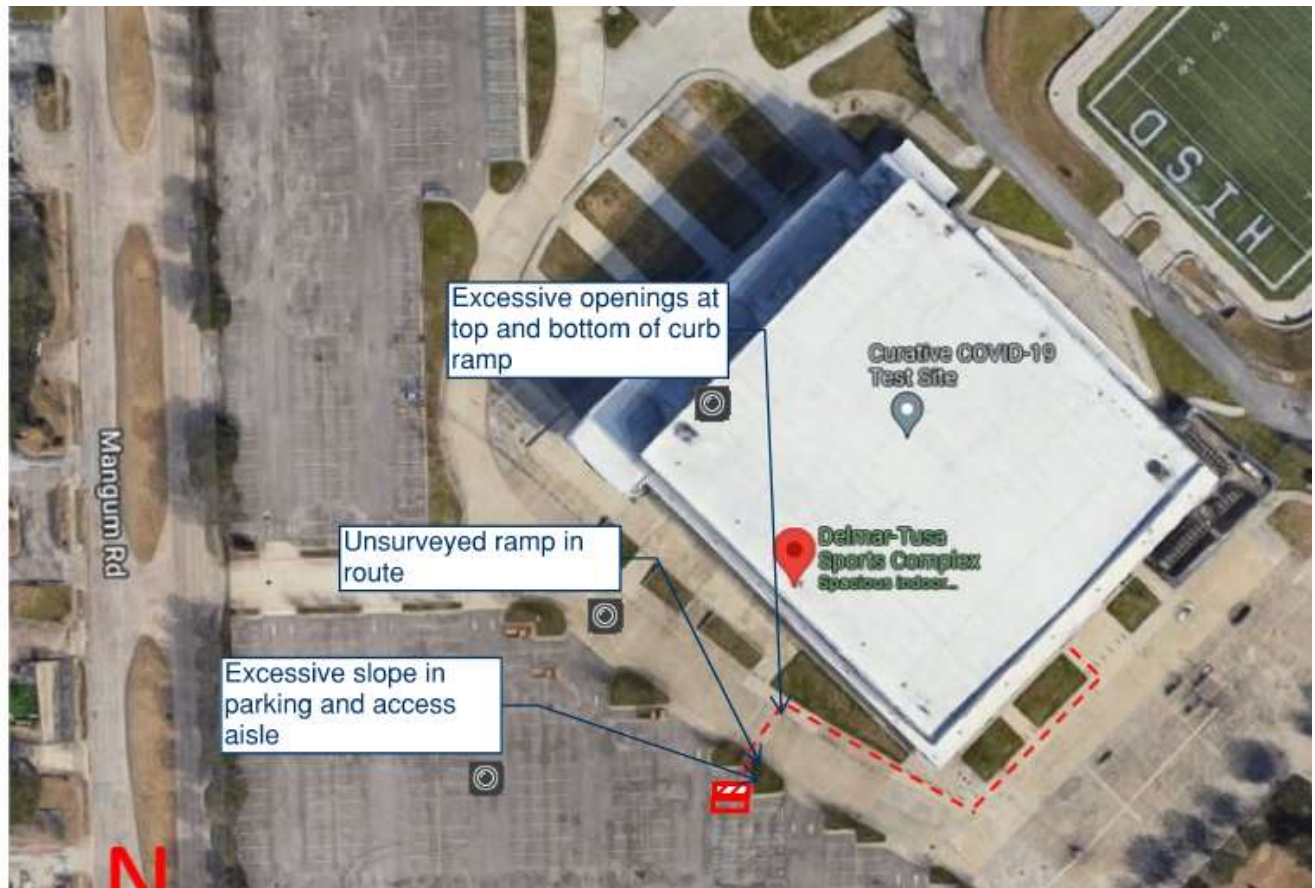
Excessive slopes were observed by the SME within the van accessible parking space and access aisle. The polling place survey did not identify any excessive slopes within this element.

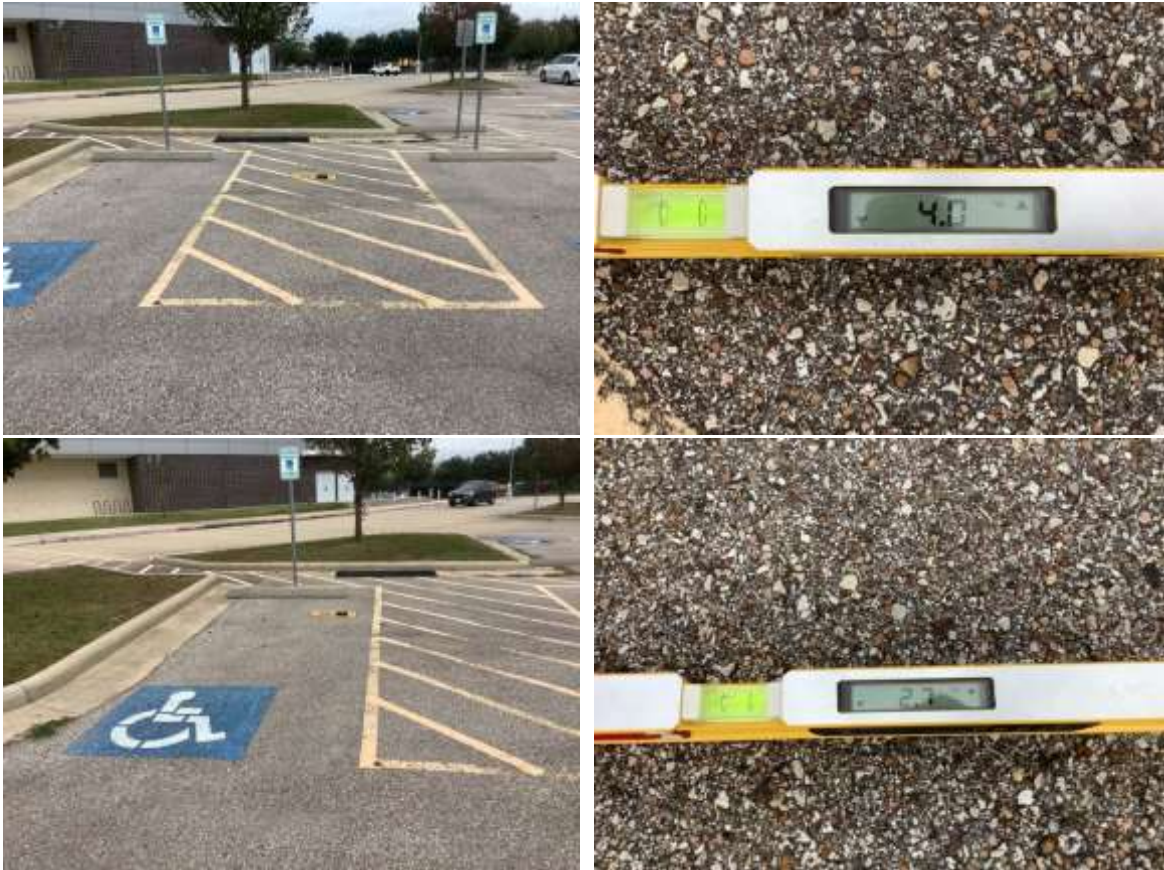
Excessive running slopes along the accessible route near parking were observed by the SME. The polling place survey did not identify running slopes along this route exceeding 5%.

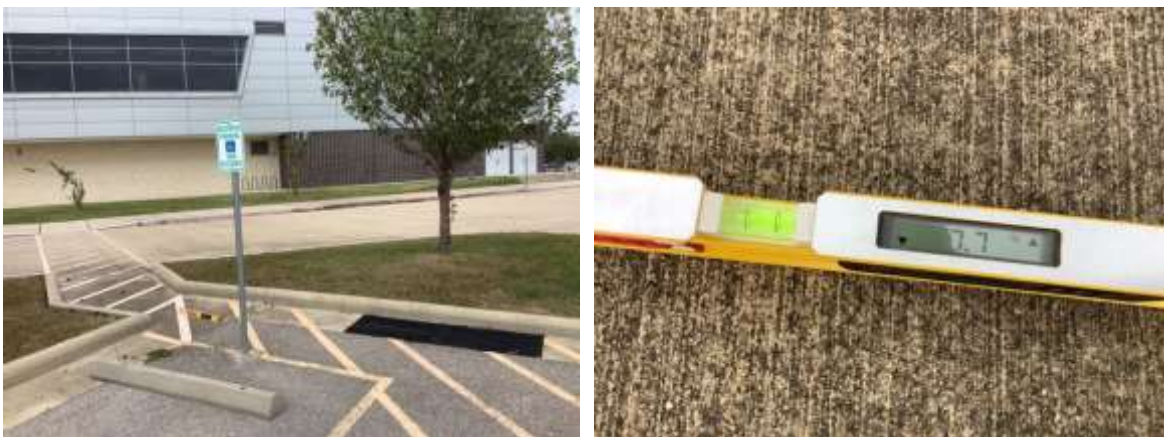
SME observed excessive openings along the accessible route from the parking to the entrance which were not documented in the polling place survey.

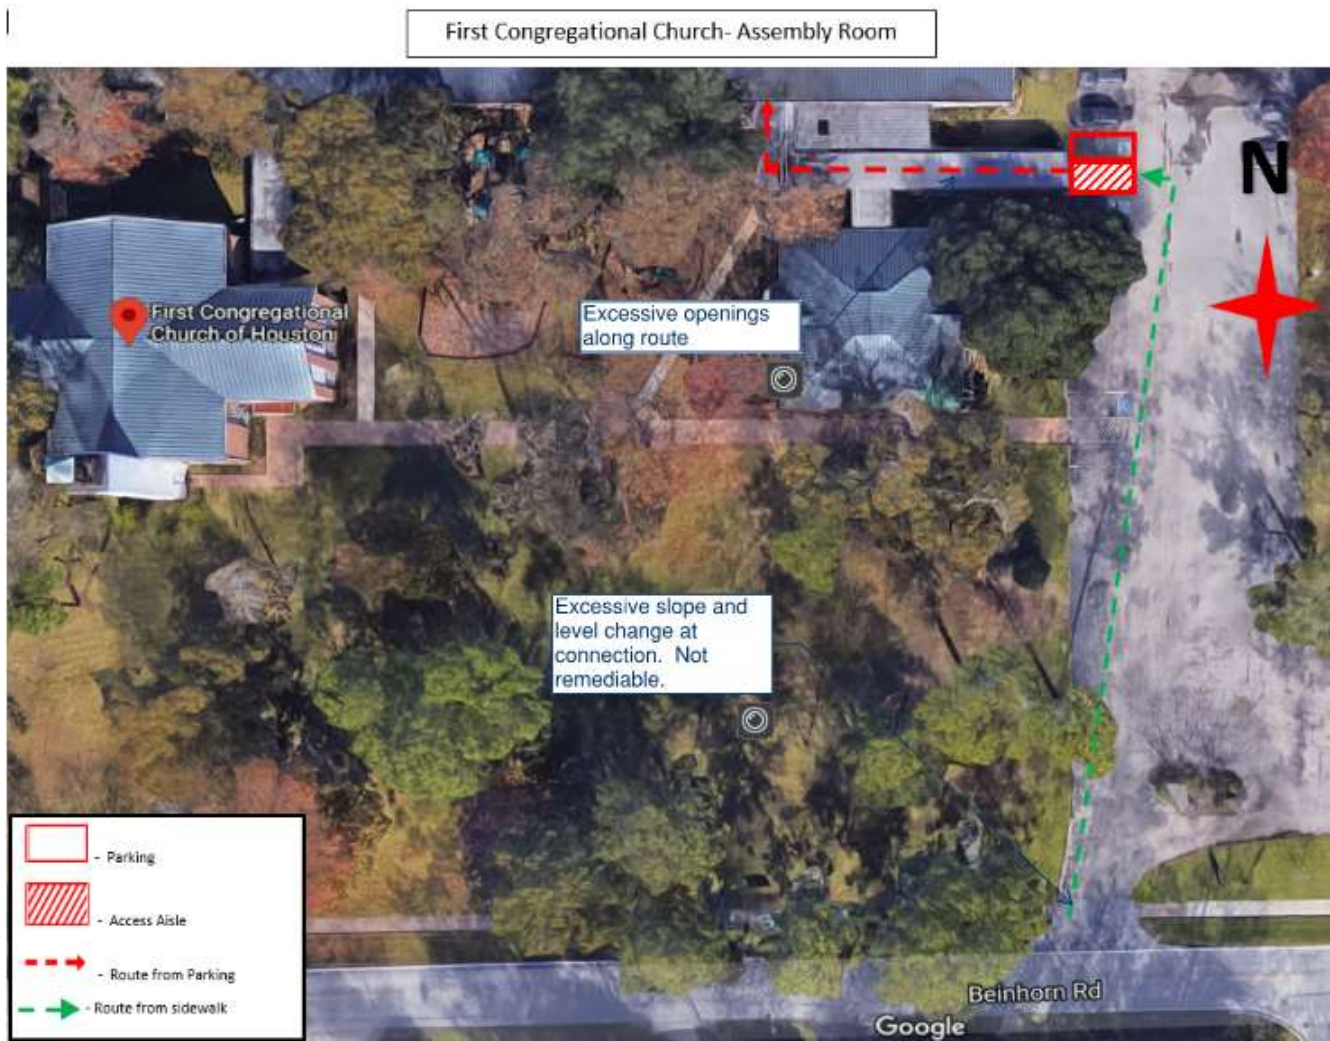
**Figure 7 - First Congregational Church**

The SME noted issues with the survey results at this polling place. The diagram below shows the locations where SME identified violations that were not found in the Harris County survey.

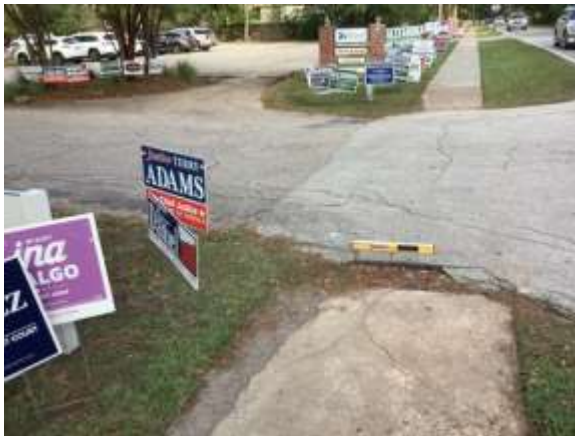
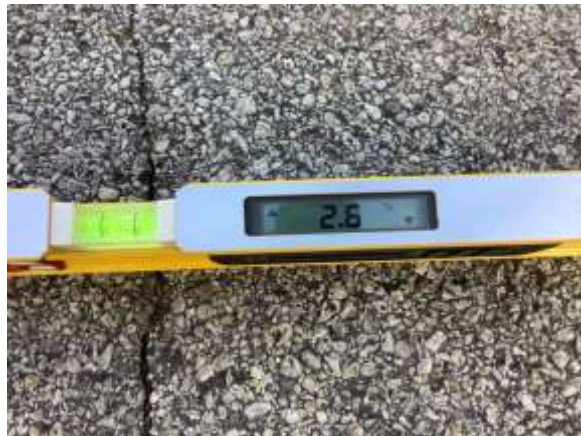
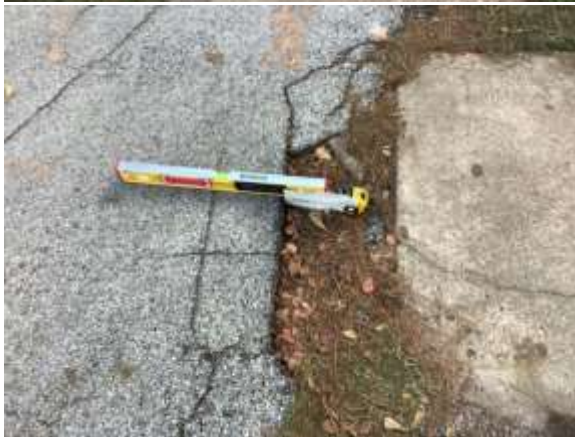
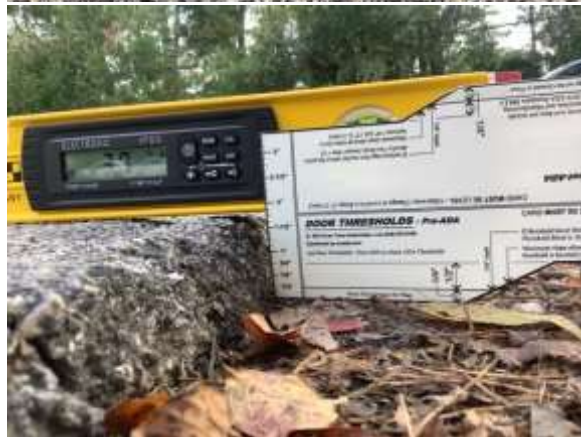
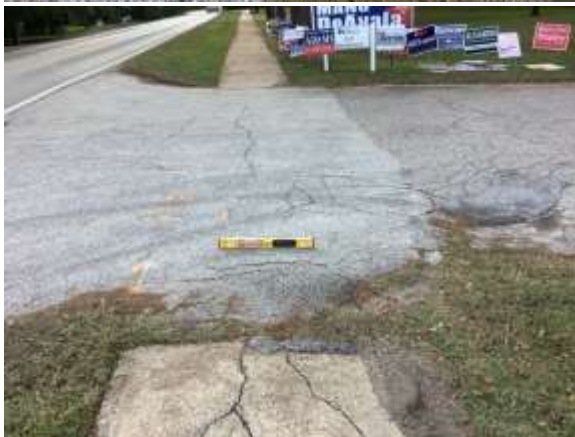
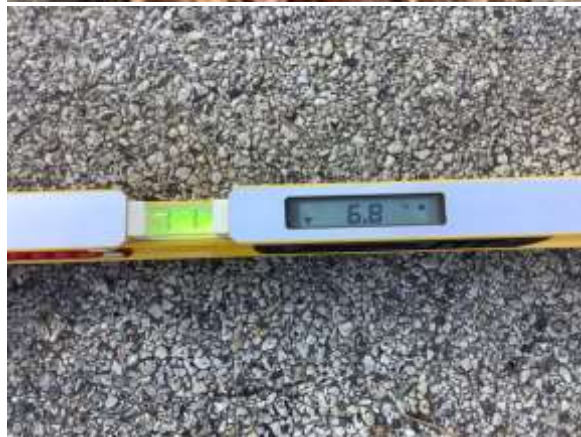
An excessive level change and excessive slopes were observed by the SME at the public sidewalk connection. The SME determined that these violations are not remediable.

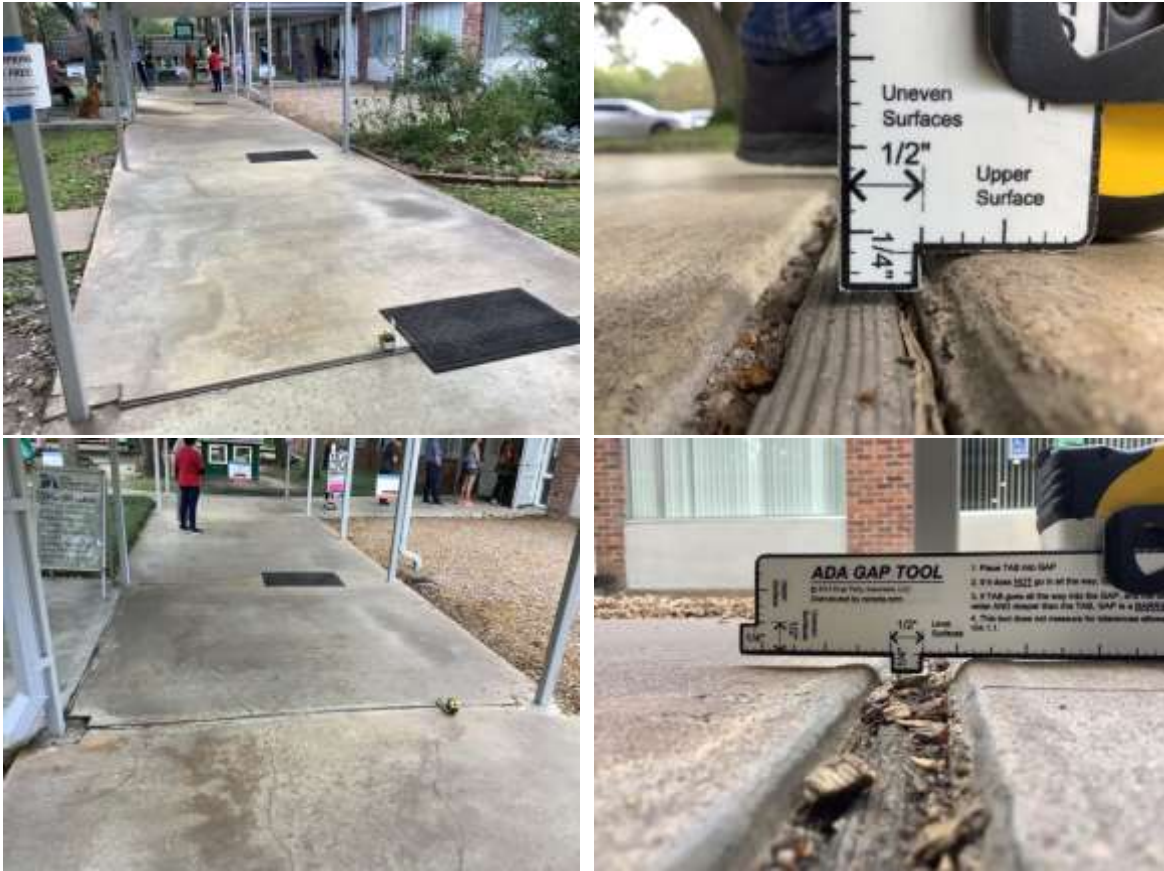
SME observed excessive openings along the route from parking that were not captured in the polling place survey.

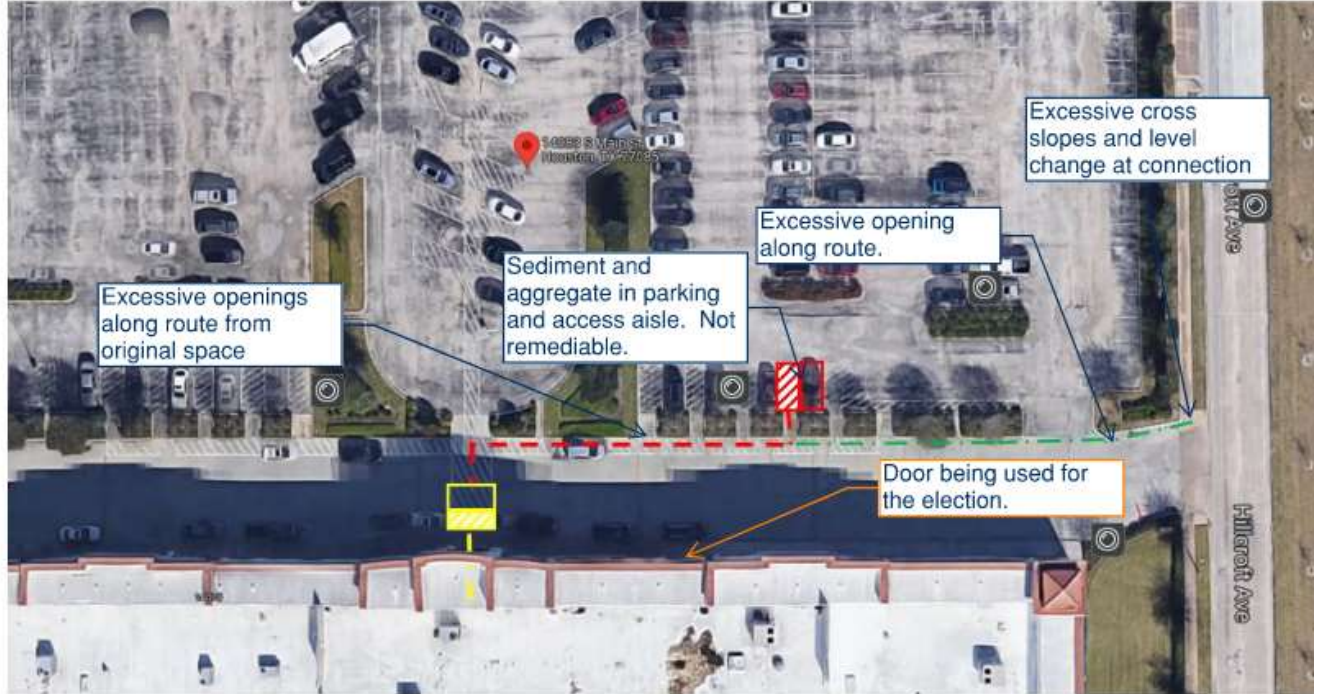
An excessive level change and excessive slopes were observed by the SME at the public sidewalk connection. The SME determined that these violations are not remediable.
