# FEBRUARY 2023 SUBJECT MATTER EXPERT PUBLIC REPORT

RE: UNITED STATES V. HARRIS COUNTY, TEXAS, NO. 4:16-CV-02331 (S.D. TEX.)

United States Dept. of Justice  
Civil Rights Division

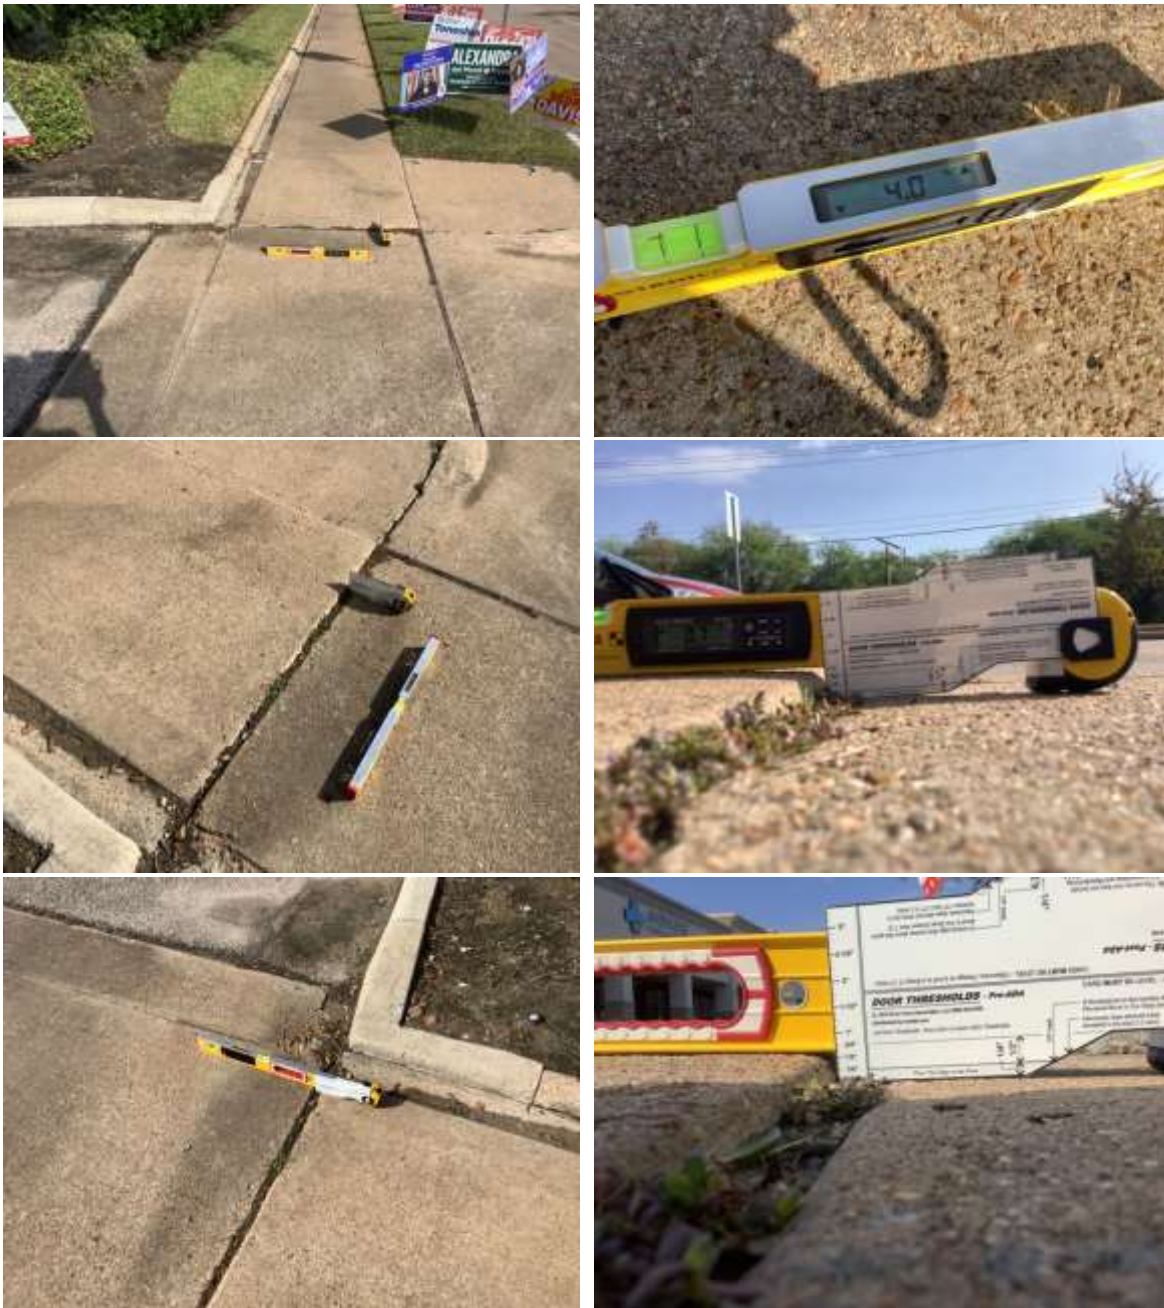
SME observed an excessive opening along the route from the public sidewalk that was not captured in the polling place survey.

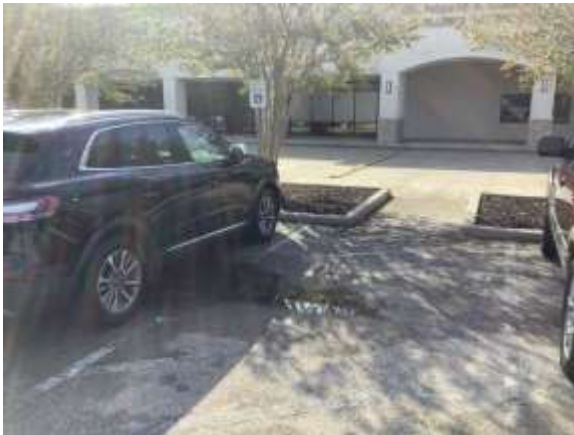
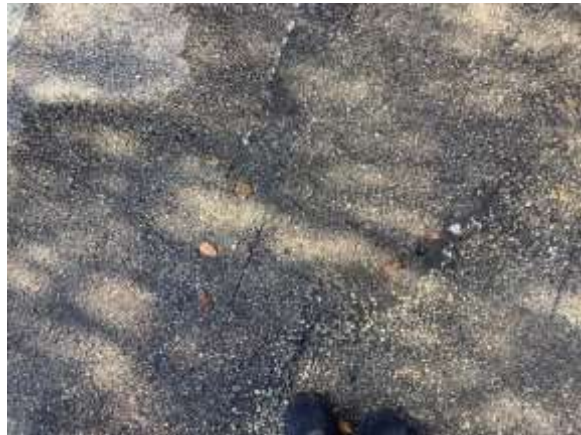
SME also observed non remediable sediment and aggregate in the van accessible parking space and access aisle.

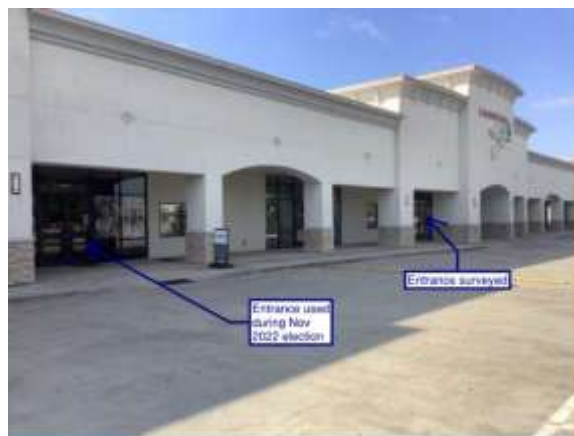
The accessible entrance door identified in the polling place survey was not used during the election.

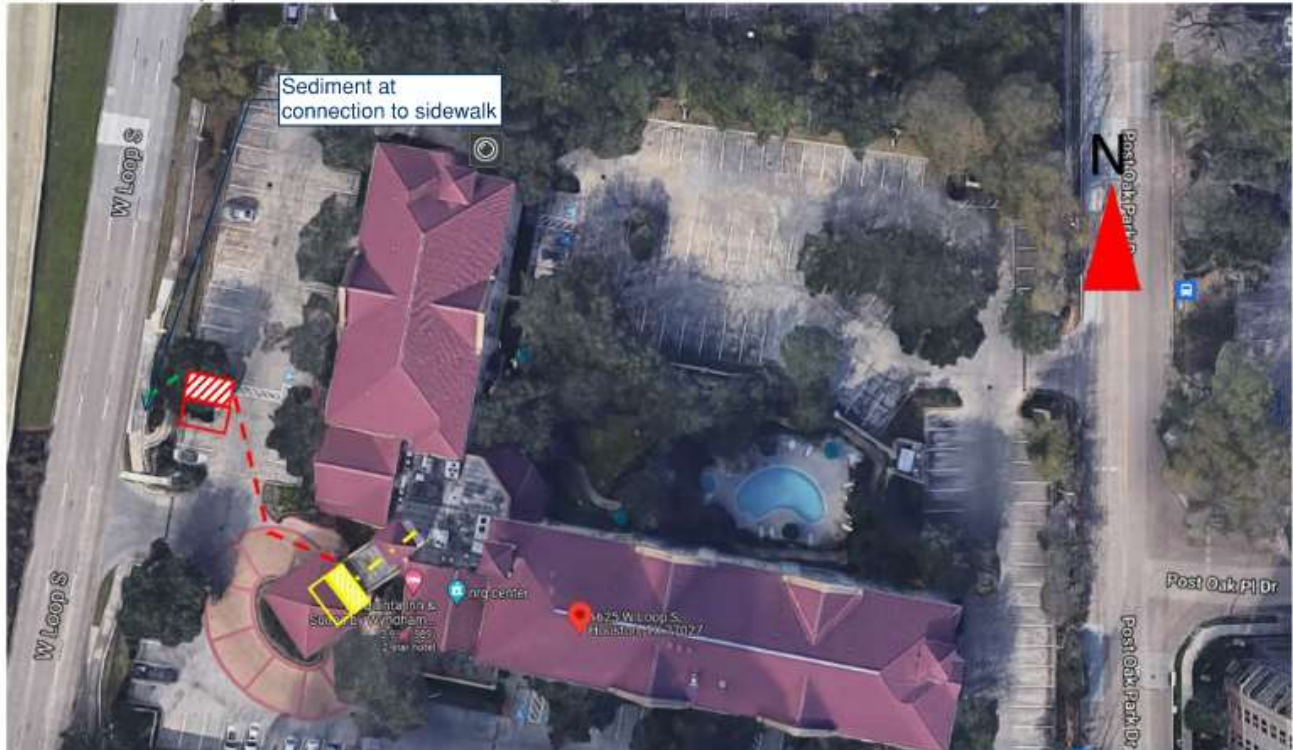
Sandy sediment runoff from the planter area was observed at the sidewalk connection on the accessible route. This appears to be a temporary issue that was not present during the polling place survey.

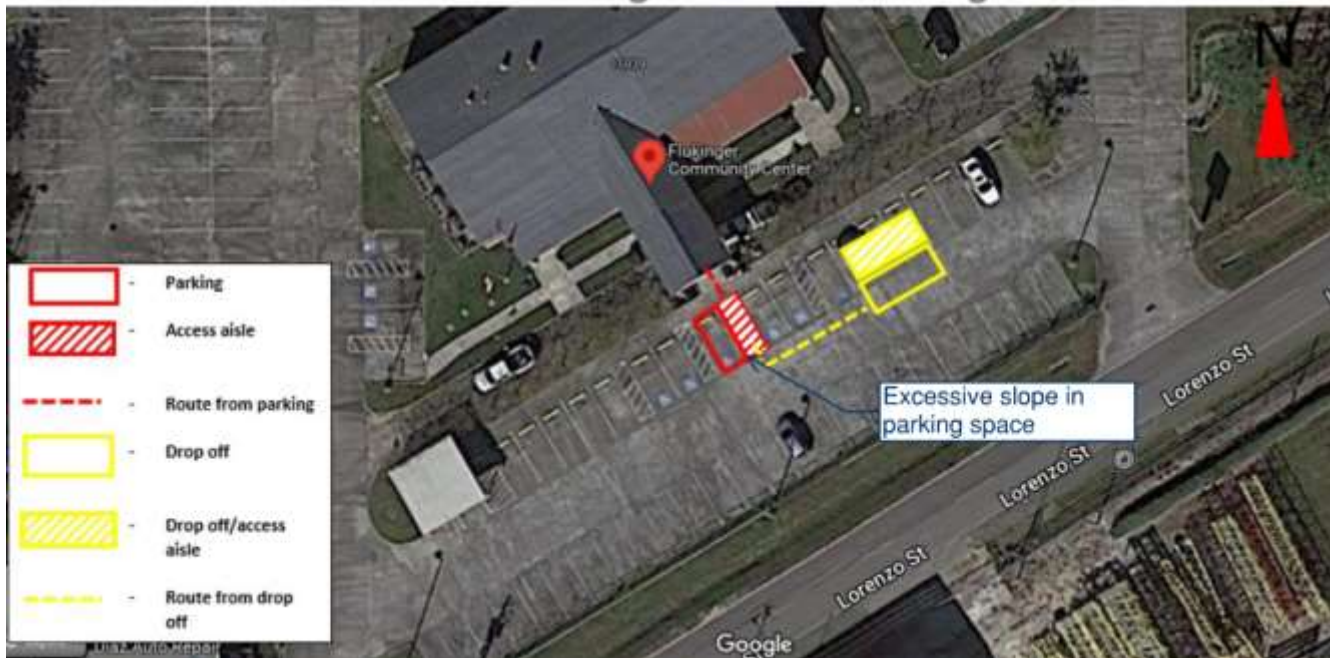
The SME observed excessive sloping within the van accessible parking space. Slopes are not permitted to exceed 2.08% in any direction within the van accessible parking space or access aisle.

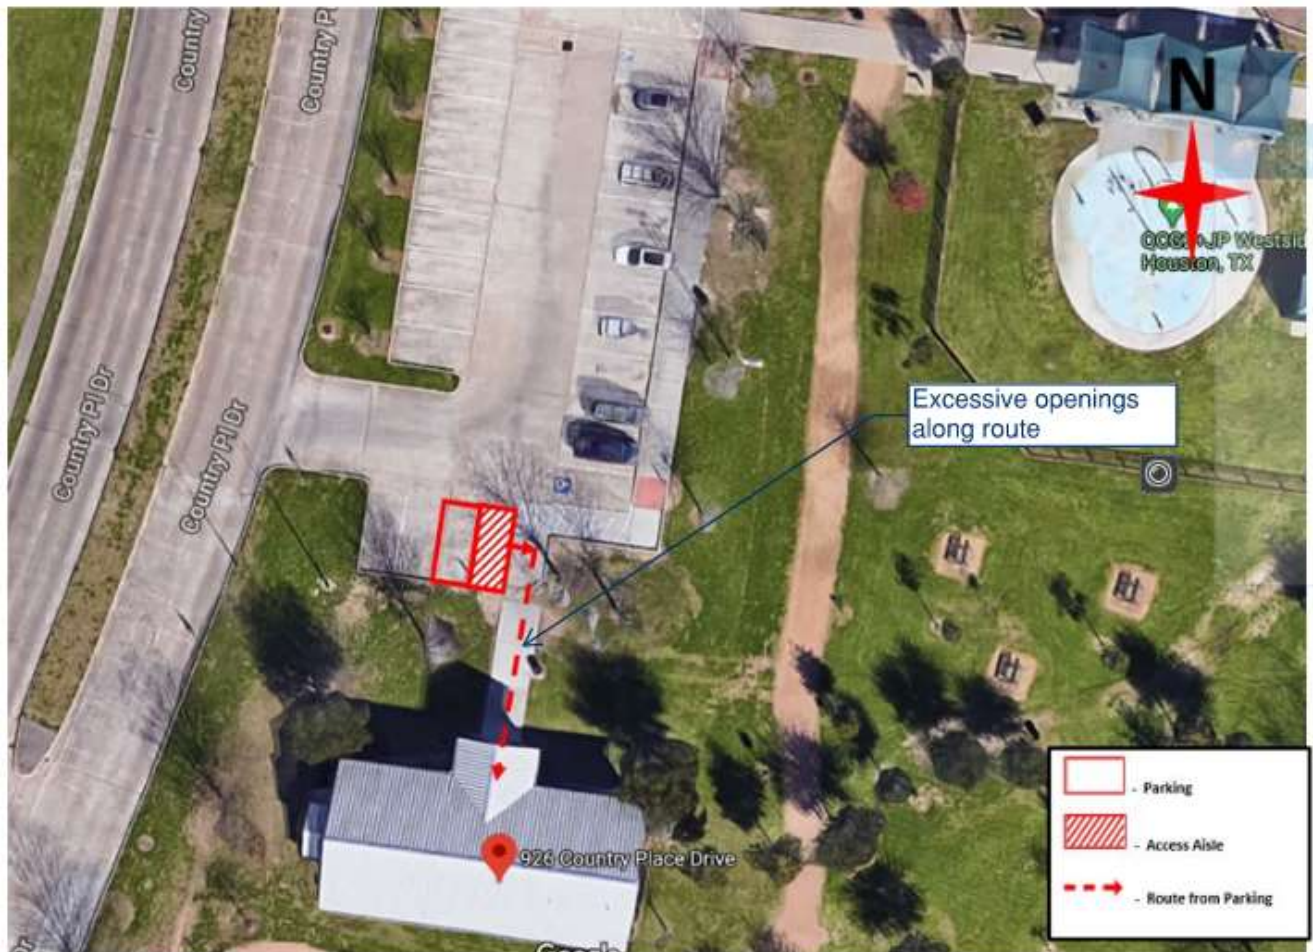
The SME observed excessive openings along the route from the van accessible parking space that were not captured in the polling place survey. Openings greater than  $\frac{1}{2}$ " wide and  $\frac{1}{4}$ " deep are not permitted along accessible routes.

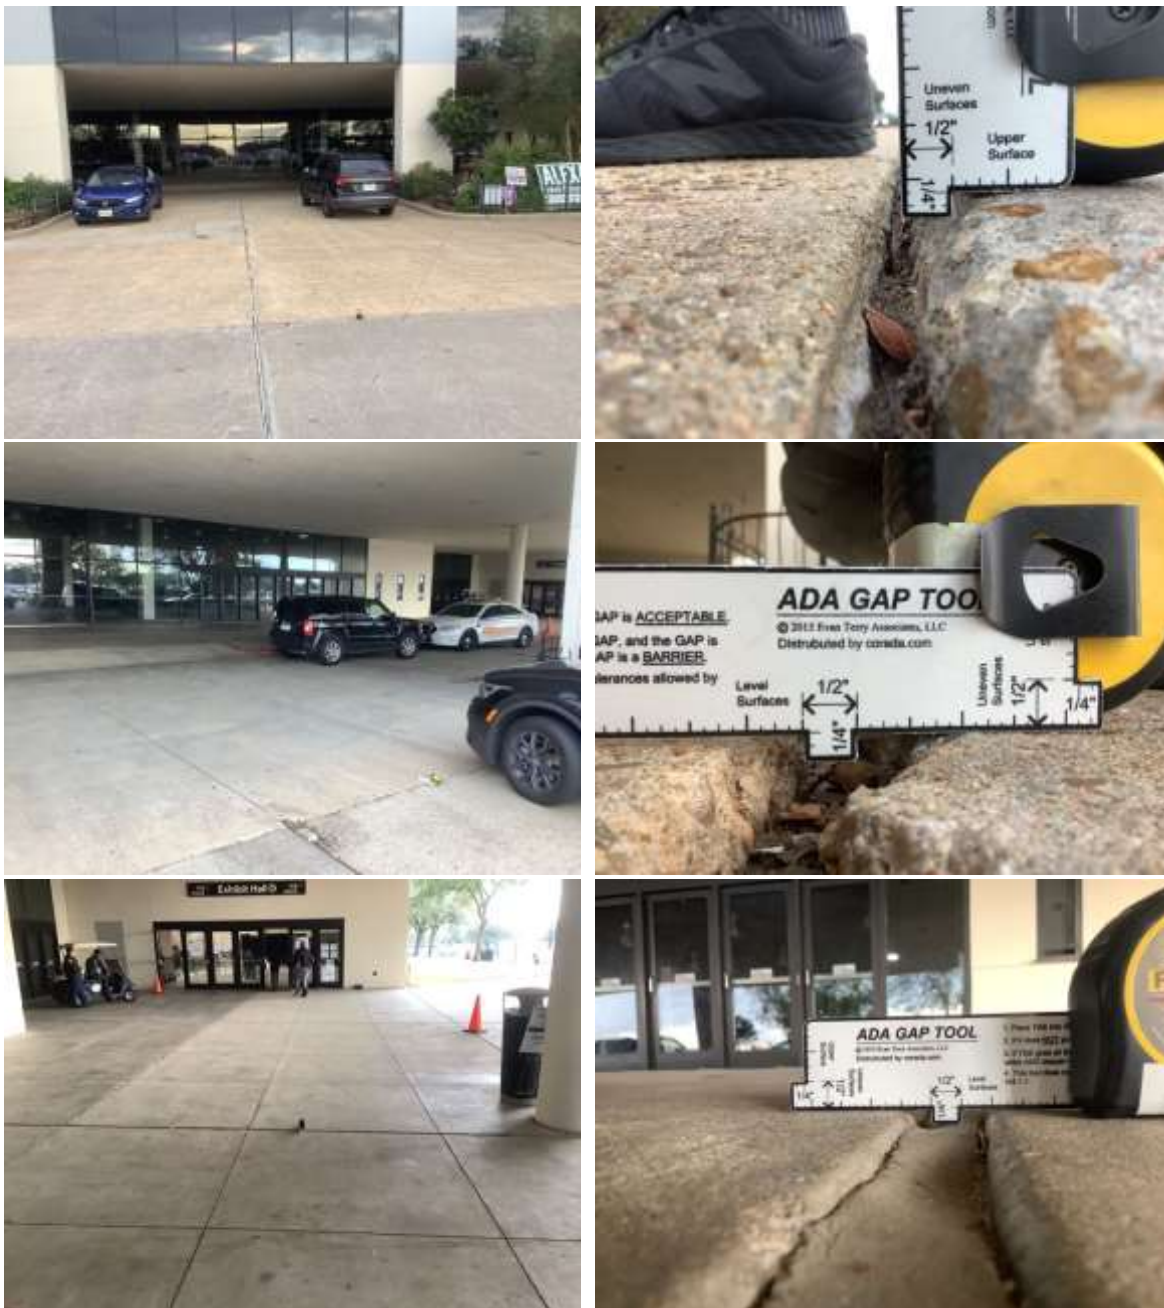
Multiple cars were parked along the accessible route from the van accessible parking. The route needs to be marked with cones so that cars do not block the route.

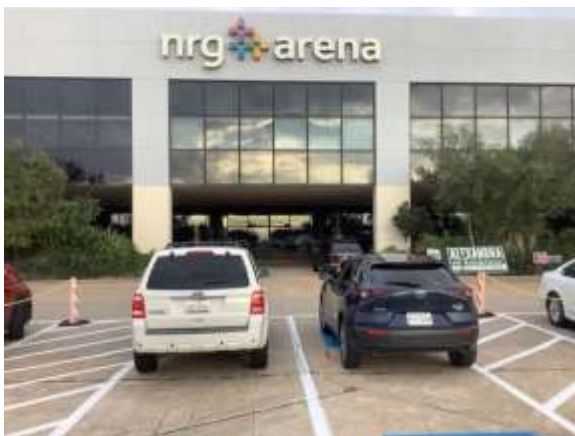
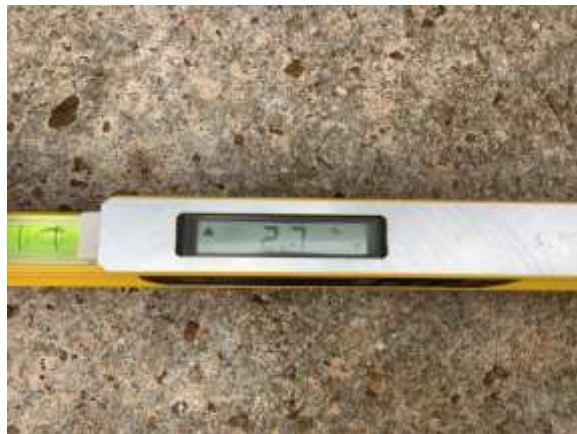
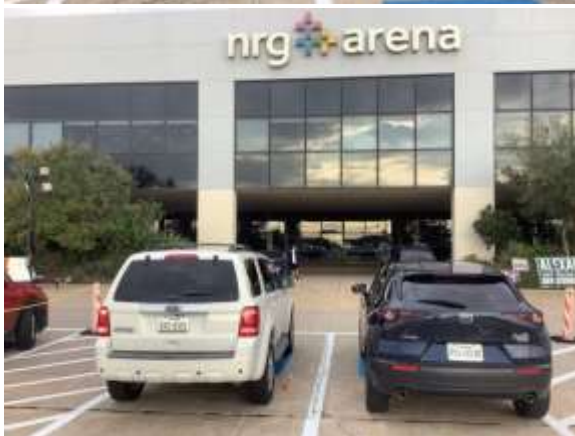
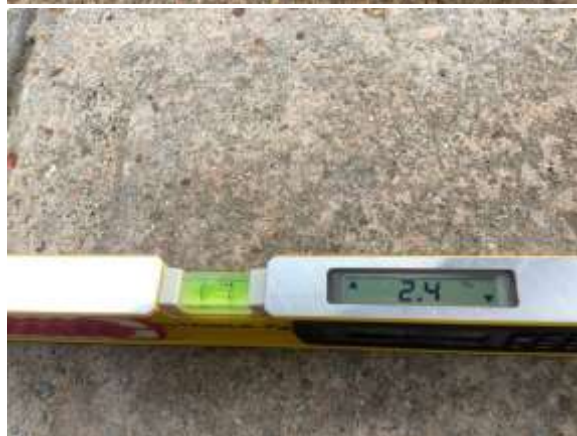
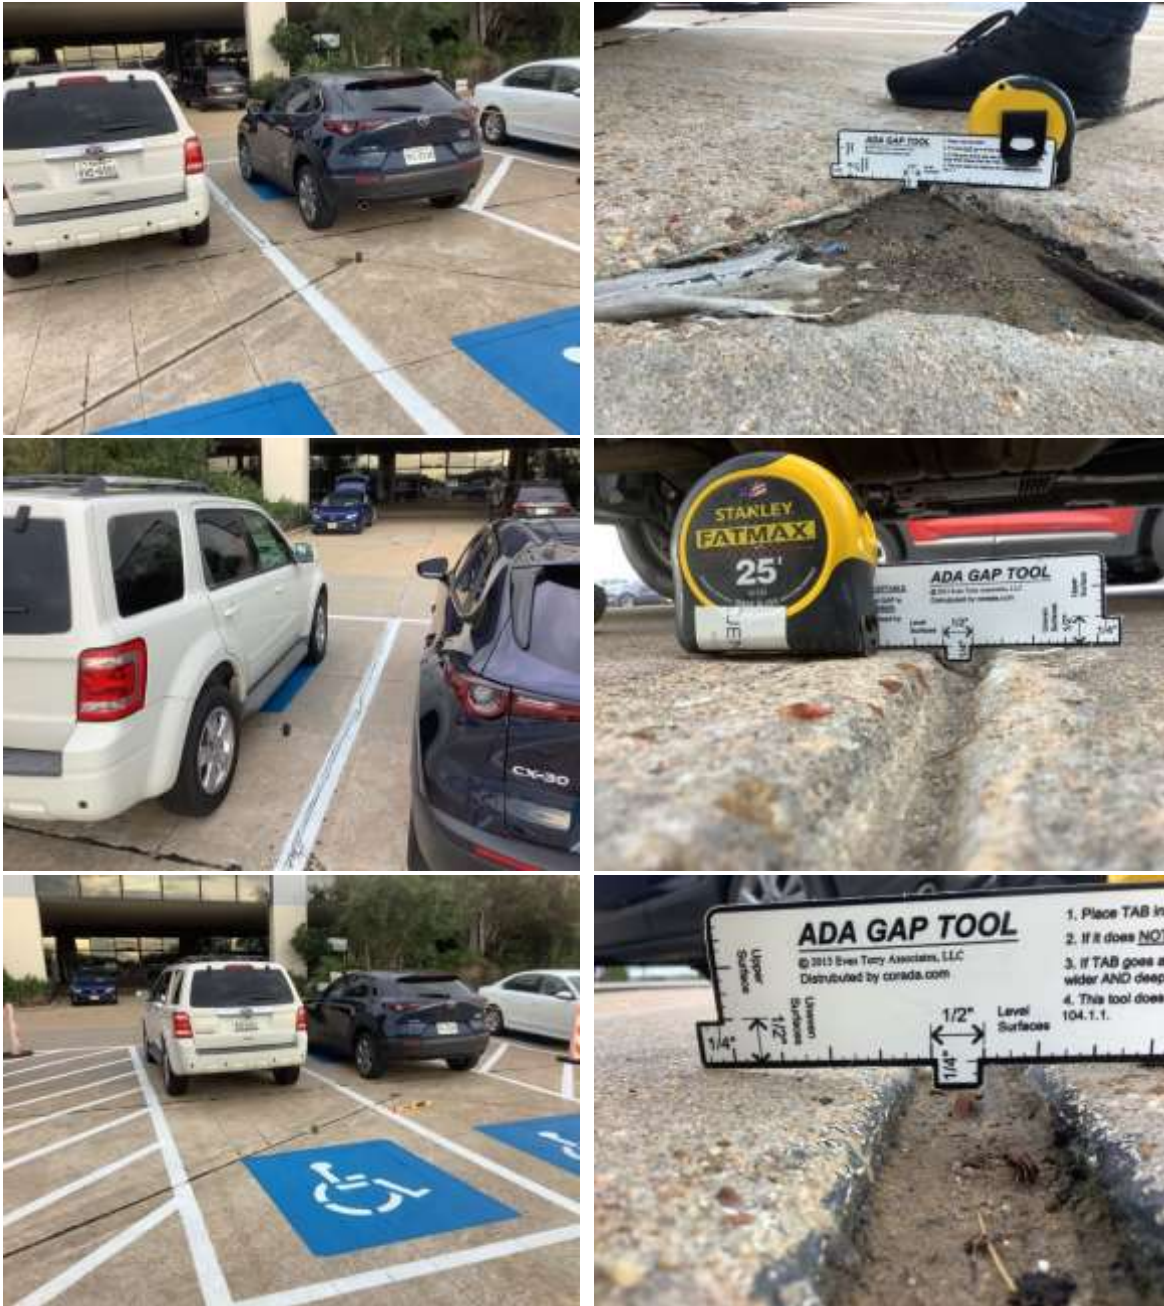
The SME observed excessive slopes and openings within the van accessible parking space and access aisle that were not captured during the polling place survey. Note that the temporary access aisle was not blocked with cones to prevent cars from parking in it. Slopes may not exceed 2.08% in any direction in accessible parking spaces and openings greater than ½" wide and ¼" deep are not permitted along accessible routes.

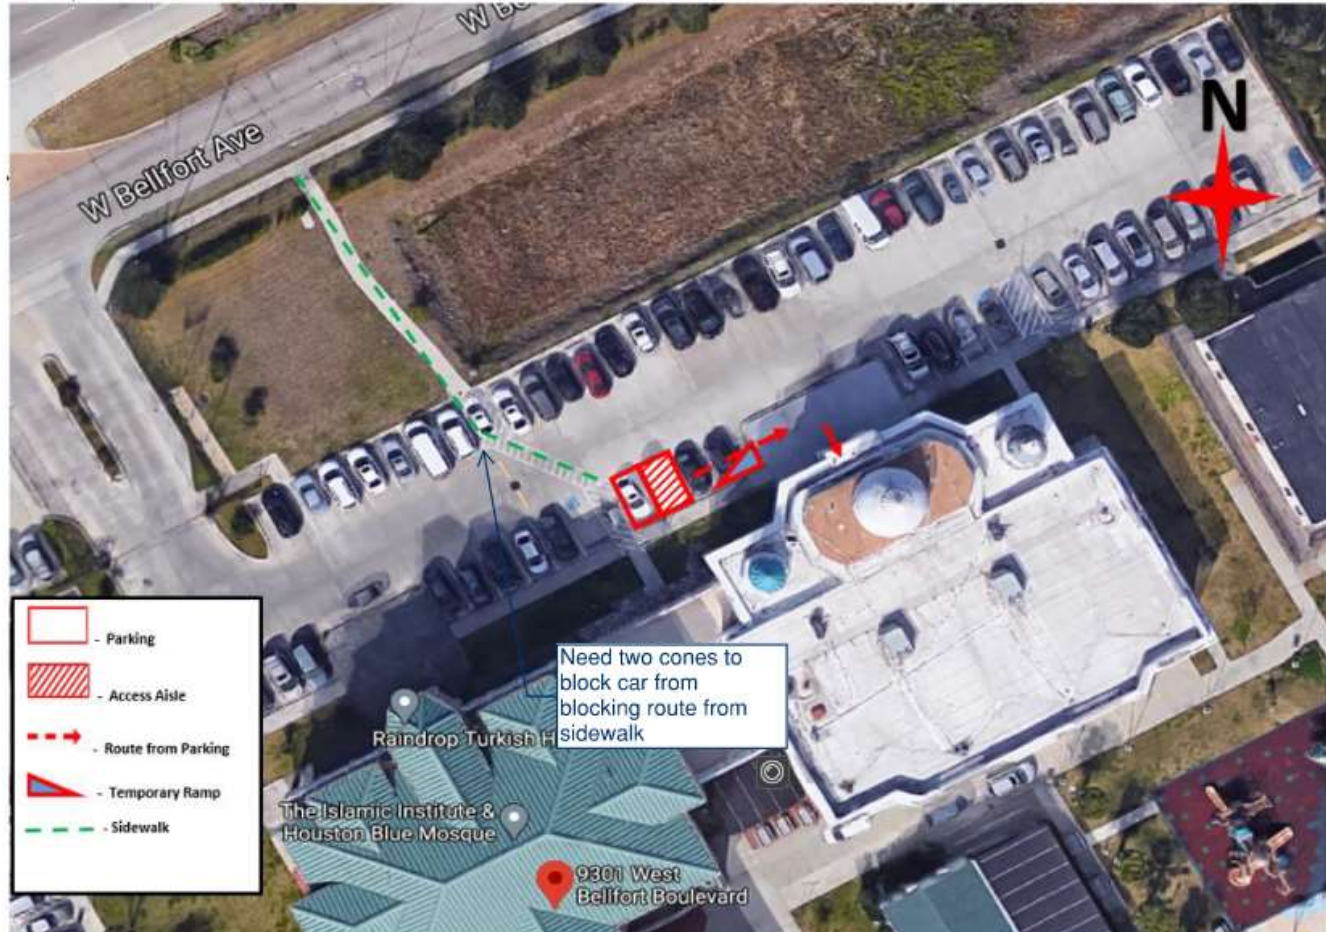
SME observed a car parked, blocking the accessible route from the public sidewalk. Based on the satellite imagery in the aerial diagram, this should not have been a surprise. A checklist item specifying placing cones to block a car from parking in that area should be created.

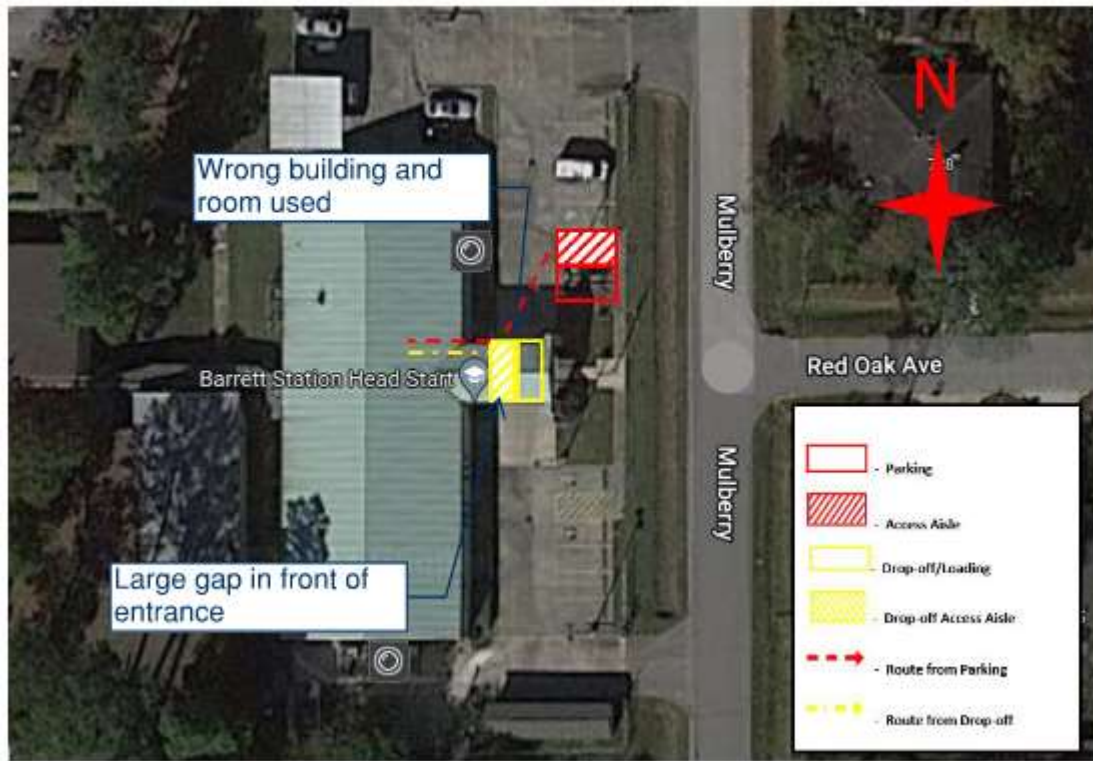
The building that is shown in the aerial and the building surveyed by Harris County is not the same building that is used for voting. The building shown and surveyed is Barrett Station Community Center. Riley Chambers is an older, less accessible facility located behind Barrett Station.

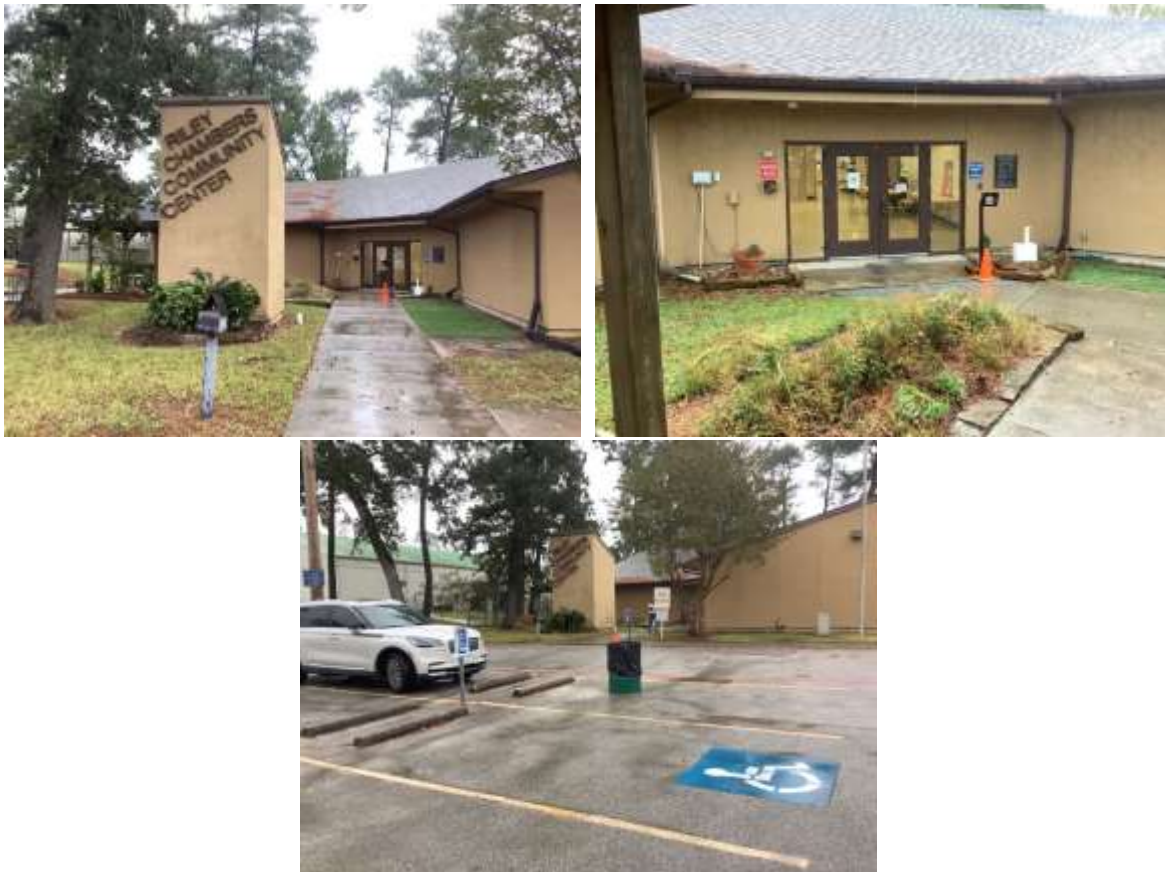
At Barrett Station, the SME observed an excessive opening in front of the accessible entrance that was not captured in the survey.

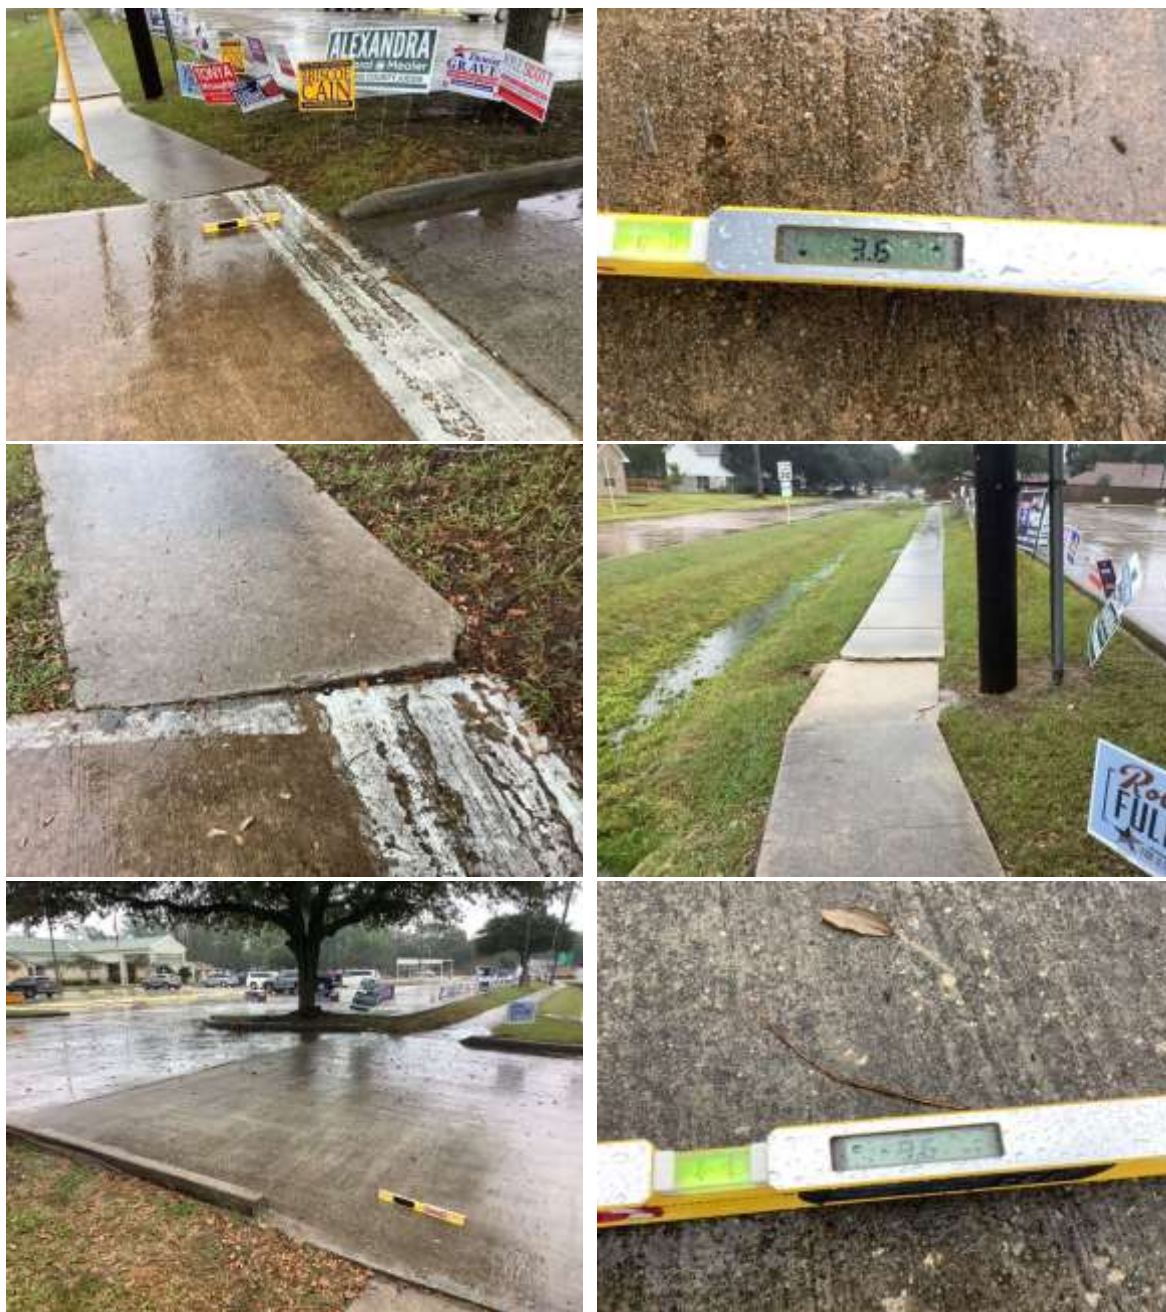
The sidewalk leading to the polling place has heaved and settled, creating a non-compliant and unsafe route for persons with disabilities. The alternate connection to the public sidewalk also contains excessive cross slopes. These items were not captured in the polling place survey and are not remediable.

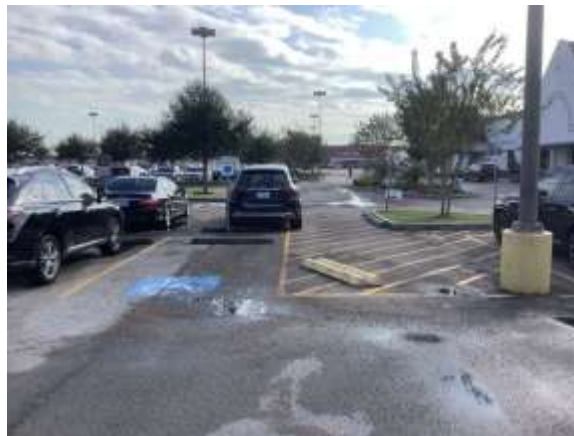
SME observed loose aggregate, gravel, and dirt within the van accessible parking access aisle. A peeling asphalt patch was also observed along the route to the entrance. These were not observed or captured in the polling place survey.

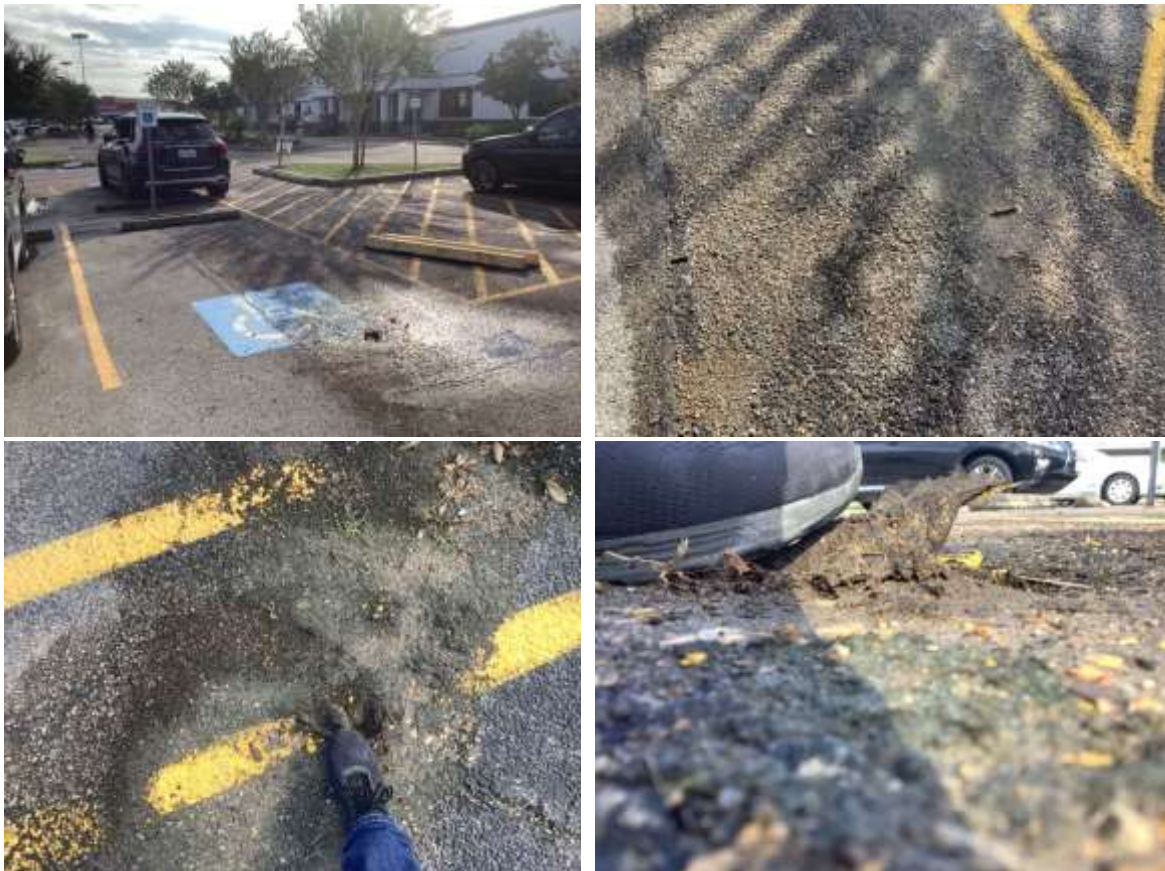
SME observed an excessive opening at the bottom of the curb ramp at the passenger drop off area that was not captured in the polling place survey.

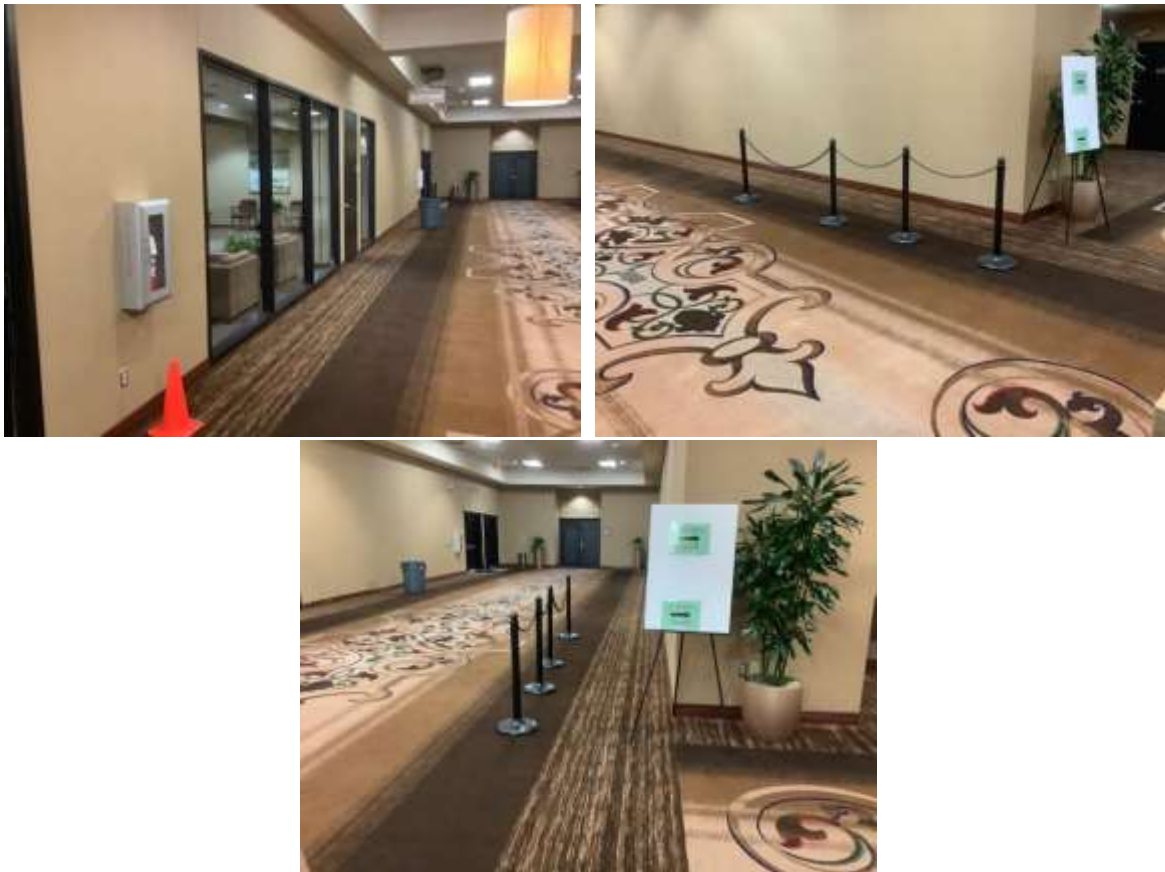
SME observed multiple protruding objects along the interior accessible route, including fire extinguisher cabinets and queue line stanchions, that were not captured in the polling place survey.

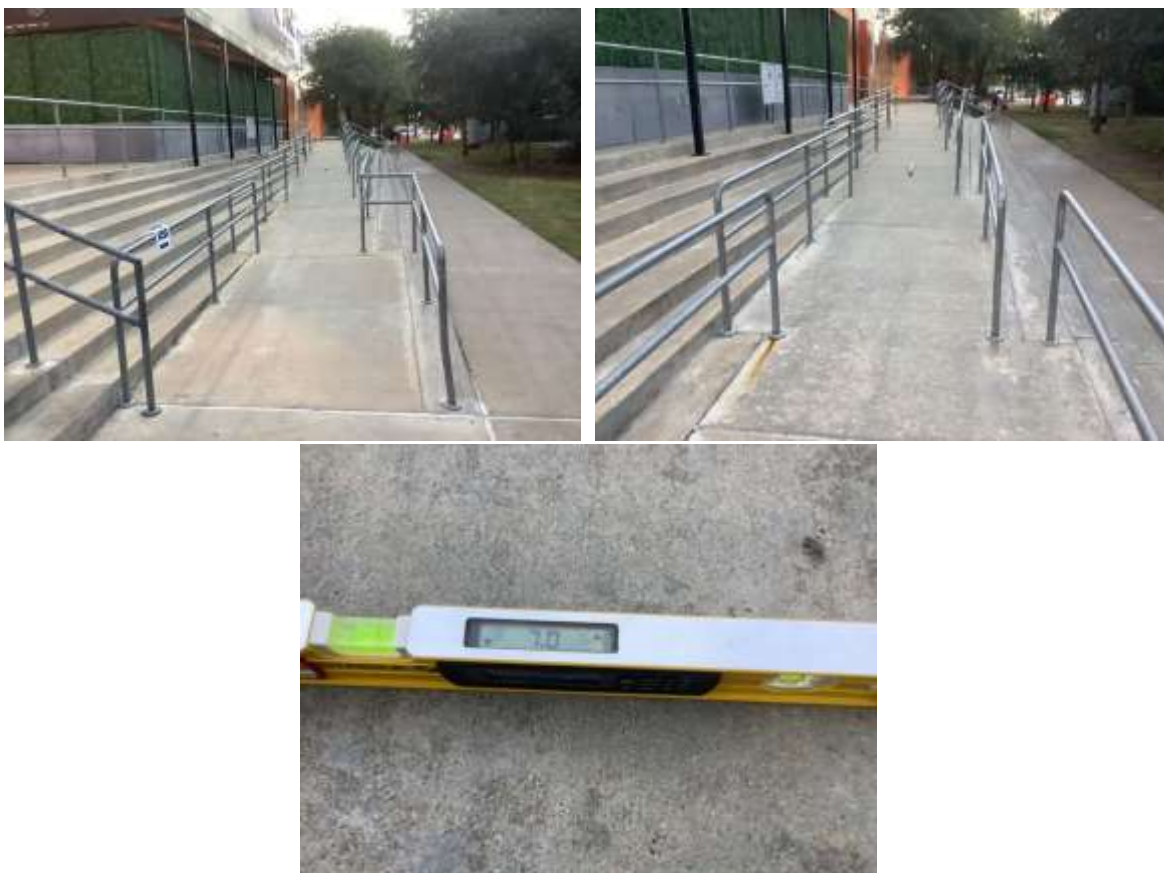
Excessive cross slopes and openings not identified in the survey were also found along the accessible route from the public sidewalk and transportation stop. Openings greater than  $\frac{1}{2}$ " wide and  $\frac{1}{4}$ " deep and cross slopes greater than 2.08% are not allowed along accessible routes.

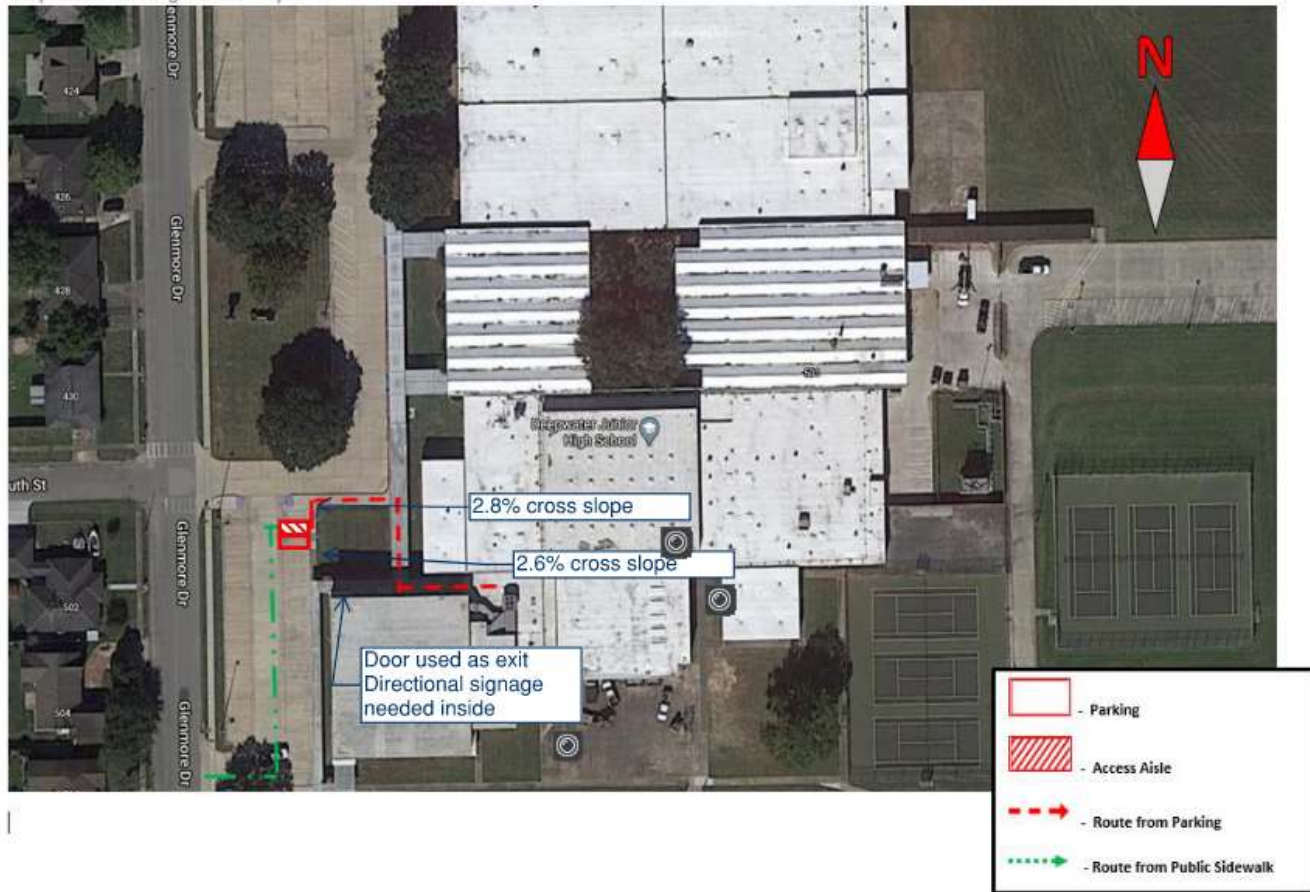
SME observed excessive cross slopes along both of the possible accessible routes from the van accessible parking space to the entrance.

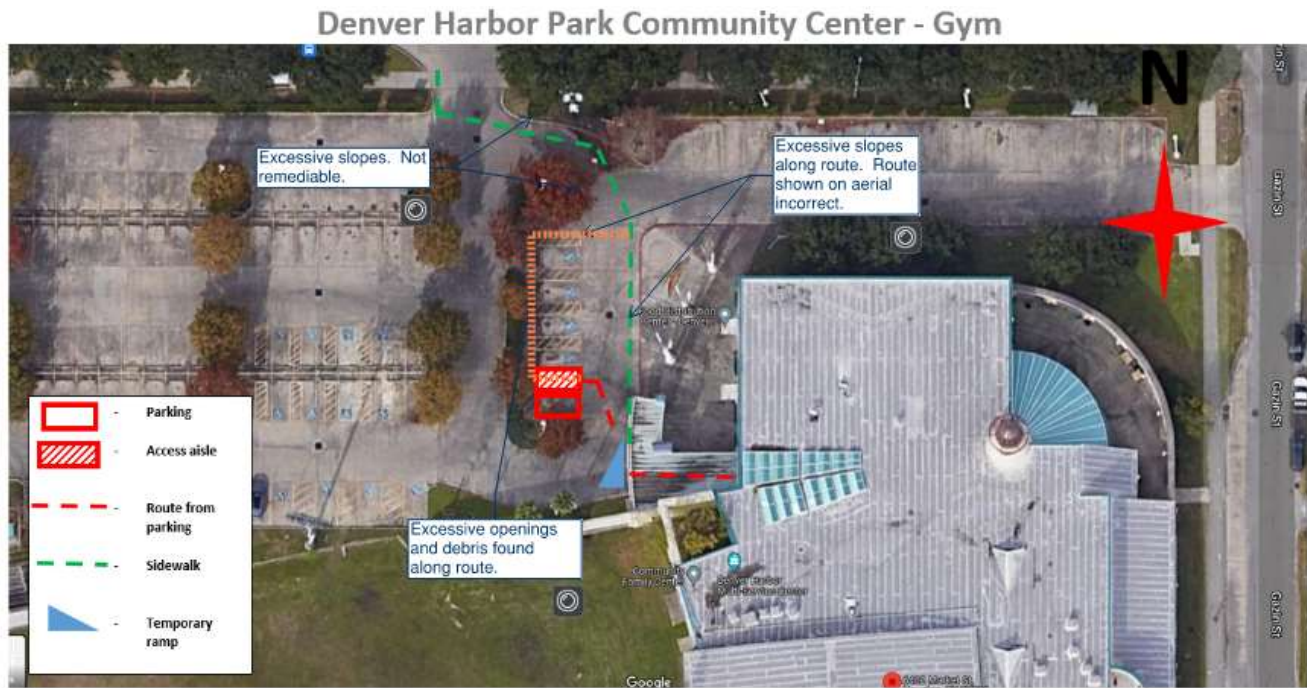
SME observed excessive cross slopes along the route from the public sidewalk that were not captured during the polling place survey. Excessive cross slopes were also observed by the SME along all other alternate accessible routes, making these cross slopes are not remediable.

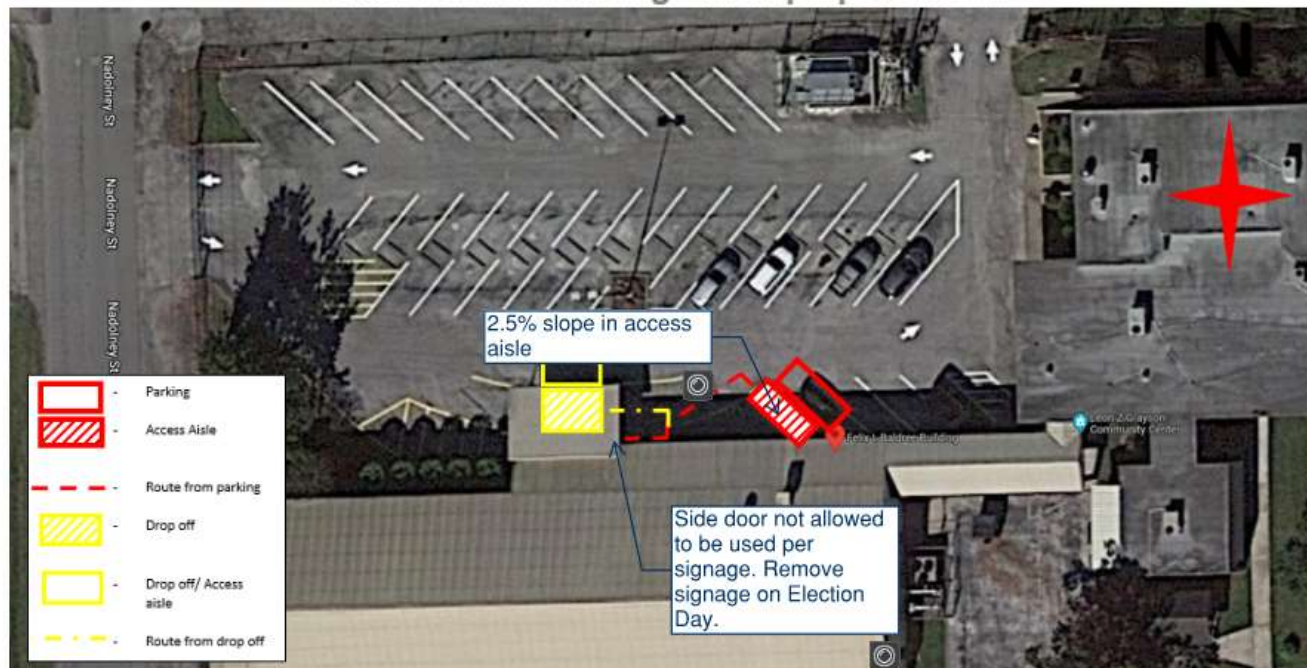
SME observed an excessive slope within the van accessible parking space access aisle. This condition was not captured during the polling place survey. Slopes greater than 2.08% in any direction are not permitted within the van accessible parking space and access aisle.

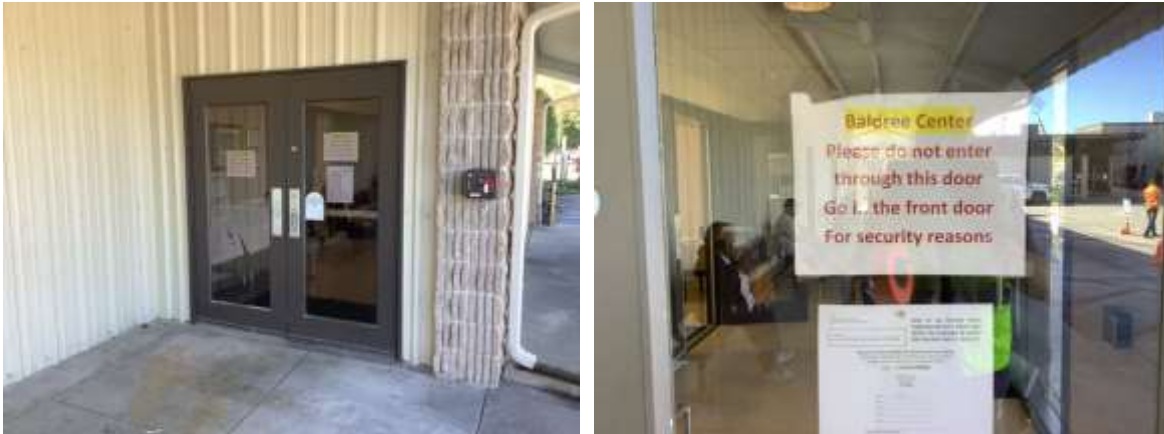
SME observed signage on the accessible entrance door stating that the door was not to be used as an entrance and that visitors must use the front door. Because the front door is non-compliant, voters with disabilities must be able to use the side door. A checklist items should be developed to remove any signage from the accessible entrance door saying it cannot be used. Coordination with the polling place may be necessary.

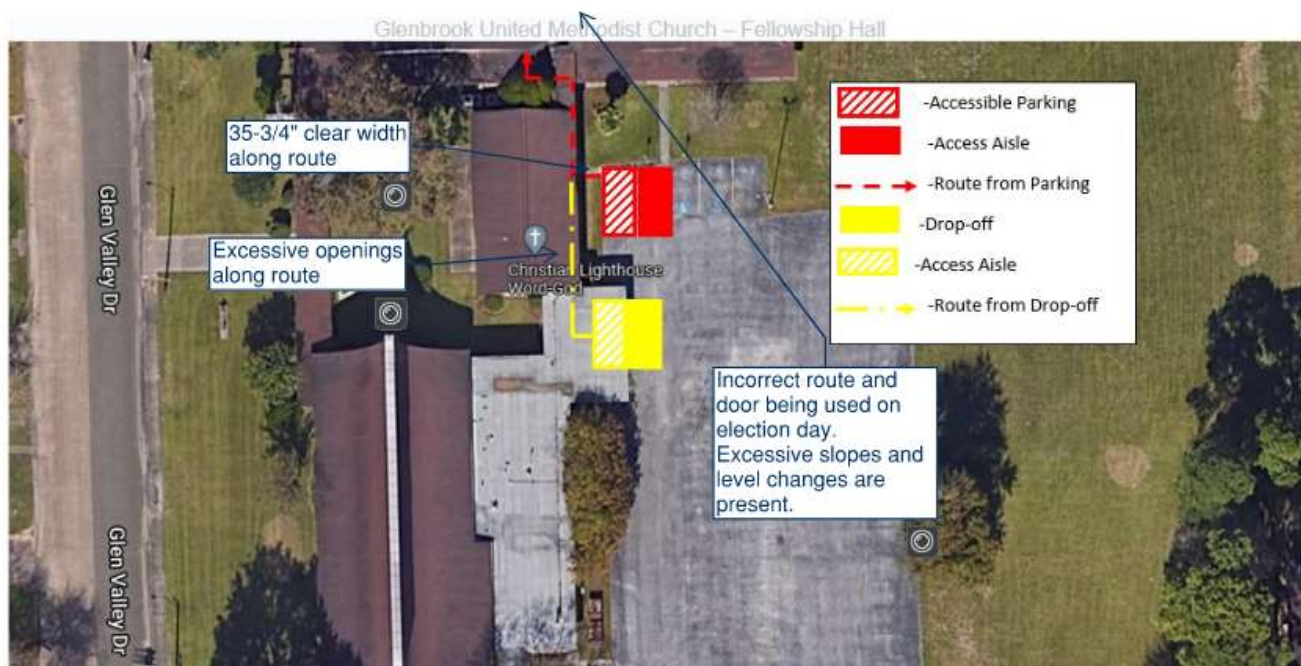
SME observed an excessive opening along the route from the drop off area. This issue was not captured in the polling place survey.
