# FEBRUARY 2023 SUBJECT MATTER EXPERT PUBLIC REPORT

RE: UNITED STATES V. HARRIS COUNTY, TEXAS, NO. 4:16-CV-02331 (S.D. TEX.)

United States Dept. of Justice  
Civil Rights Division

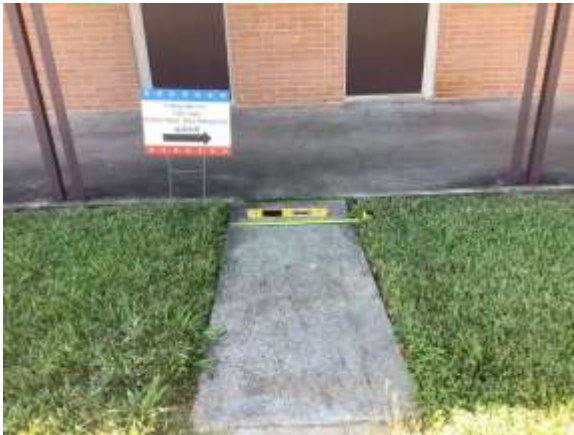
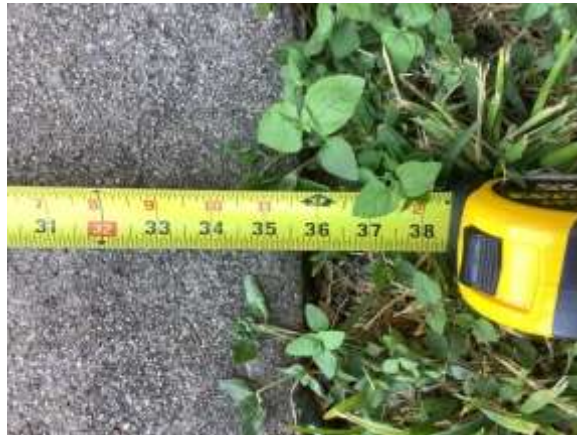
SME observed that the clear width along the route from the van accessible parking space was 35-3/4". This issue was not captured in the polling place survey. Clear width along accessible routes are not permitted to reduce below 36" for a distance of more than 24".

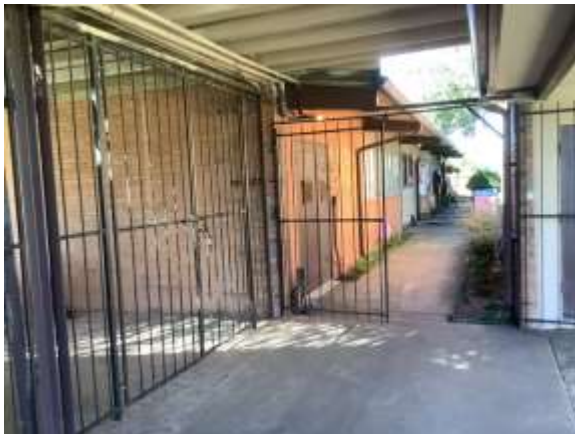
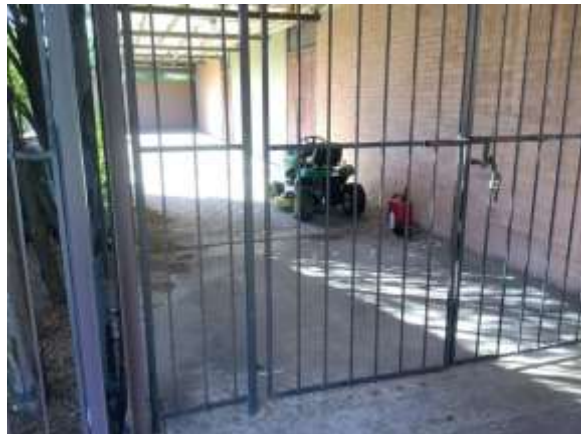
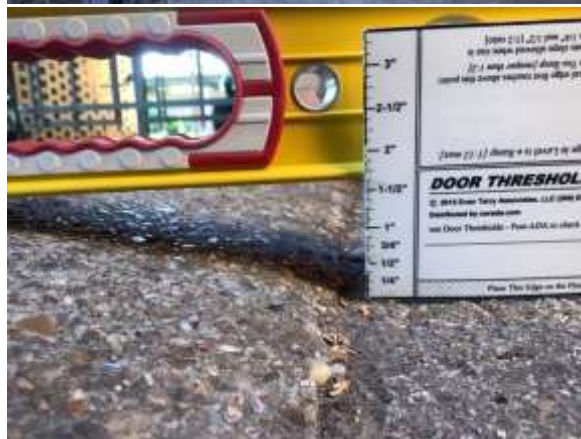
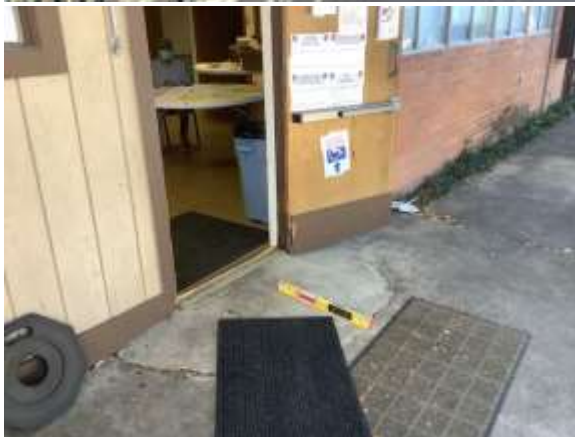
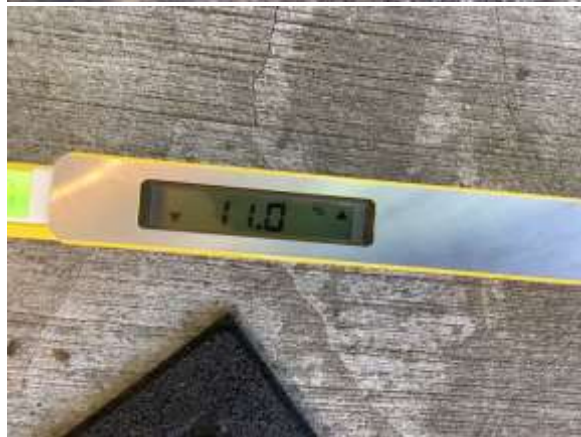
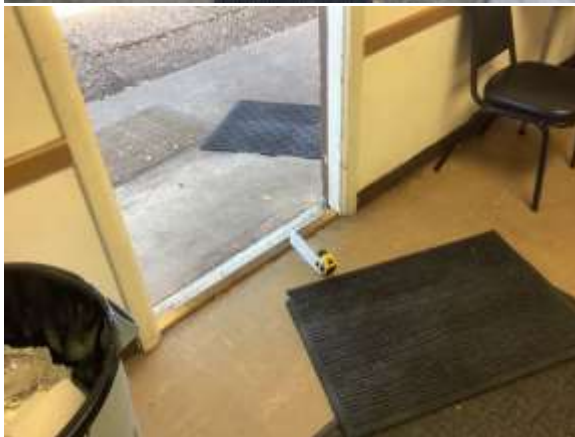
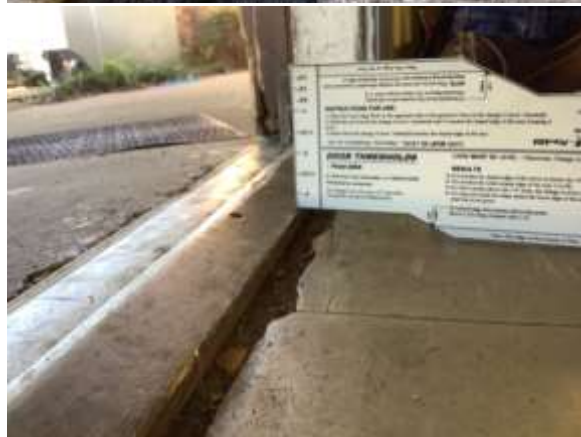
The route used on election day was different from the route surveyed. A locked gate was observed by the SME along the route surveyed. The route used contains excessive slopes and level changes. When notified of the issue, the presiding judge stated that he was unaware of the route and was unable to unlock the gate. It is imperative that election judges are notified that they must ensure the route identified in the aerial and on the judge checklist.

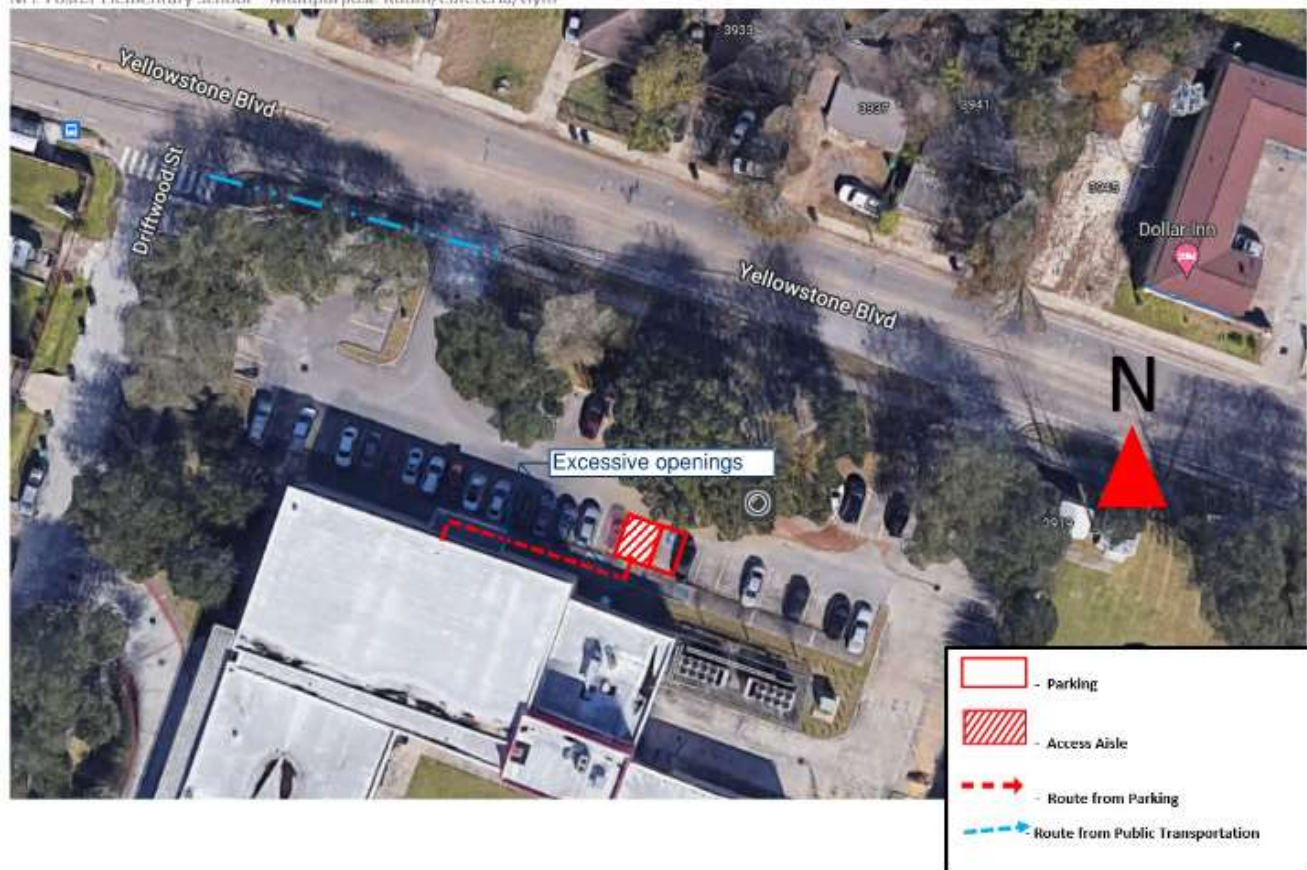
SME observed excessive openings along the route from the van accessible parking space to the accessible entrance. These openings were not captured in the polling place survey.

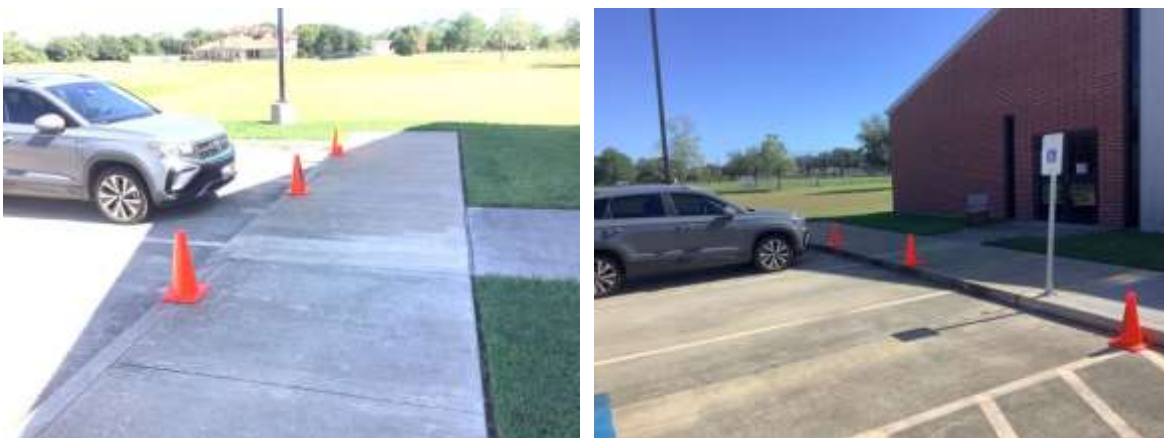
The accessible route from the van accessible parking spaces to the accessible entrance travels in front of parking spaces without wheel stops, which allow parked cars to block the route. SME recommends placing cones at the front of these spaces, as shown in the photos below, to protect the accessible route.

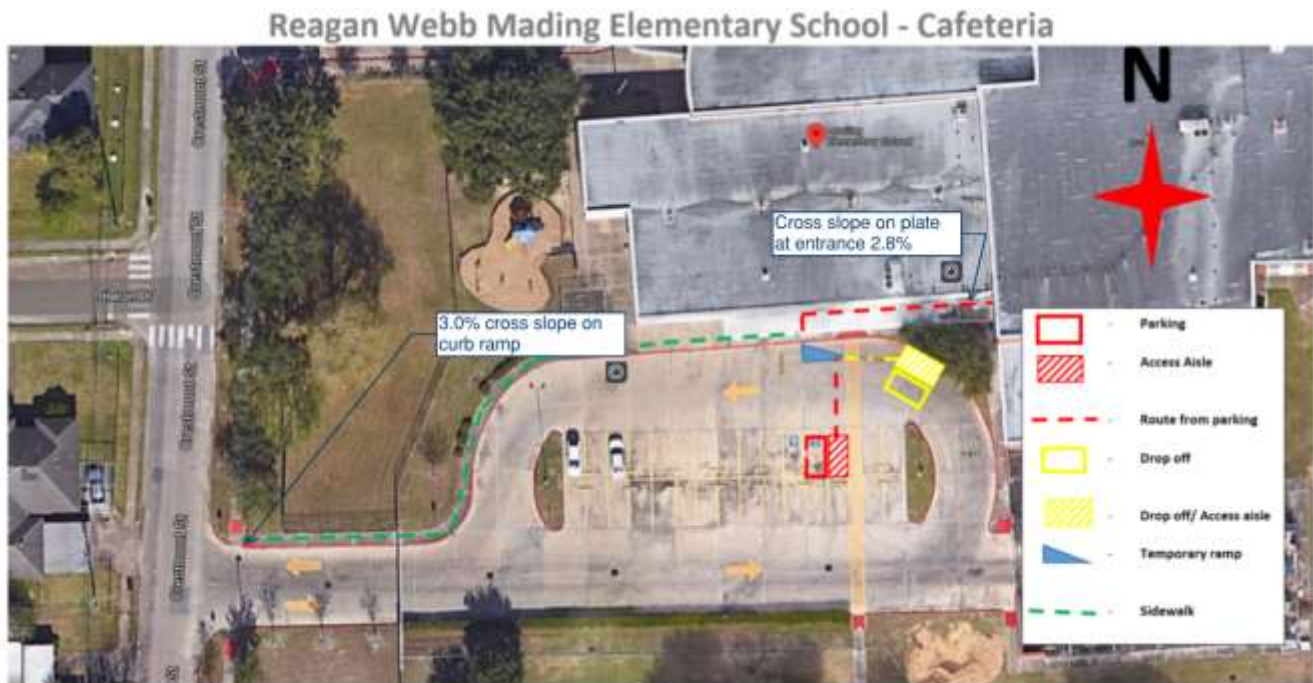
SME observed an excessive cross slope on the curb ramp at the pedestrian connection to the public sidewalk. This was not captured in the polling place survey. Cross slopes greater than 2.08% are not permitted on curb ramps. SME recommends Harris County explore alternate routes to the polling place from the public sidewalk.

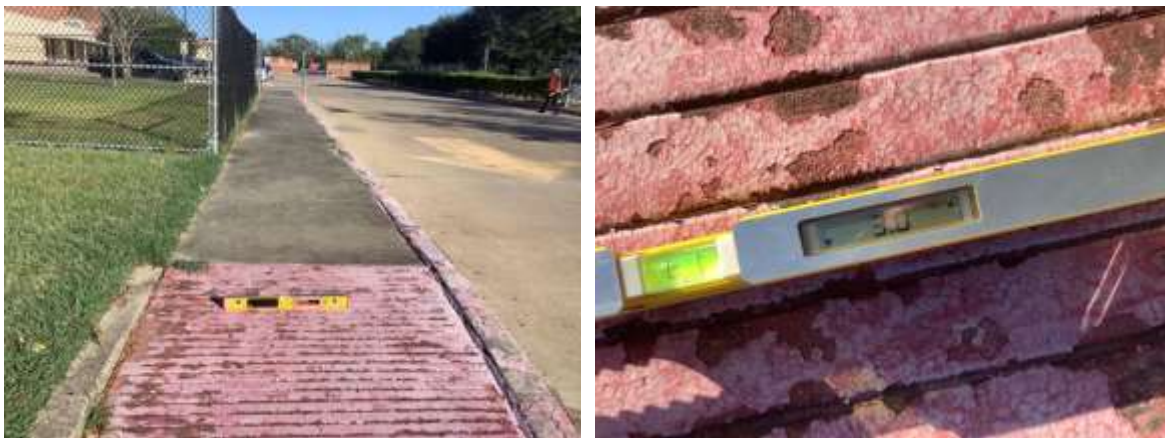
SME also observed an excessive cross slope on the aluminum plate used for a corrective action. SME recommends Harris County explore a different placement of the plate at the level change in front of the accessible entrance to ensure that compliant cross slopes are maintained.

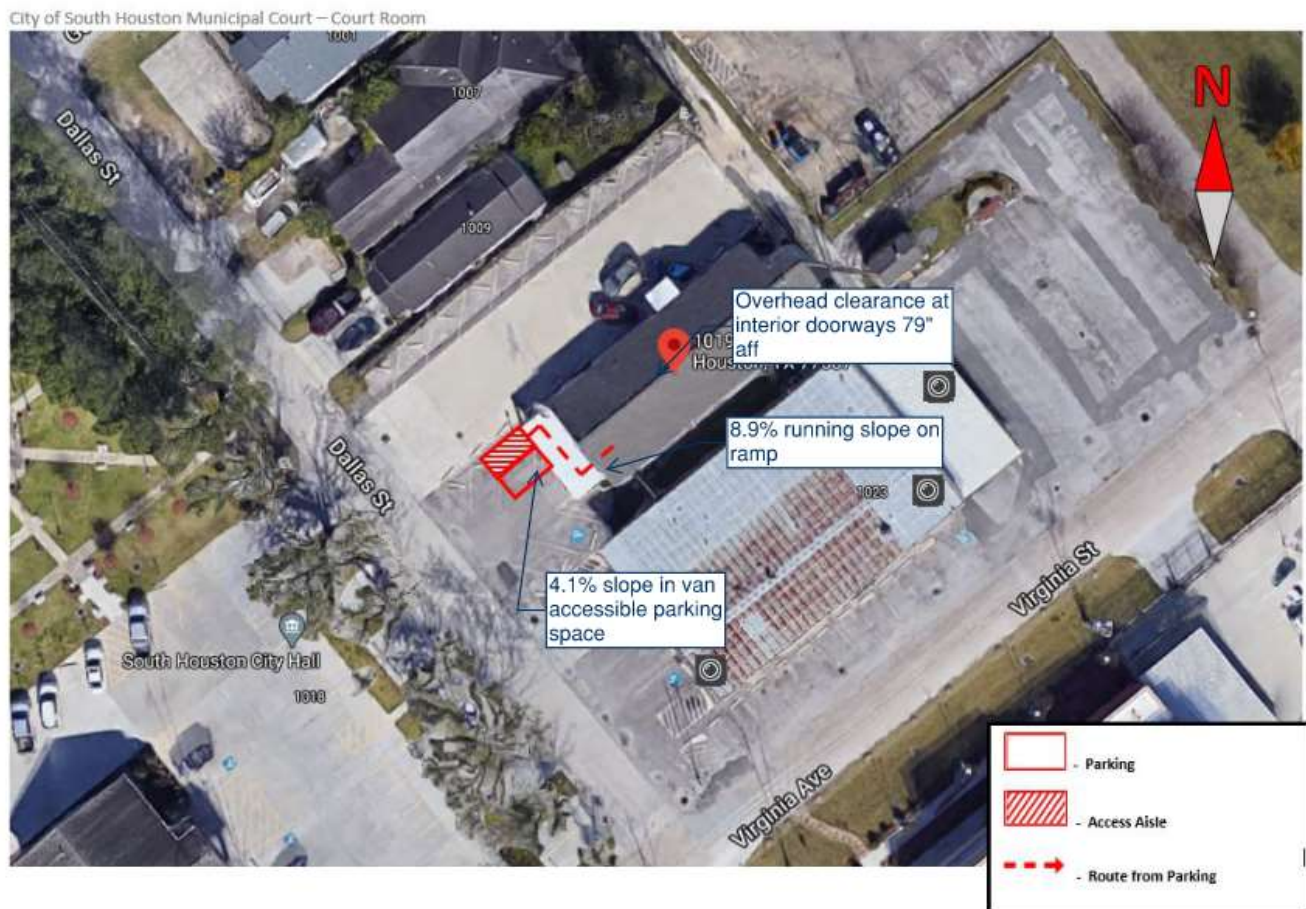
SME observed excessive slopes within the van accessible parking space. Slopes greater than 2.08% in any direction are not permitted within the van accessible parking space or access aisle.

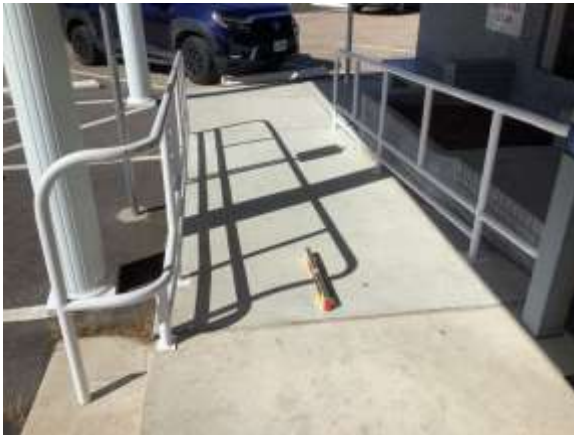
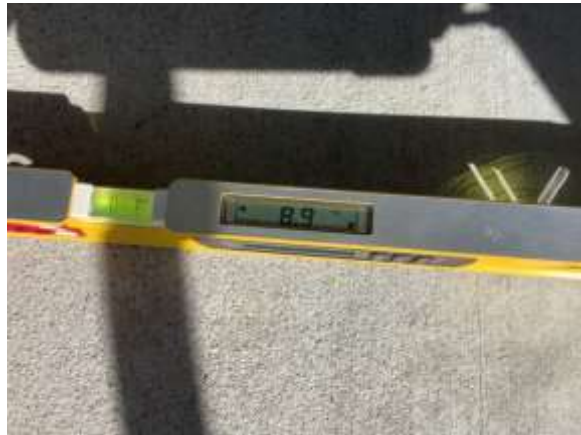
SME observed an excessive running slope on the ramp leading to the accessible entrance. Running slopes greater than 8.33% are not permitted on ramps along accessible routes.

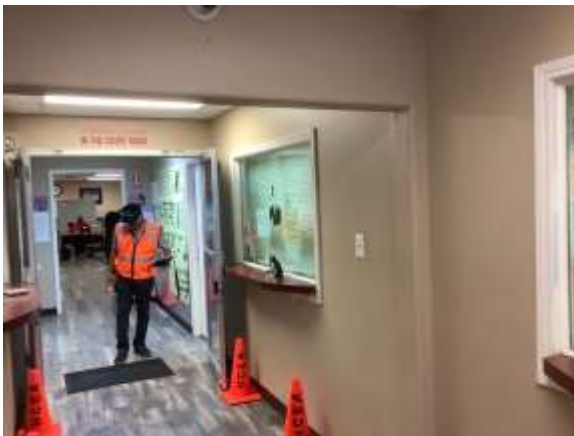
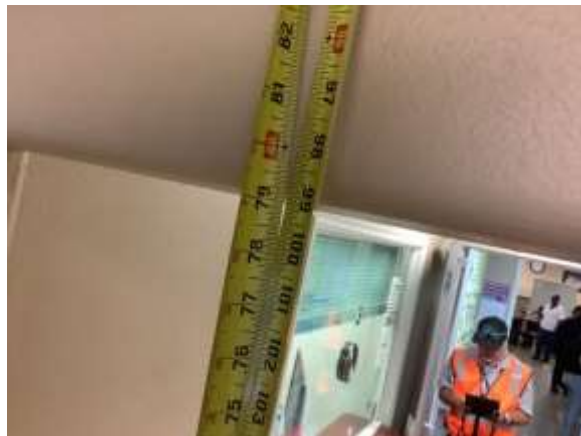
SME observed deficient vertical clearance along the interior accessible route. Vertical clearances less than 80" are not permitted along accessible routes or circulation paths.

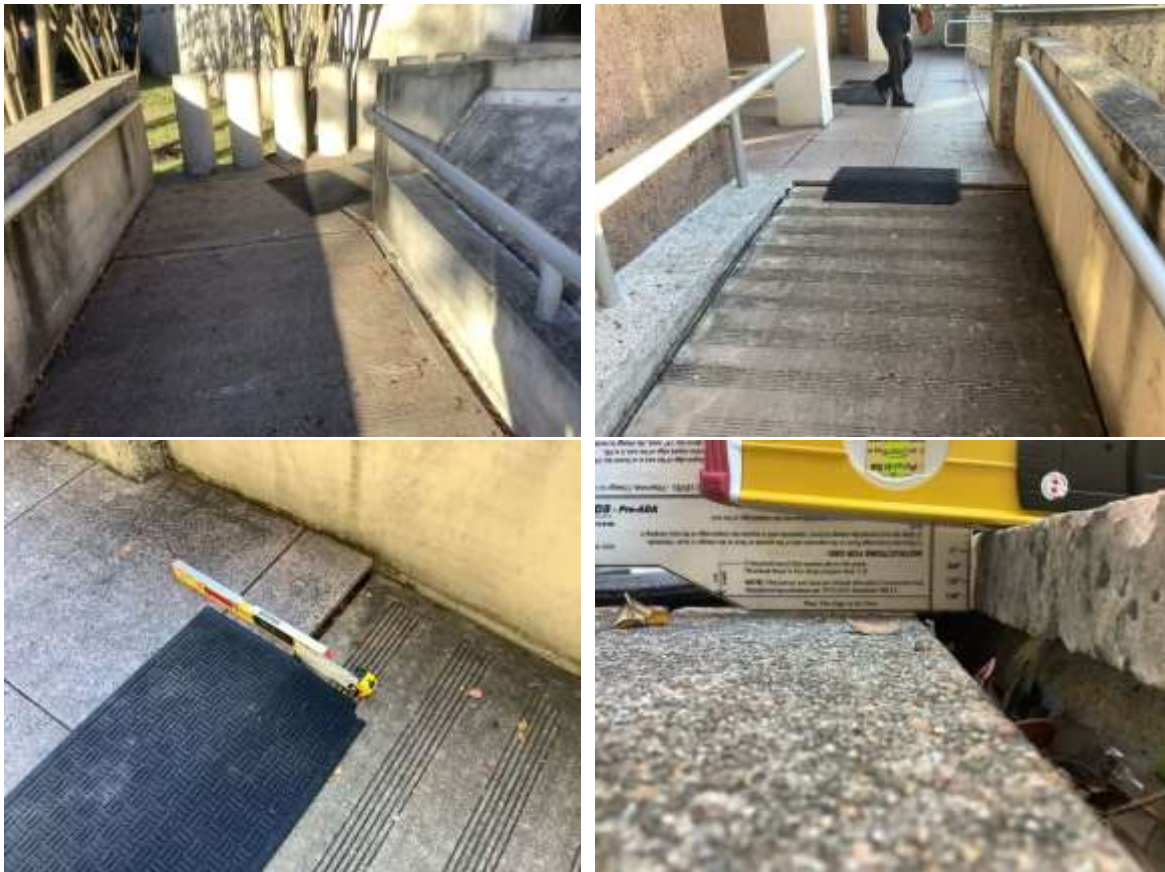
SME also observed that some mats placed as remedial measures for level changes do not adequately remediate the violations. Remedied level changes must be ½" high or less.

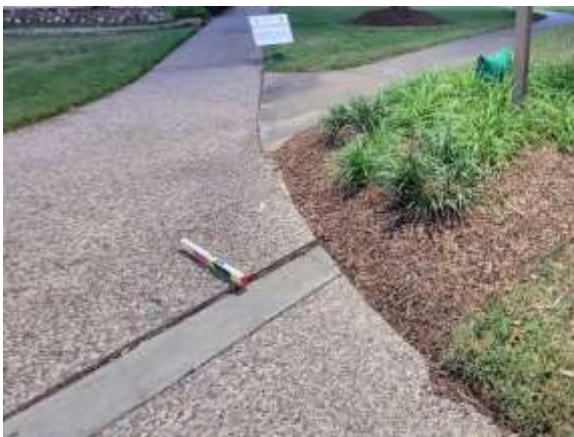
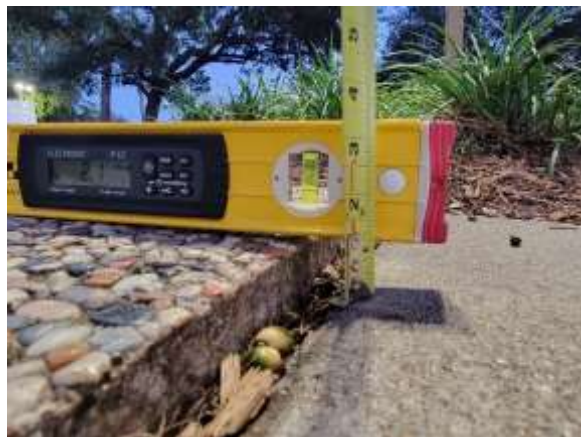
An excessive level change along the route from the van accessible parking space was observed by the SME. Level changes greater than  $\frac{1}{2}$ " high are not permitted along accessible routes. This was not captured in the polling place survey.

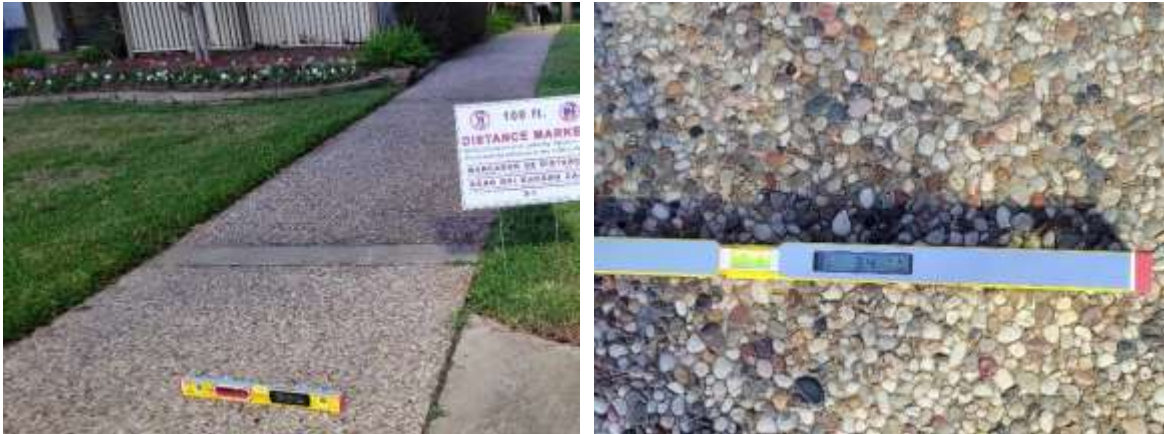
SME also noted excessive cross slopes along the same route that were not captured in the polling place survey.

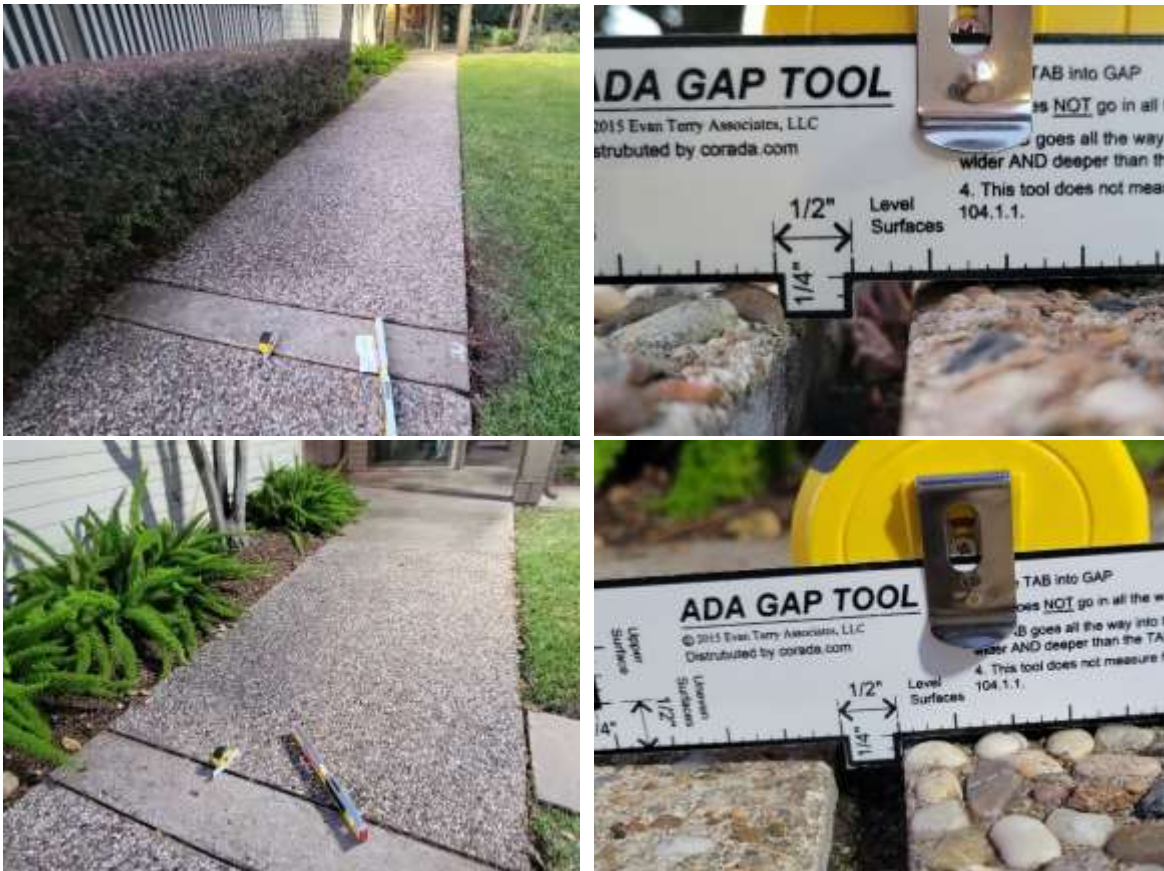
Multiple excessive openings not captured in the polling place survey were also observed by the SME.

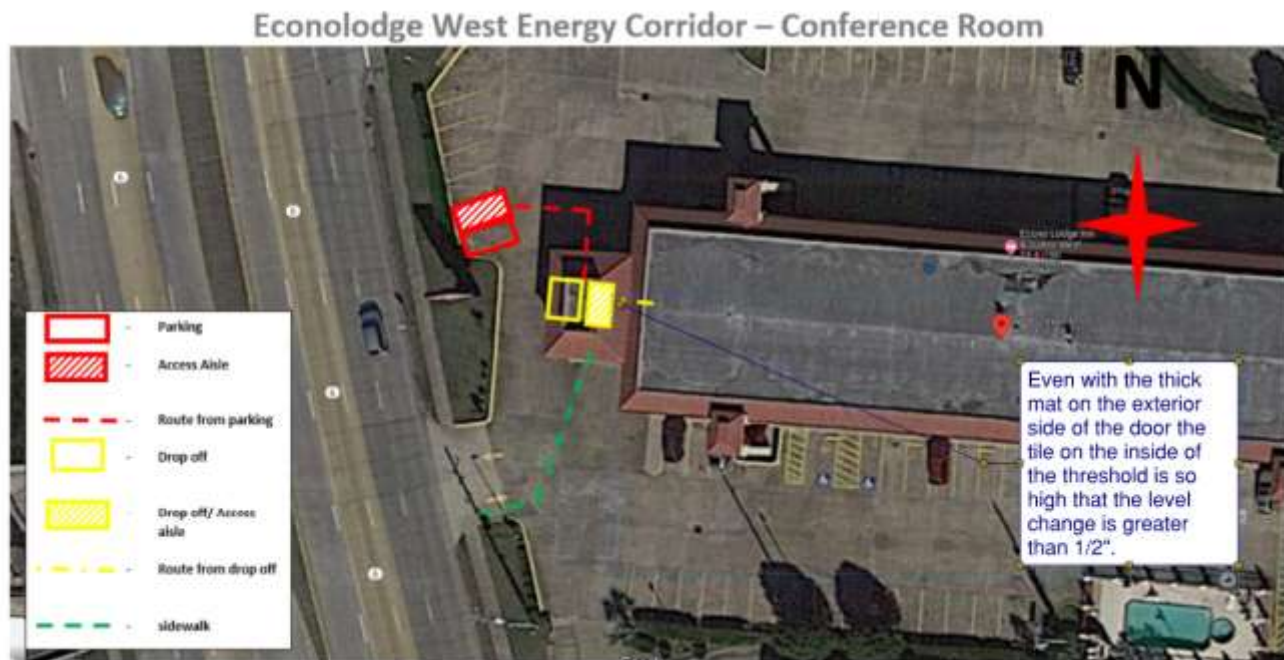
The thick mat placed at the accessible entrance door threshold does not adequately address the violation of the threshold height being excessive. The top of the interior floor surface is greater than  $\frac{1}{2}$ " above the top of the mat when placed, which is not permitted.

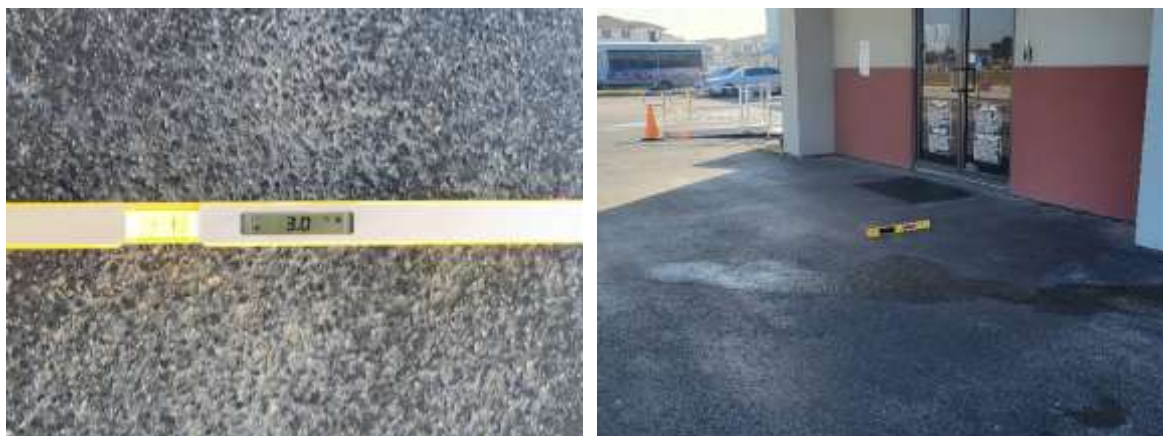
Excessive slopes within the passenger drop off area were also observed.

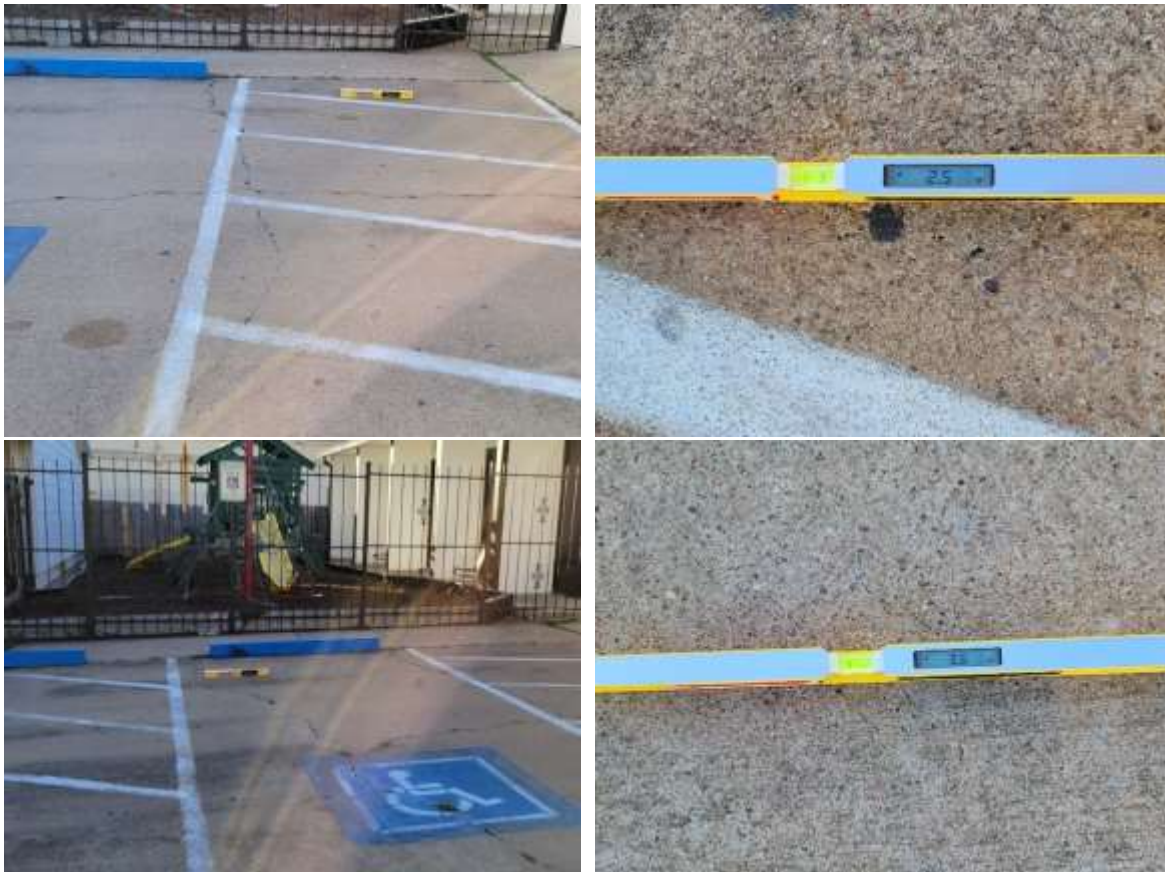
Since the polling place survey was completed, some of the tiles along accessible routes have deteriorated, creating excessive openings.

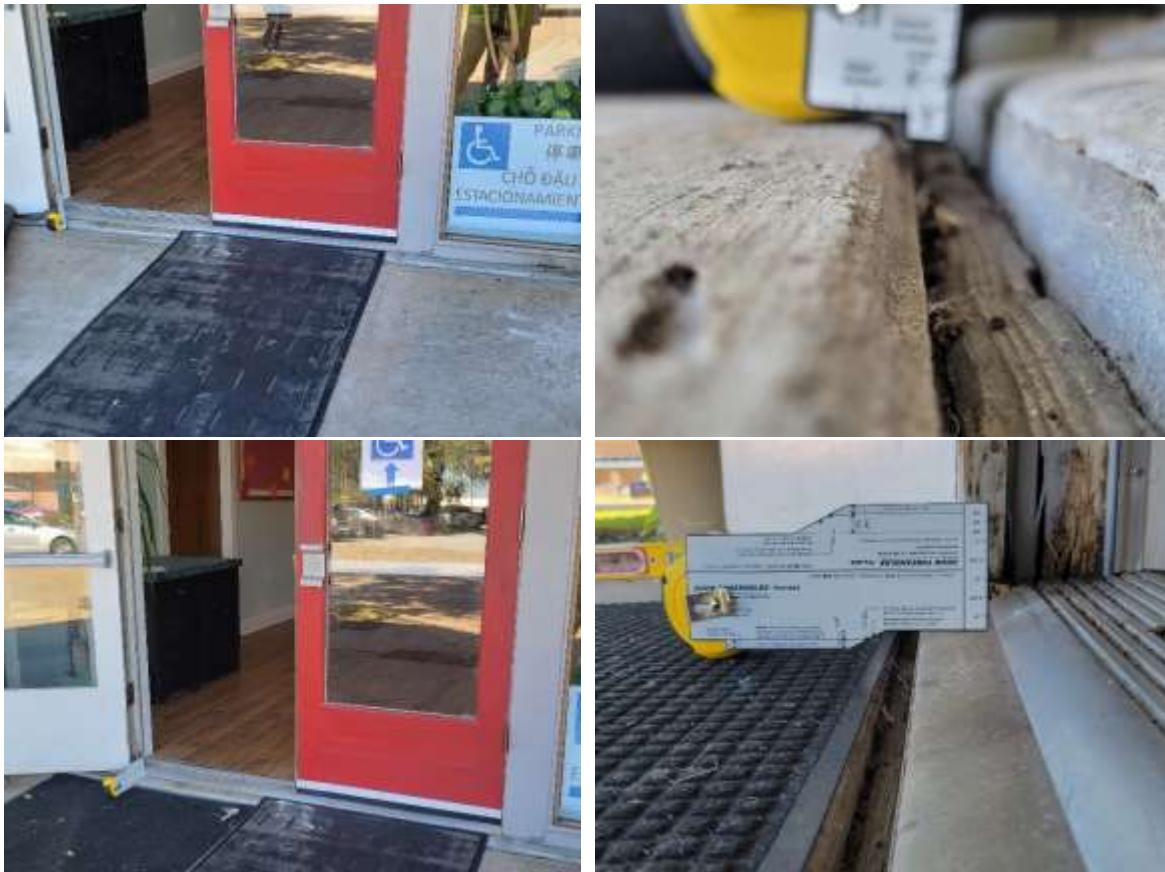
The SME team observed excessive slopes in the designated van accessible parking space. An excessive level change not noted in the polling place survey was also observed along the accessible route from parking.

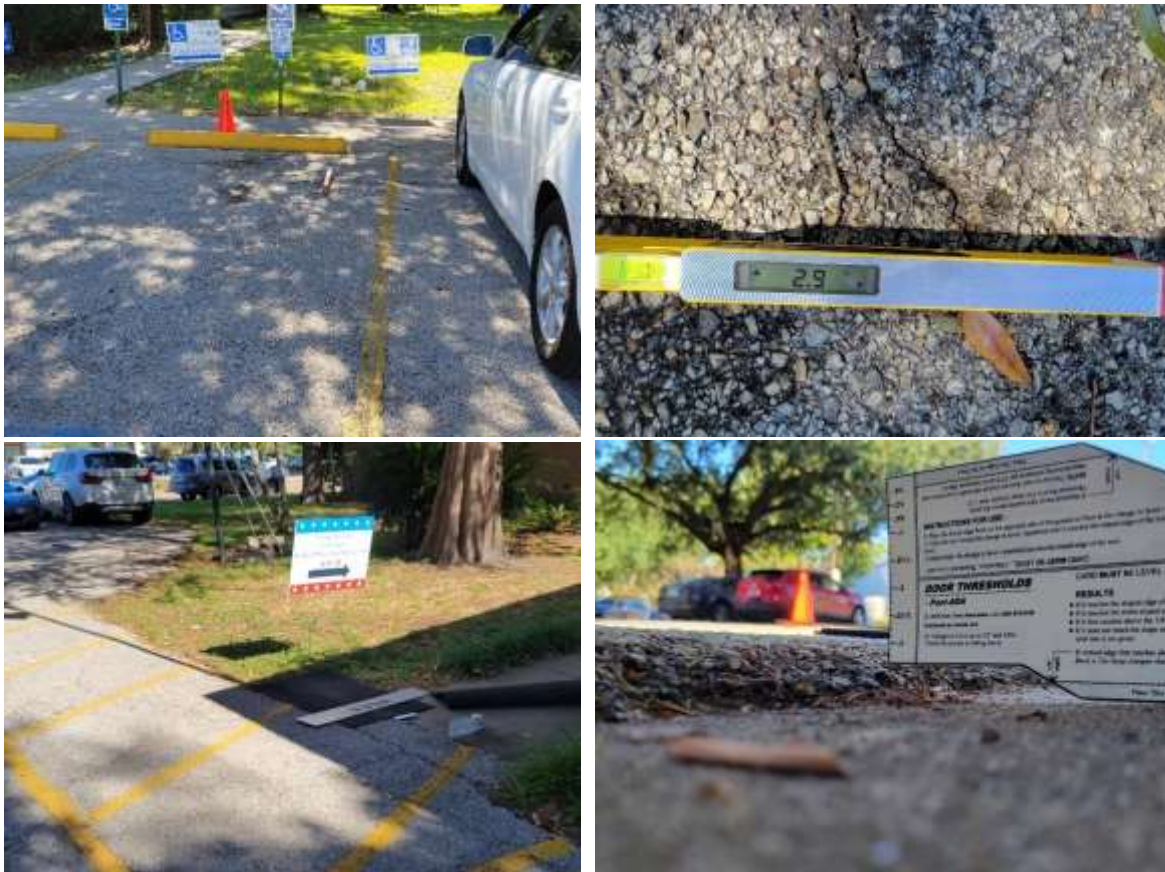
The SME team also noted that a facility mat was in place at the accessible entrance, remediating a non-identified excessive threshold height. A Harris County mat should be placed at the threshold. A checklist item for this needs to be developed.

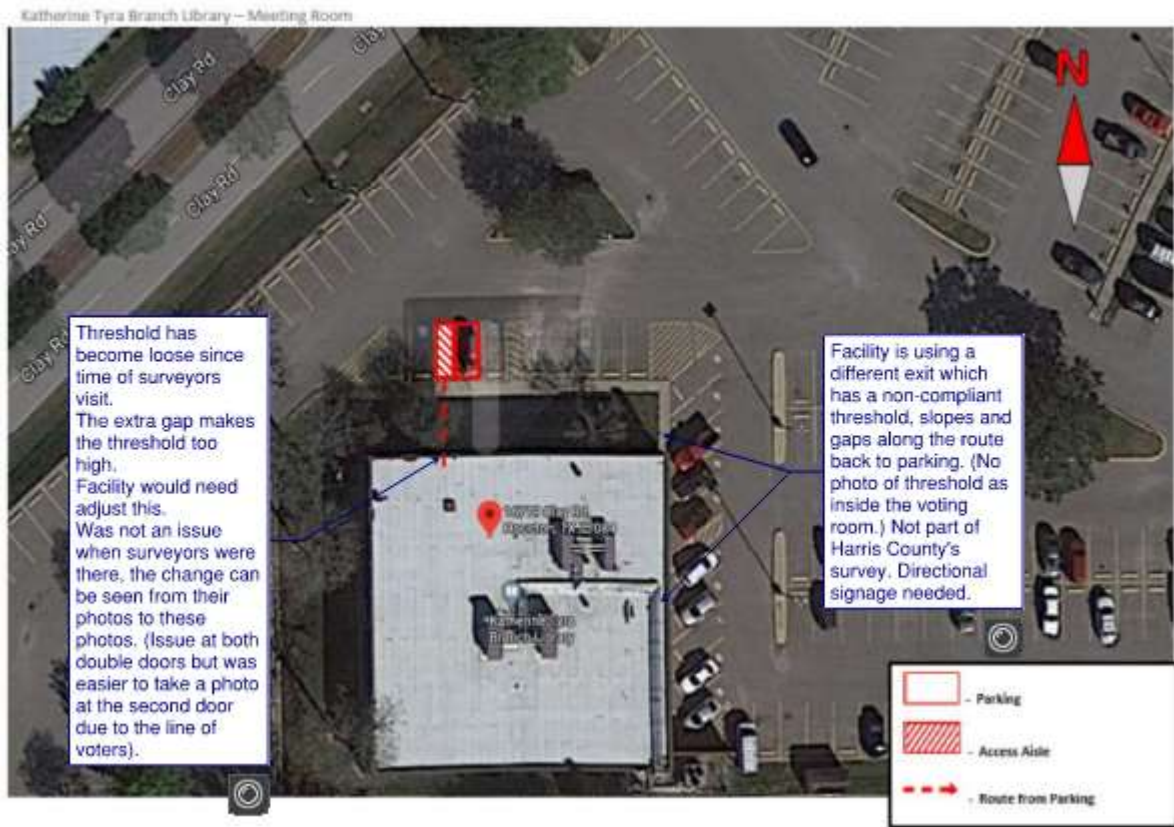
The SME observed that the threshold at the accessible entrance became loose since the polling place survey was completed, creating an excessive height.

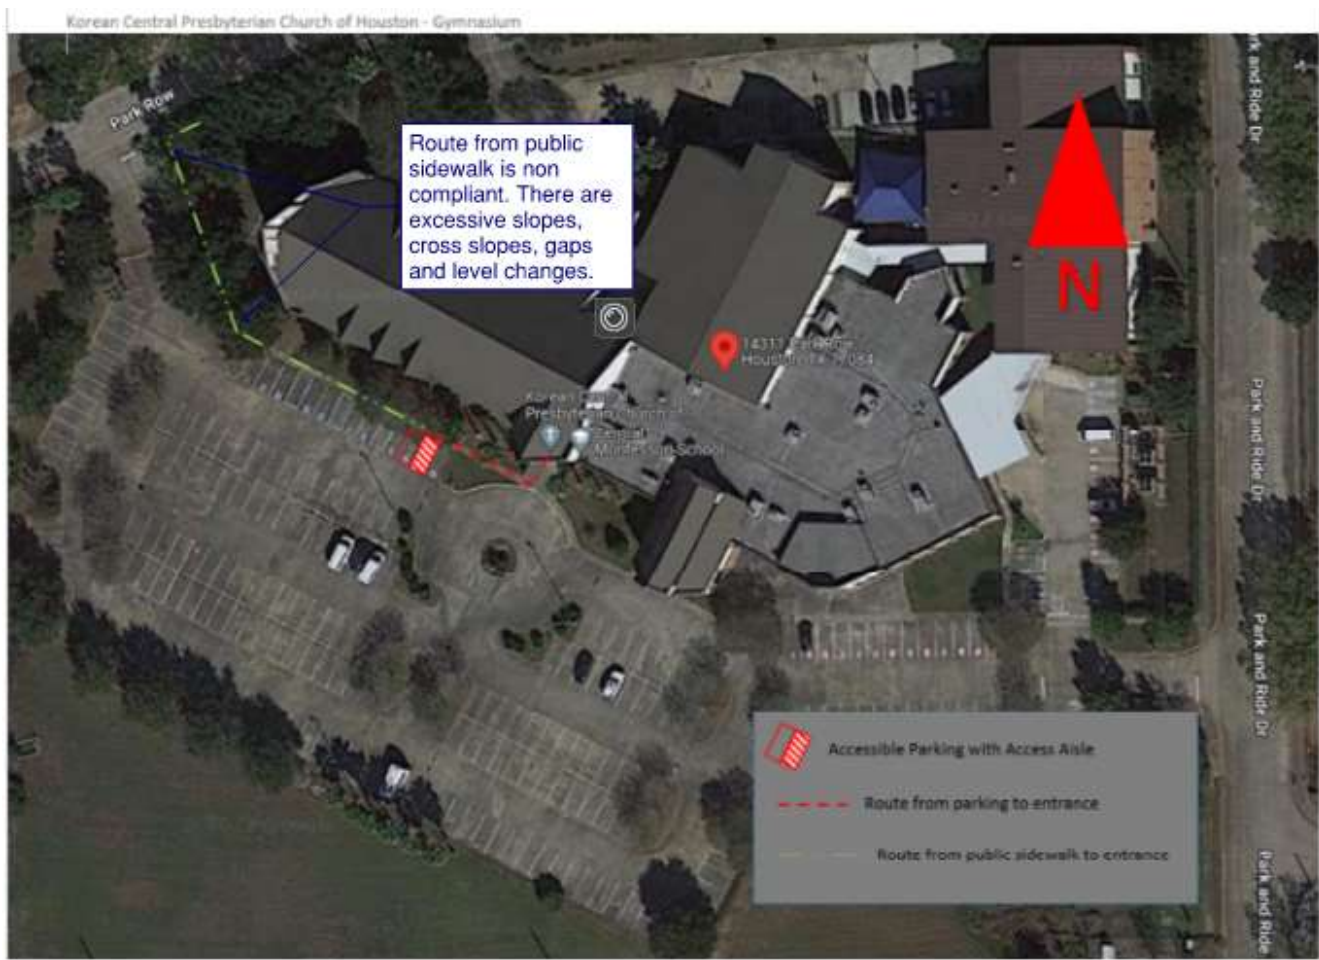
Multiple obvious violations along the accessible route from the public sidewalk were observed by the SME team. No violations along this route were identified in the polling place survey. SME recommends resurveying this polling place.

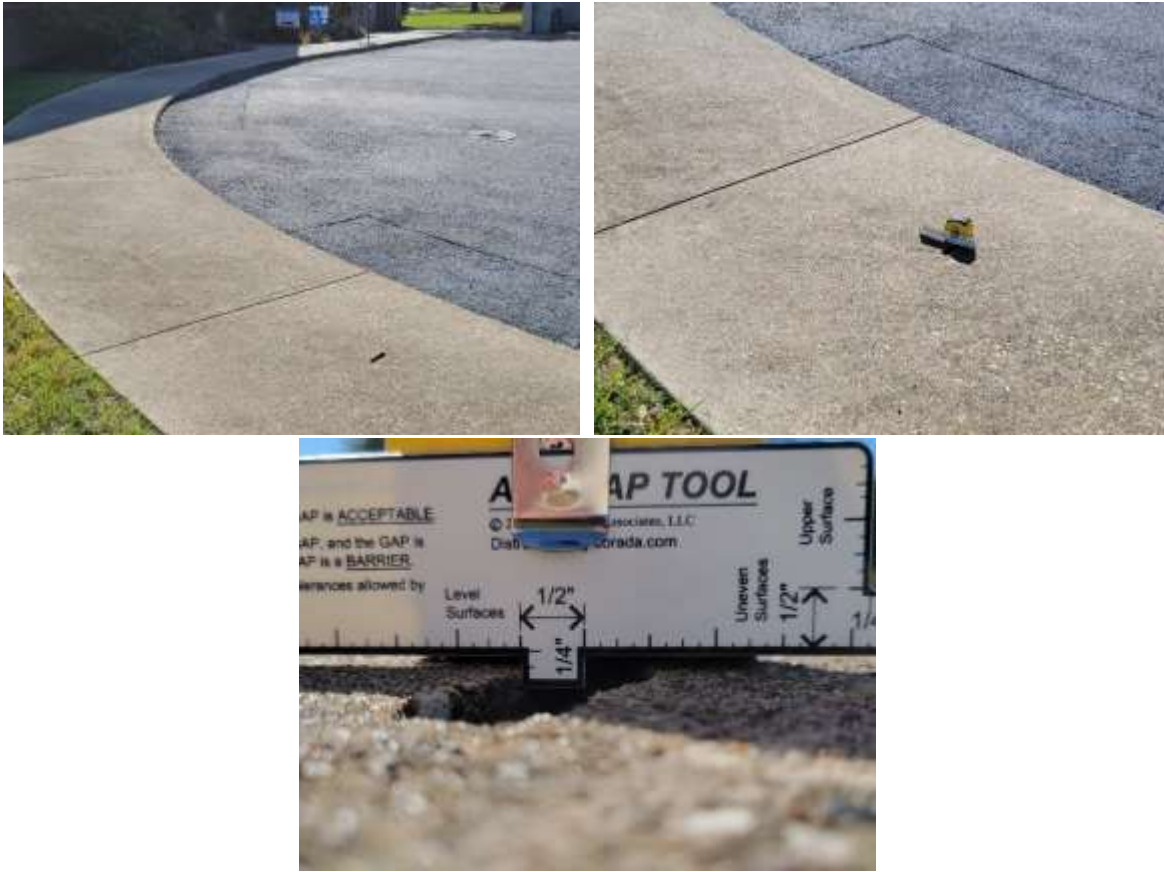
The SME team observed an additional excessive opening along the accessible route that was not identified in the survey.
