AUGUST 2022 SUBJECT MATTER EXPERT PUBLIC REPORT

RE: UNITED STATES V. HARRIS COUNTY, TEXAS, NO. 4:16-CV-02331 (S.D. TEX.)

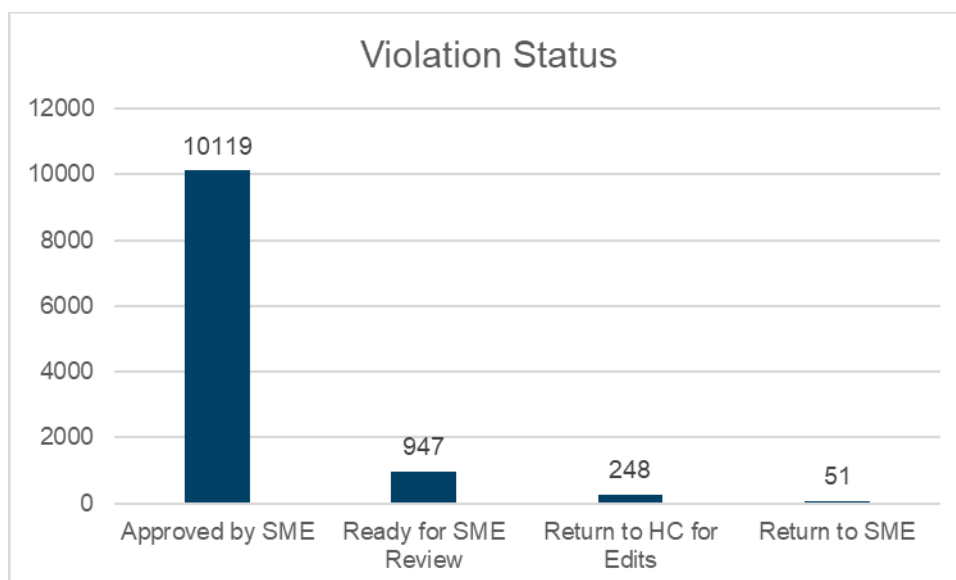
**Figure 2 - Violations Status**

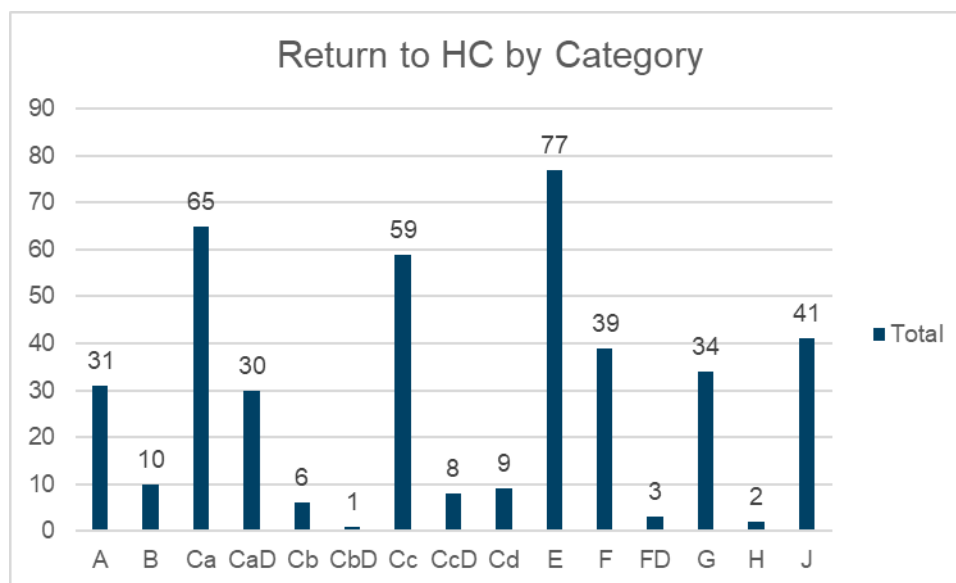
Many of these questions are found in the Exterior Route from Parking (Ca), Exterior Route from Public Street and Sidewalks (Cc), and Accessible Entrance (E) categories.

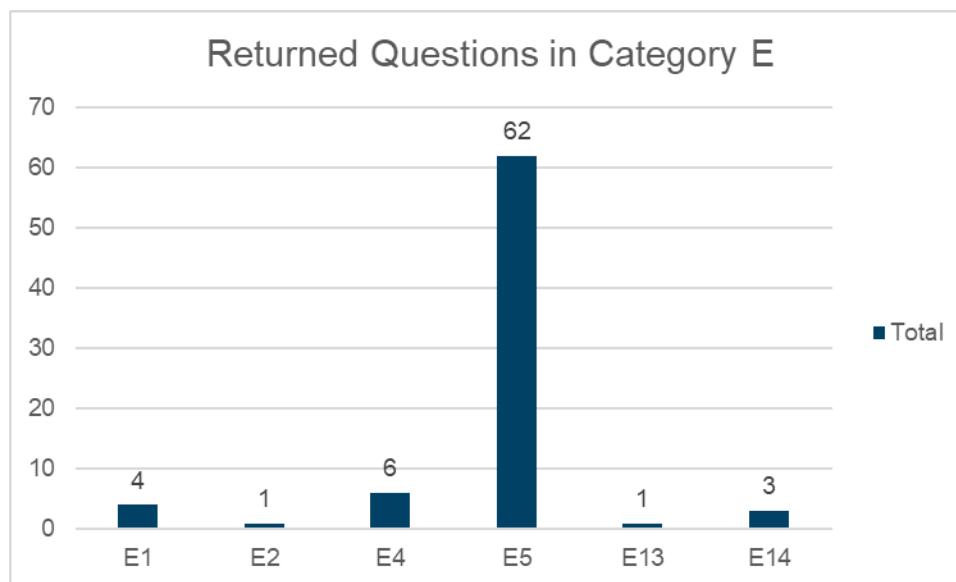
Forty-one (41) questions were returned for Question J1, which determines the compliance status of the survey. Some of these were errors in selecting the correct answers based on the survey. Over one half (27) of these returned questions are contingent on resurveying alternate elements or analyzing alternate remedial measures. Thirteen (13) incorrect compliance statuses were identified and marked Return to HC for Edits.

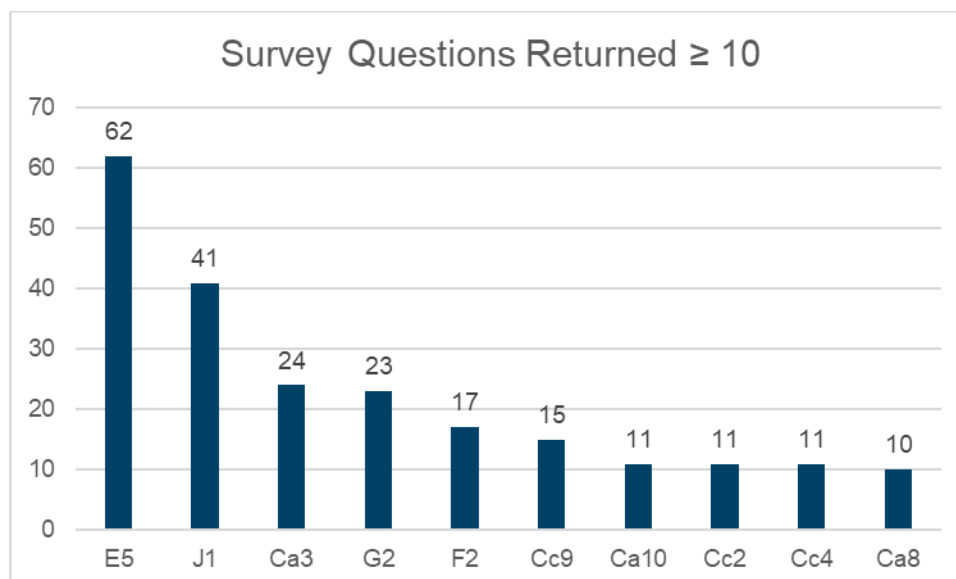
Question G2 relates to objects protruding from walls within the voting room. Many of those returned relate to inaccurate or missing descriptions of remedial measures. Some questions returned relate to missing or inadequate measurements of elements projecting off of walls.

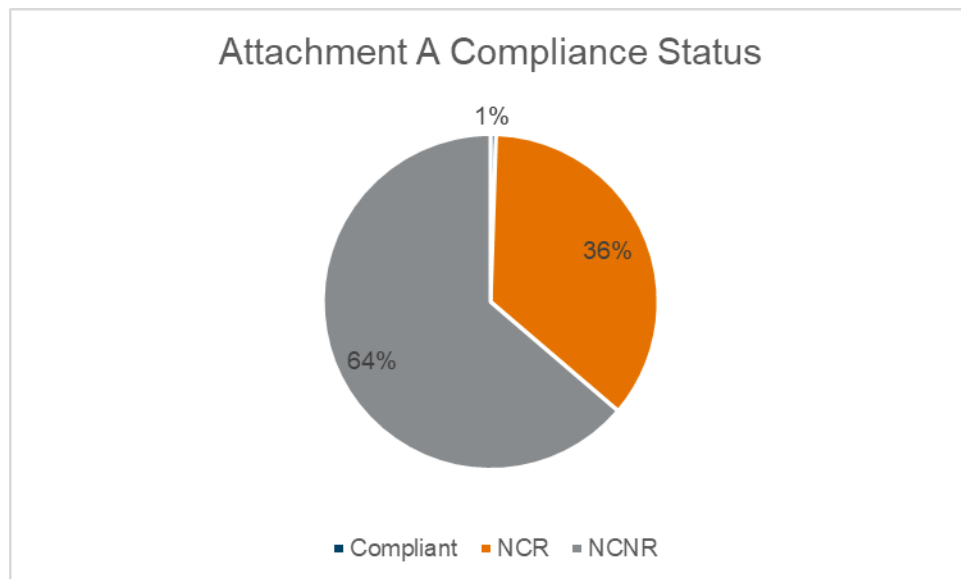
1,832 violations at these polling places have been identified by the surveyors to date. Of these violations, 1,283 (87%) had remedial measures that were approved by the SME. Of the violations that have yet to be approved by the SME, zero (0%) are pending DOJ review, 124 (8%) have been addressed by Harris County and are awaiting an additional review by the SME, 30 (2%) have been flagged by DOJ for additional SME review, and 43 (3%) have been returned to Harris County for edits. This aligns with the overall survey trends.

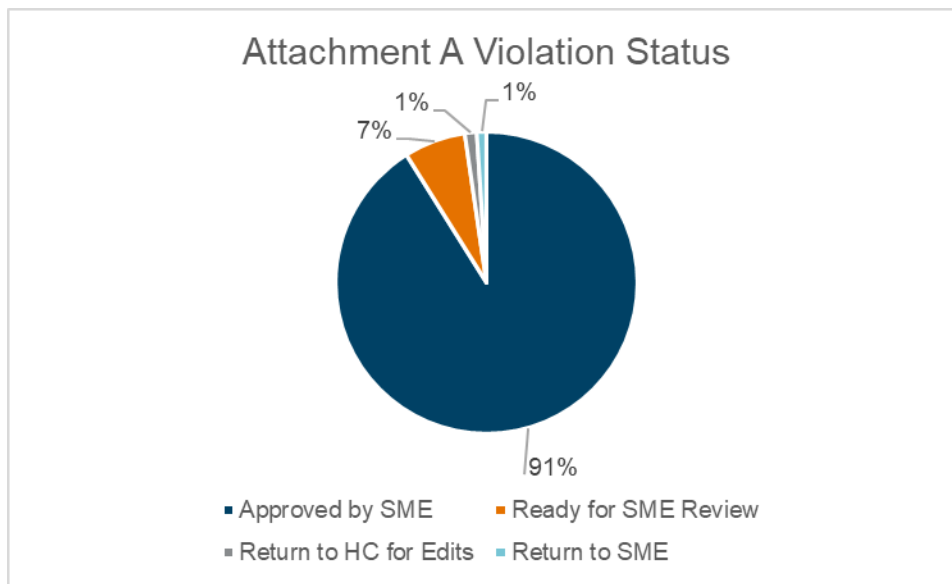
4.0 March 2022 Primary Election Harris County Assessment

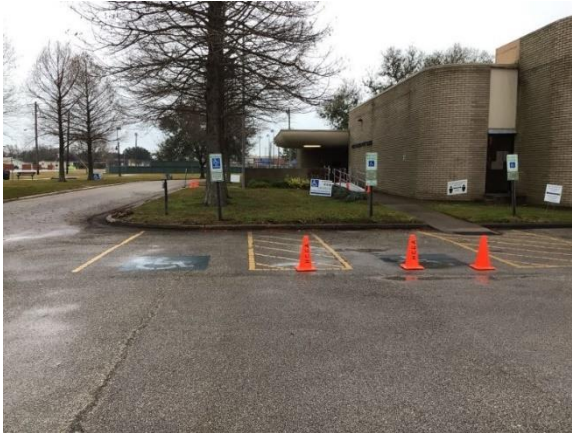
SME observed the cones placed in the incorrect parking space. SME fixed the issue in the field. Harris County's photographs show that the cones were set up properly.

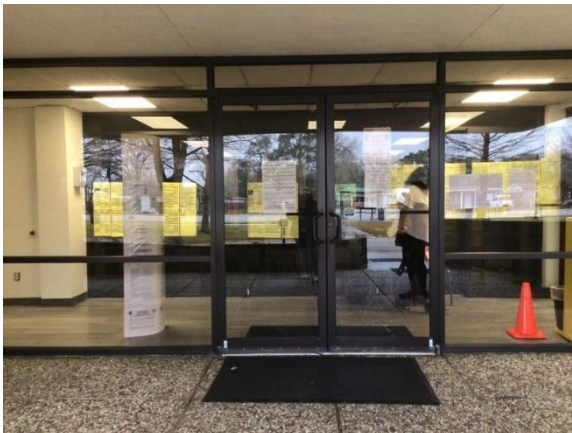
SME noted that the third mat was not installed (a facility mat was in place, but not covering the gap) and the door was not propped open. Harris County's photos show the same facility mat in place and the door not propped open. In item 6366, the HCEAD EDS notes that a poll worker is stationed at the door, which, if they open the door for all voters entering and exiting, is an acceptable alternative to propping open the door.

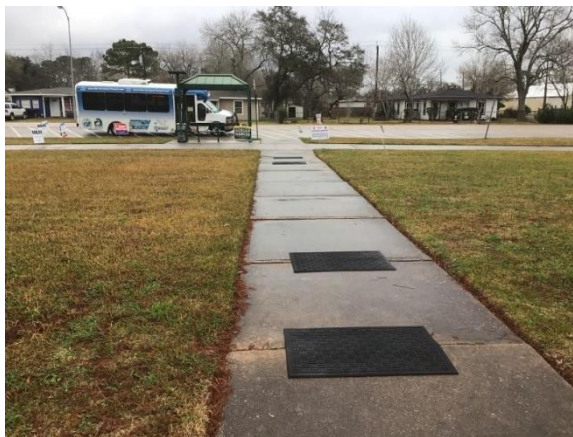
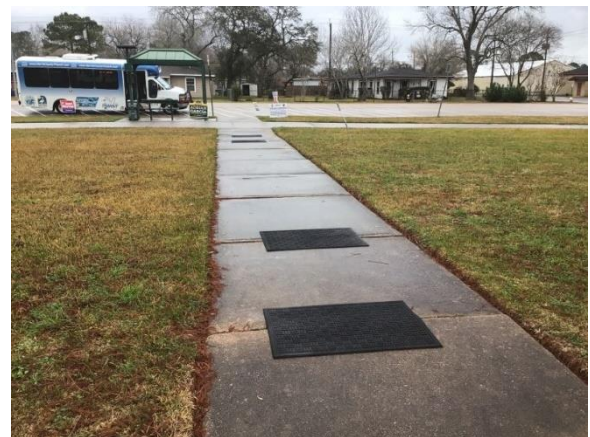
SME noted that the mat and plate were placed over the level change, not abutting it. SME fixed the item in the field, which could explain the difference between the statuses. Regardless, HCEAD EDS photos are not sufficient to determine compliance. The mat in question in the HCEAD photos is the furthest one shown. SME recommends additional training for the HCEAD EDS.

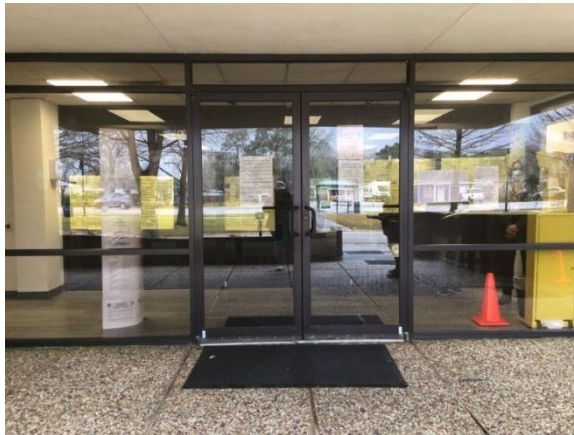
The SME noted that a poll worker was stationed but did not open the door when it was approached. The HCEAD EDS noted "Poll workers are stationed at accessible entrance" but did not indicate whether they opened the doors for voters.

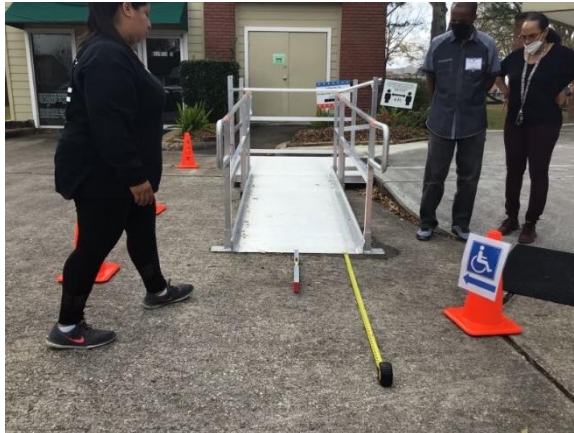
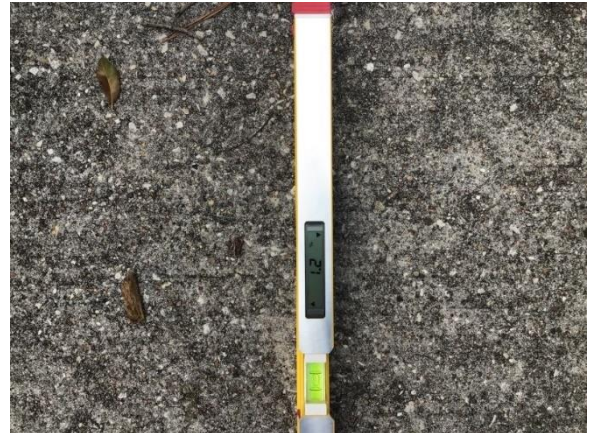
SME observed excessive ground slopes in the bottom landing at the installed ramp. The maximum slope permitted in the bottom landing of the installed ramp is 2.08% but SME observed slopes up to at least 3.3%. It appears that the HCEAD EDS surveyed the bottom landing appropriately and observed a complaint slope in the same location. SME is unsure why this would have occurred. SME will emphasize digital level calibration instructions in future EDS trainings.

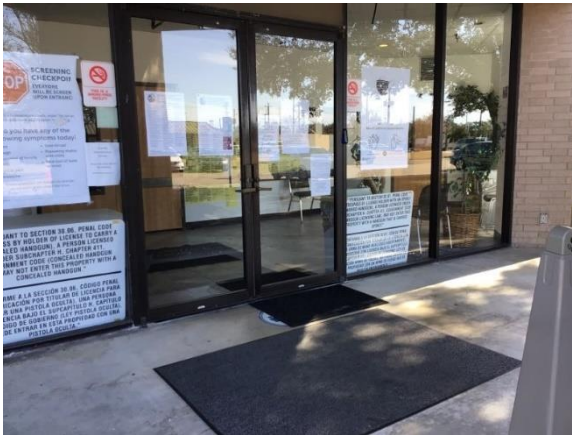
SME noted that the door was not propped open and the greeter positioned at the door was not opening the door for voters. SME explained to the Election Judge that if the door is not propped open, a poll worker would need to open the door for all voters entering and exiting. The HCEAD EDS noted "Facility has a poll worker inside to open door for voters."

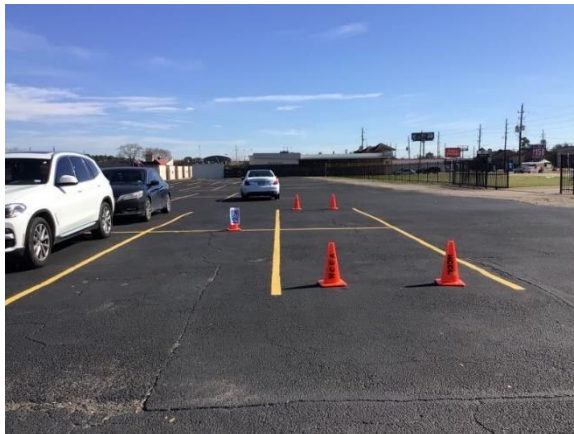
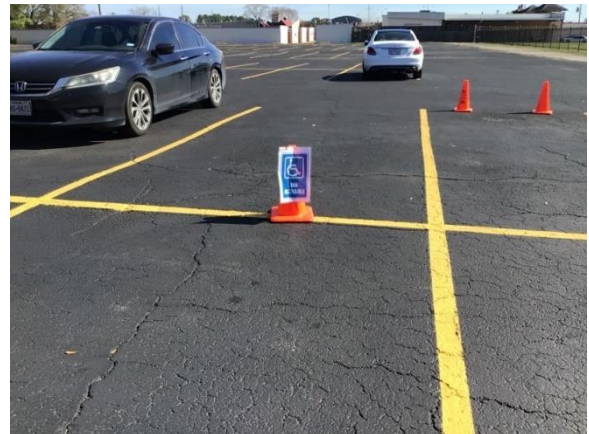
SME noted that the cones and signage were not placed in the correct spot and fixed the issue while on site. The EDS photos demonstrate that they analyzed the remedial measure correctly.

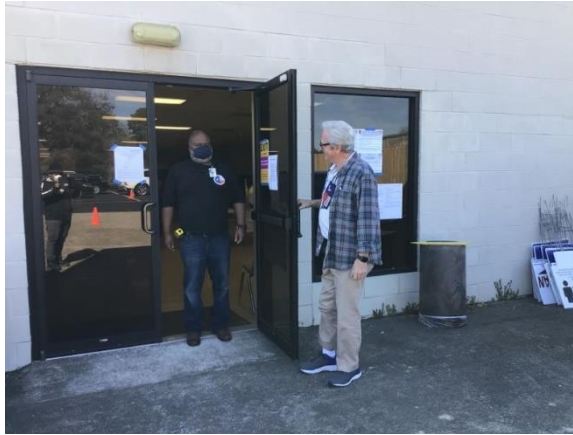
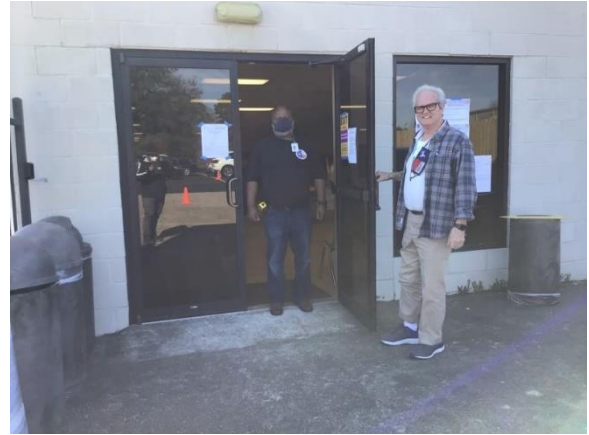
SME noted that the door was not propped open, and a poll worker was not placed to open the door for all voters. The SME notified the Election Judge that the door has to be propped open or a poll worker needs to be placed at the door to open it for all voters entering and exiting the polling place. The EDS noted that a poll worker was placed at the door but didn't open it for voters. The EDS appears to have analyzed the remedial measure correctly.

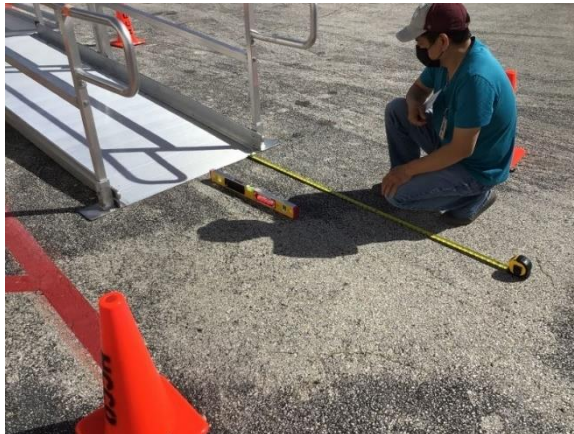
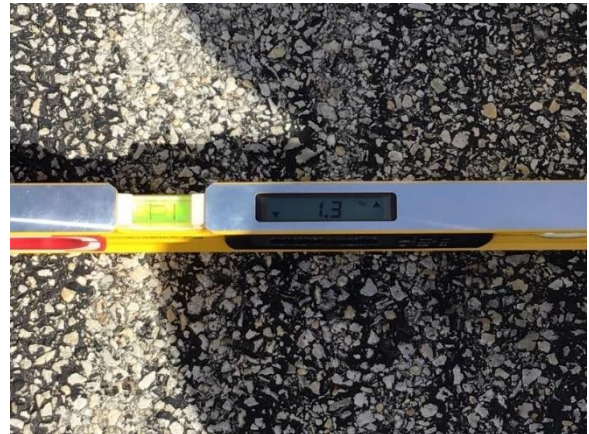
SME observed excessive ground slopes in the bottom landing at the installed ramp. It appears that the HCEAD EDS surveyed the bottom landing appropriately and observed a complaint slope in the same location. SME is unsure why this would have occurred. SME will emphasize digital level calibration instructions in future EDS trainings.

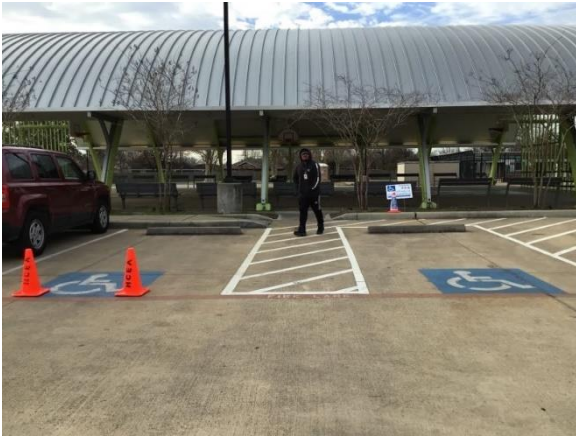
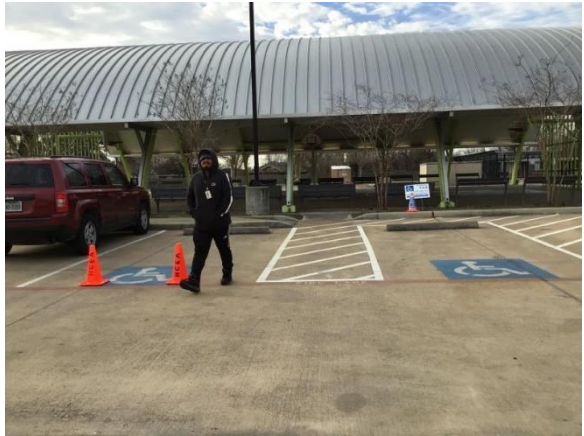
</div> </div>			
<div> <div>HCEAD Photos</div> <div>

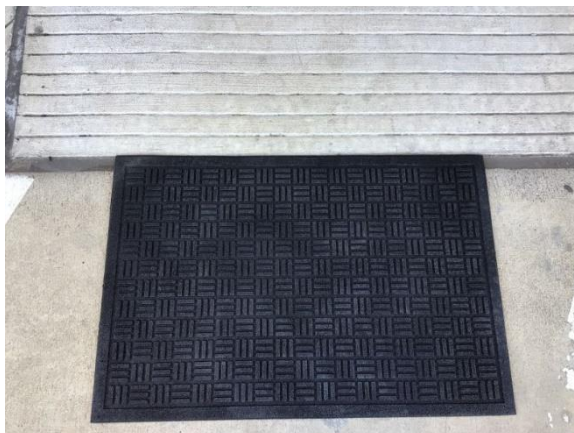
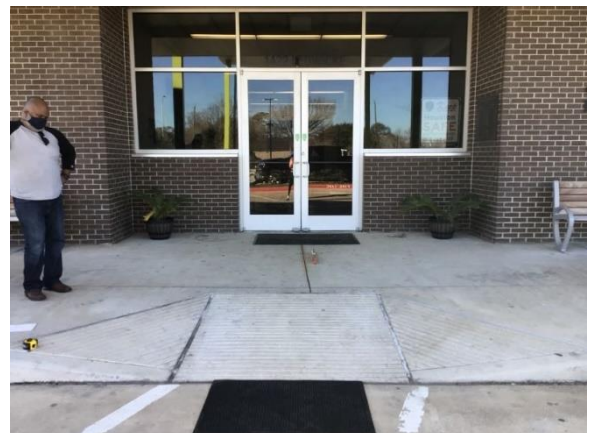
SME noted that the mat was not placed as shown in the checklist photos, abutting the level change at the curb ramp. It is understandable how the mat was replaced in the incorrect position as the remedial measure does not specify that the mat should be placed abutting the bottom of the curb ramp, however, the checklist photos show it in a specific position. SME will update the EDS training to emphasize that EDSs should refer to the checklist photos when analyzing remedial measures.

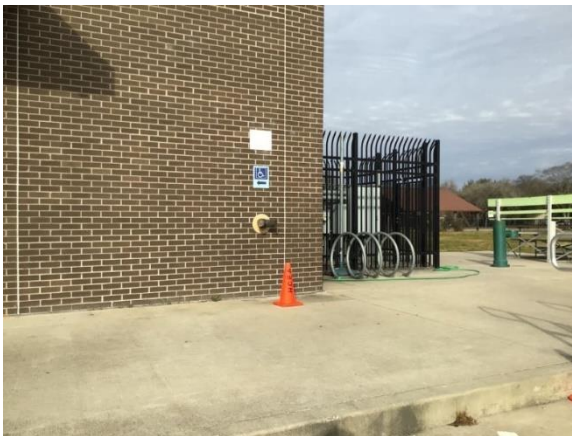
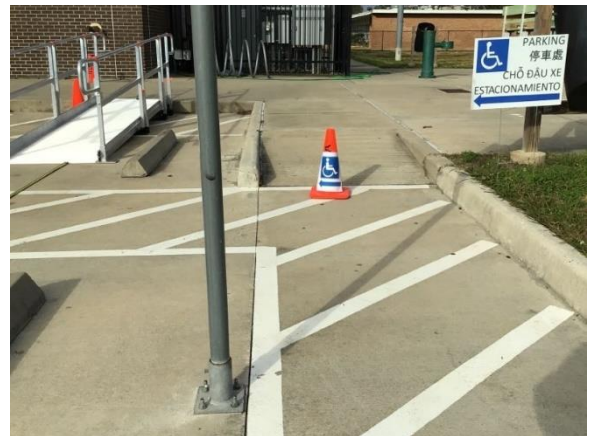
SME noted that the arrow at the curb ramp was not in place at the time of survey. SME fixed the issue while on site. The EDS photos show that the remedial measure was properly analyzed.

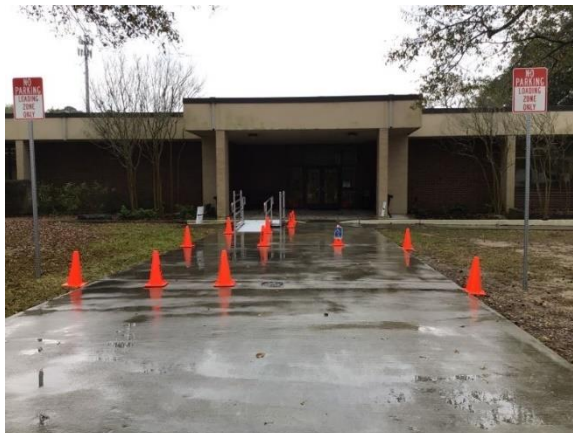
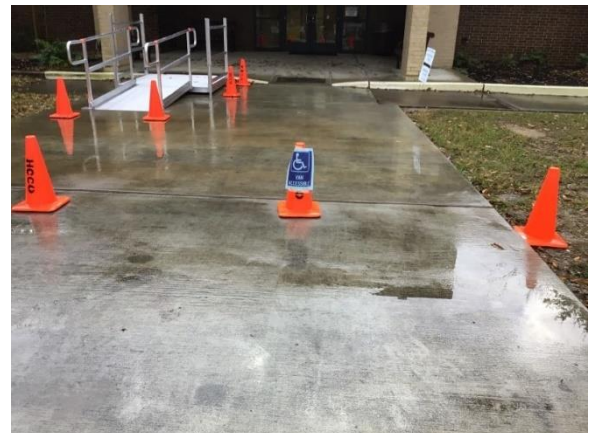
SME noted that the cones were not setup to provide an access aisle. While the EDS photos show a mirrored parking space and access aisle configuration, the functionality is essentially the same as what's shown in the SME "After" photo. This is because for perpendicular parking, the ADA allows the access aisle to be on either the driver or passenger side of the vehicle.

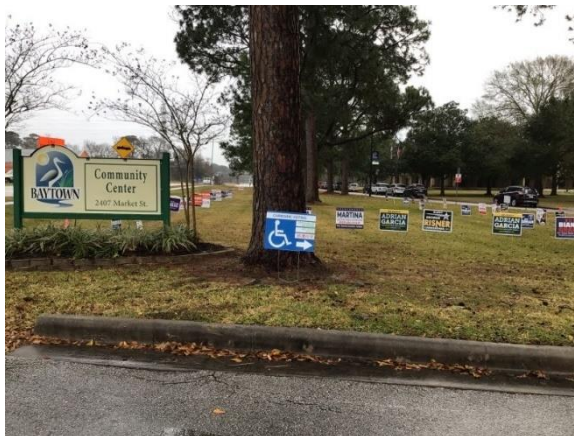
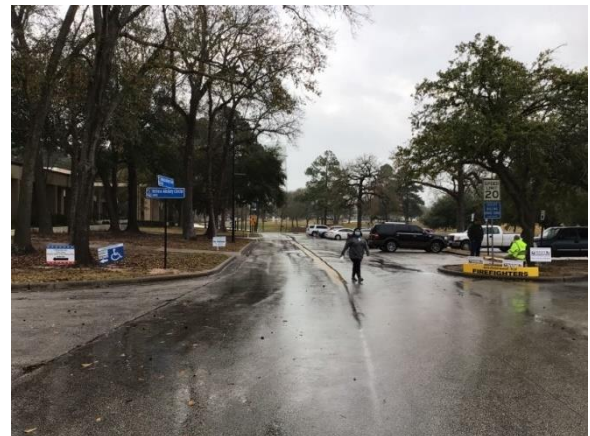
SME noted that no parking directional signage was placed. SME fixed the issue while on site. The EDS also noted that no signs were posted, but poll workers were there to direct voters. Based on the notes and photos provided, the EDS analyzed this remedial measure correctly.

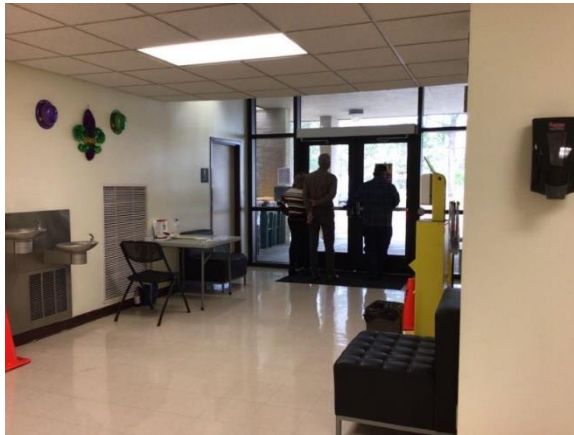
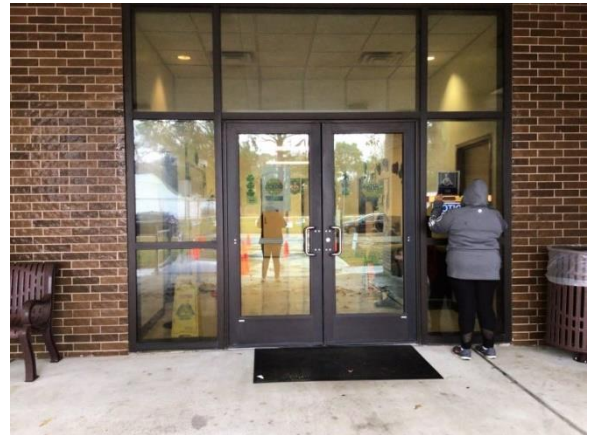
SME noted that the door was not propped open nor did the poll worker stationed at the welcome desk open the door for voters. The EDS noted that a poll worker was stationed at the door but did not open the door for voters. Photos and notes show that the EDS analyzed the remedial measure correctly.

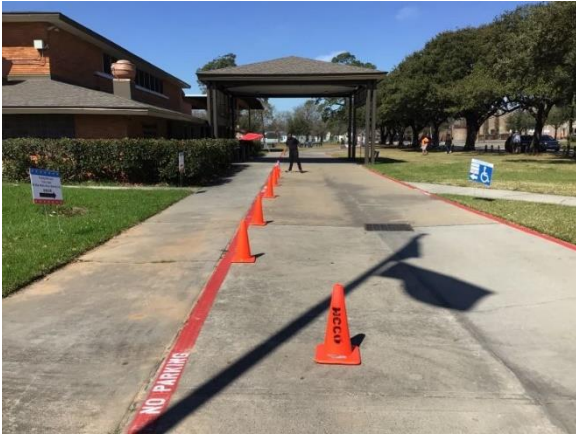
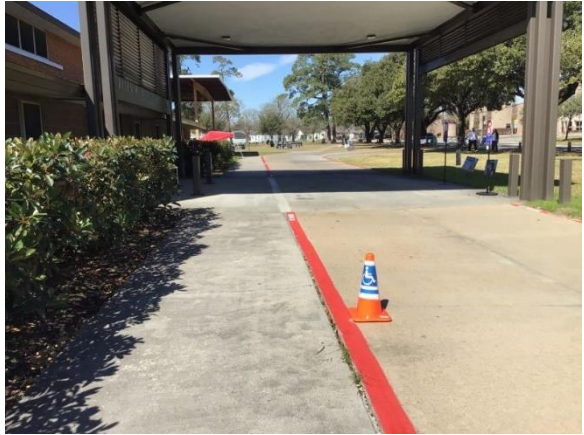
SME noted that no left arrow was placed closest to the Porte Cochere (carport) and fixed the issue while on site. The EDS photographed the directional signage in the correct location.

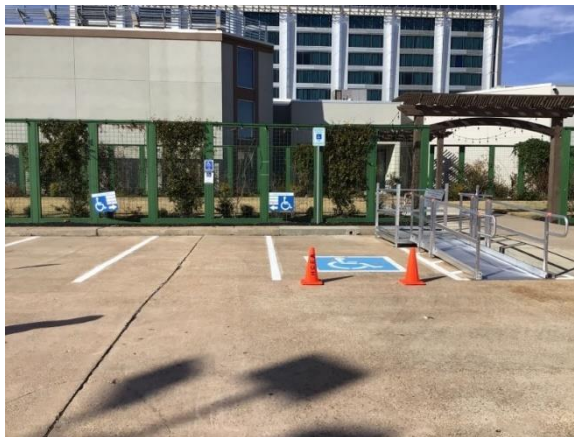
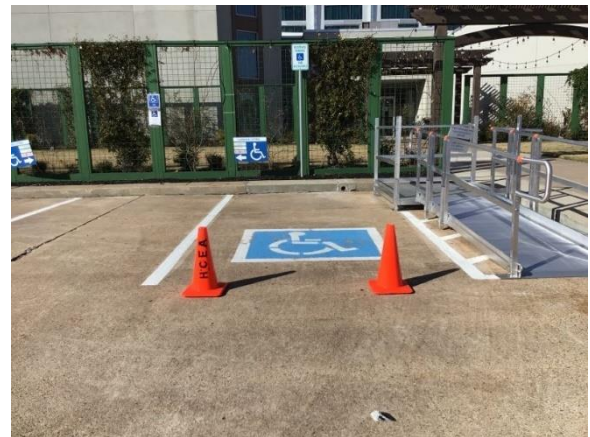
SME noted that the cones do not effectively block the access aisle and fixed the issue while on site. The EDS photos show the correct cone configuration.

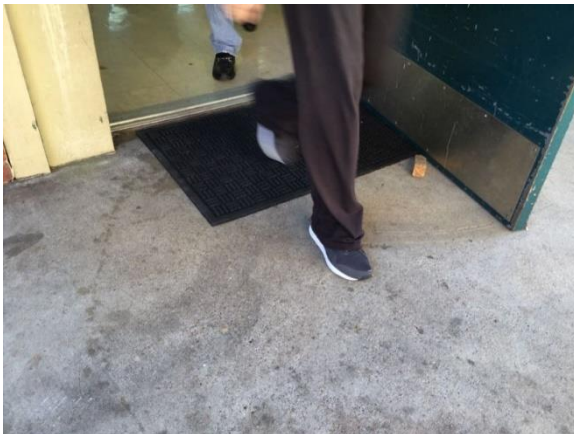
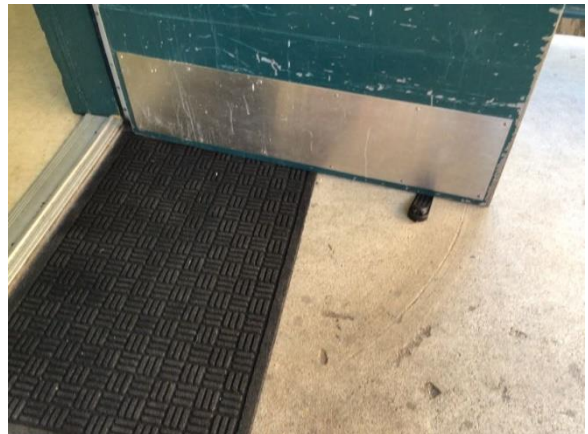
SME observed no mat at the door and the door not propped open and fixed the issue in the field. The EDS photos show a mat placed properly and the door propped open.

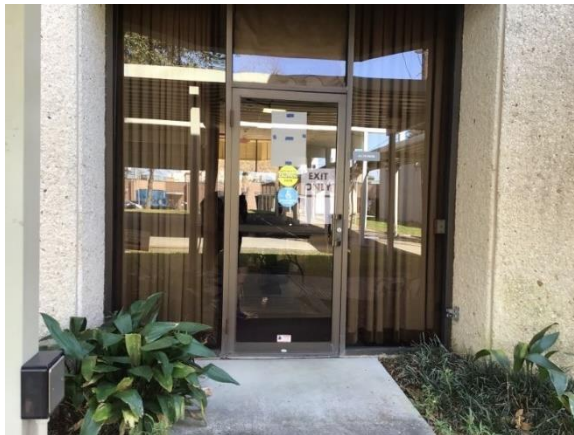
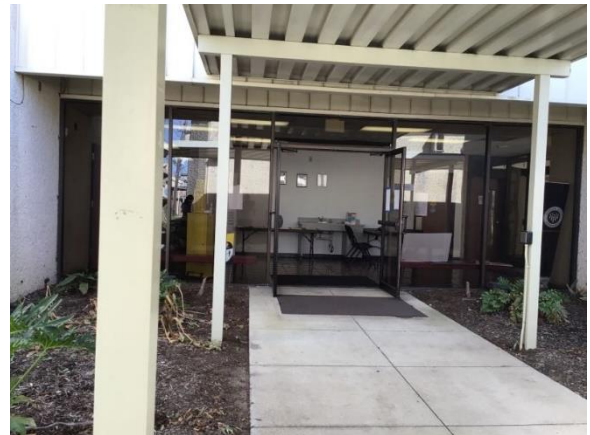
SME noted that the door identified in the checklist item was propped open and noted that the entrance was not being used. The EDS showed in photos that it was not propped open and that another entrance was being used. Both remedial measure statuses appear to be accurate based on the supplied photographs.

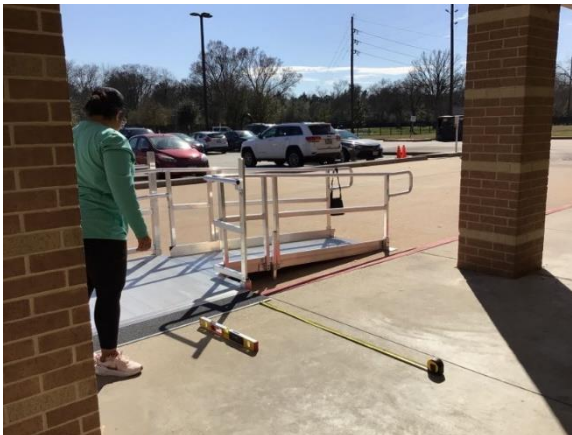
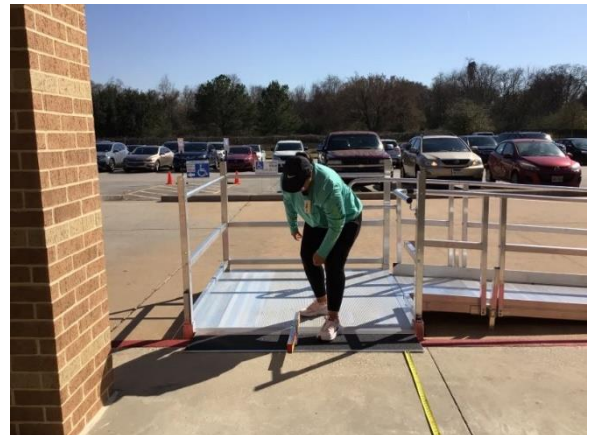
SME noted that the top transition plate on the ramp was loose. The Election Judge indicated that the school had moved the ramp after it was installed by Harris County contractors and reinstalled without notifying the County. SME notified Harris County of this and they fixed it shortly thereafter. The EDS analysis show it in place properly.

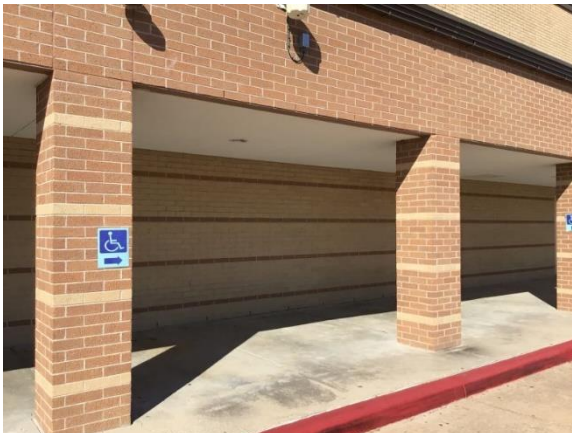
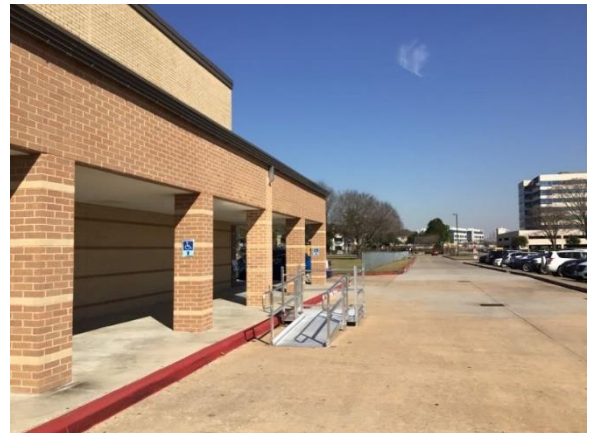
SME noted that the up arrow was not placed and fixed the issue in the field. The EDS photos show it in place.

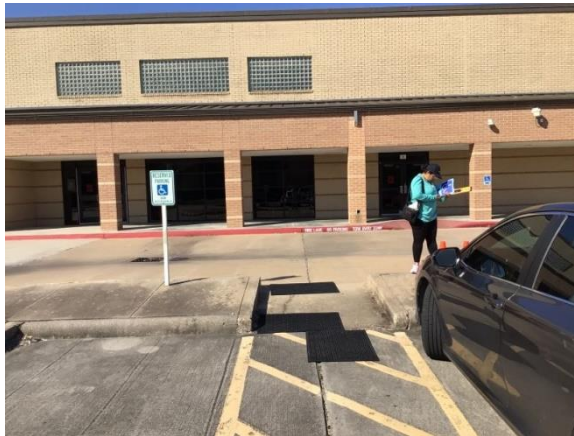
SME noted that the Election Judge set up the mats at the incorrect cut-through in the parking lot and fixed the issue in the field. The EDS photos show them in the correct location.

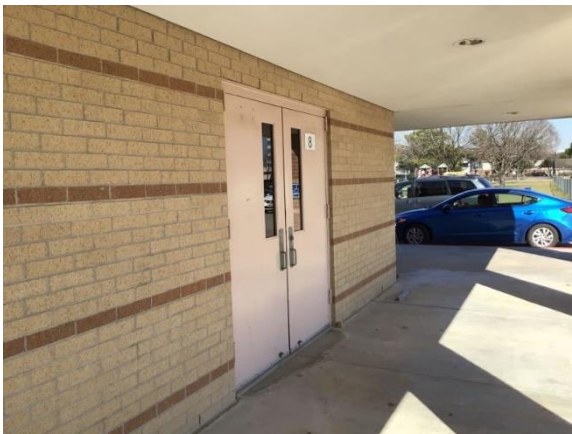
SME noted that there was no arrow at door 7. The EDS did not provide photographs of door 7. The EDS photos show door 8 without directional signage, which was a result of Item 7174, described below.

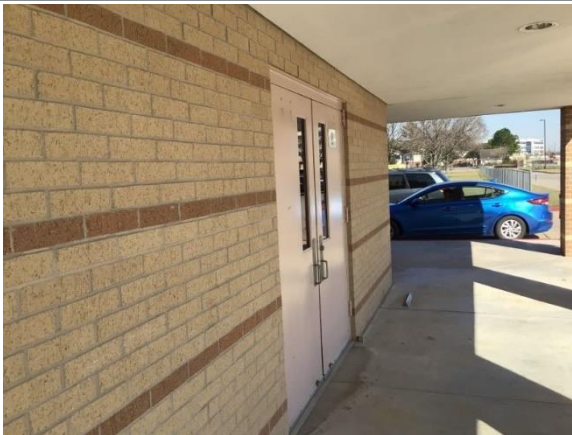
SME noted that door 8 was being used as an exit. It was not propped open, and the mat was not placed properly. The school did not want the door propped open and the mat placed at the threshold would not allow the door to swing. SME instructed the Election Judge to utilize door 7 for both entry and exiting. The EDS noted that door 8 was not being used during voting hours. It appears that the EDS analyzed the remedial measure correctly.

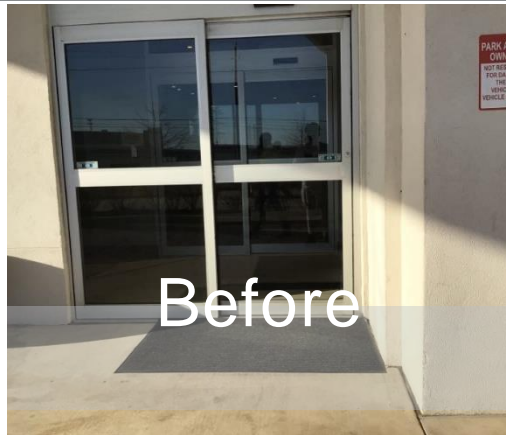
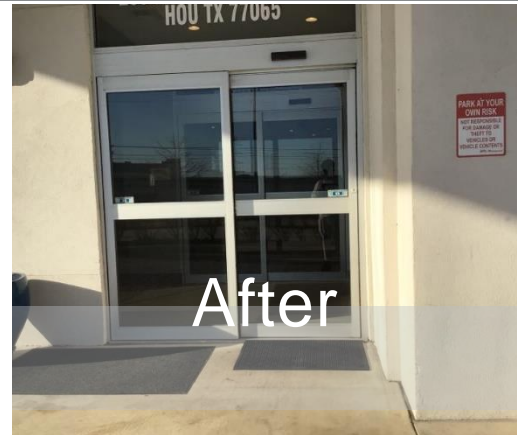
The EDS noted that the mat and plate were not placed and fixed the issue in the field. SME observed the mat and plate in place.

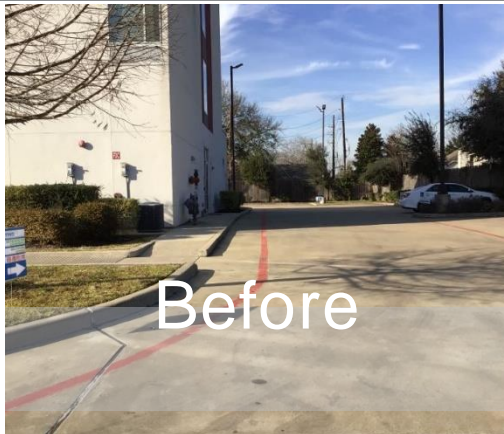
The EDS noted that the cones were not placed and fixed the issue in the field. SME observed the cones in place.

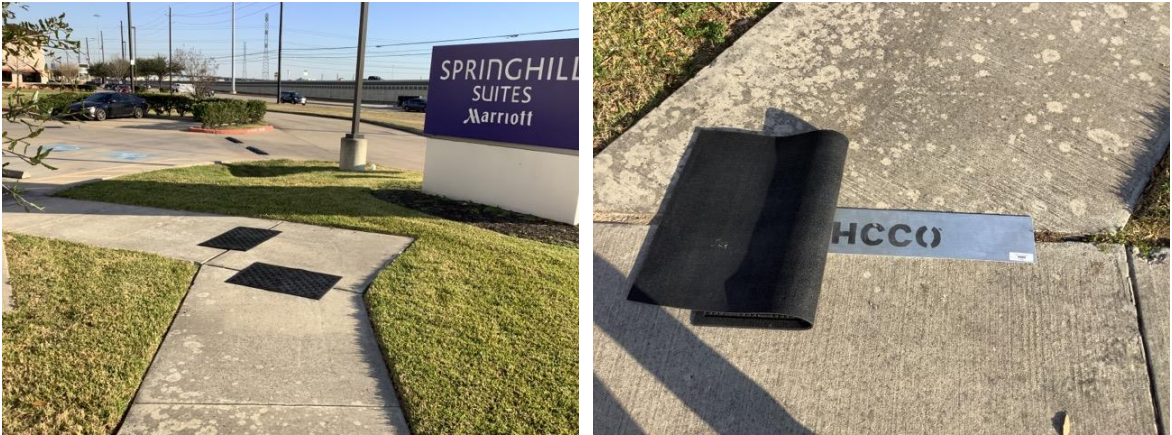
Item #	Proposed Remedy	SME Results	HCEAD Results
7583	Judge must place one mat over one plate in first joint next to tree when coming from sidewalk. Judge must place one mat over one plate on the third joint when coming from sidewalk connection transition. Judge must place one mat over one plate in joint after previous gap. Both are to the left of the connection transition when walking towards the facility. Reference photos	Implemented Properly	Not Implemented Properly
SME Photos

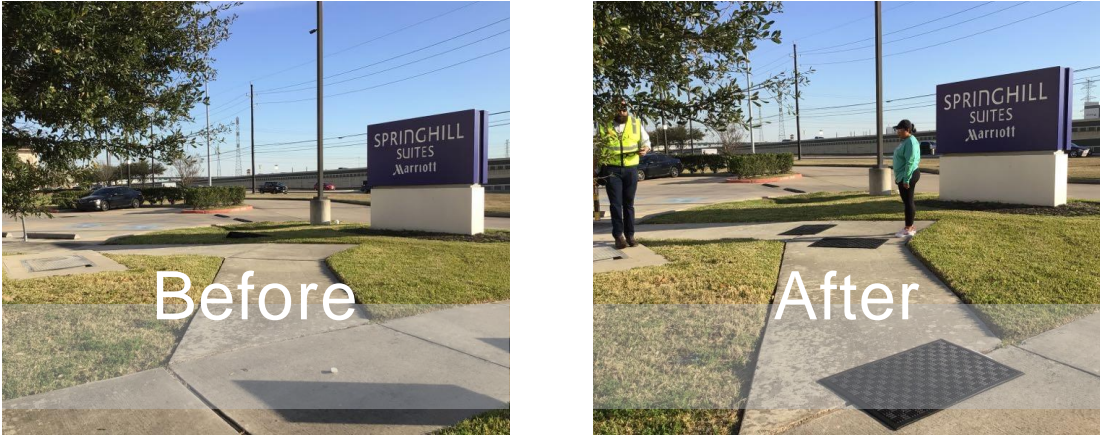
The EDS noted that the mats and plates were not placed and fixed the issue in the field. SME observed the mats and plates in place.

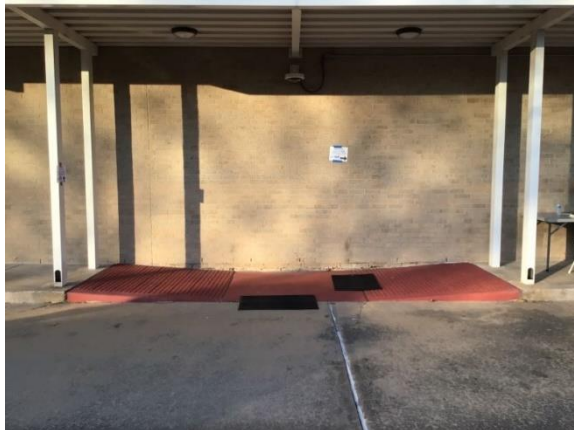
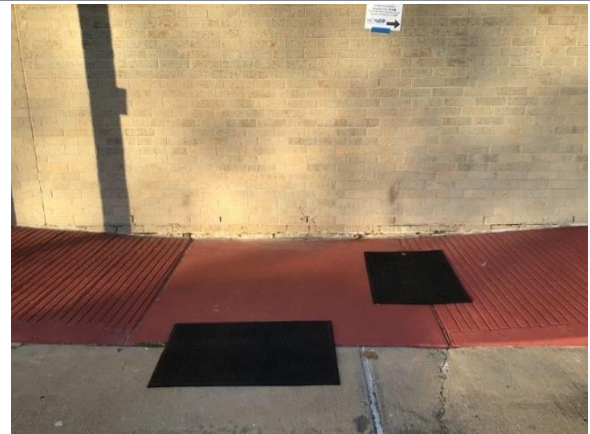
SME noted that the mat and plate were not correctly placed and fixed the issue in the field. The EDS documented the mat and plate in the correct location.

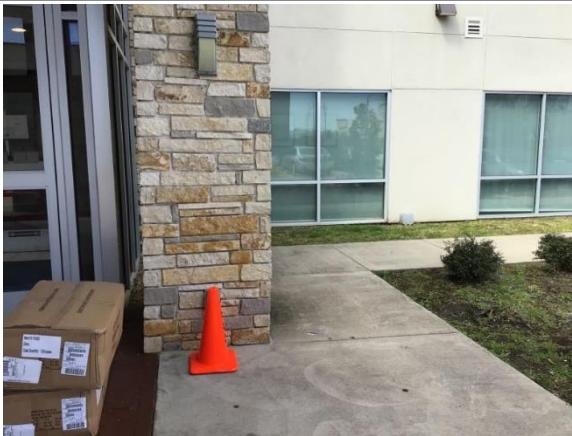
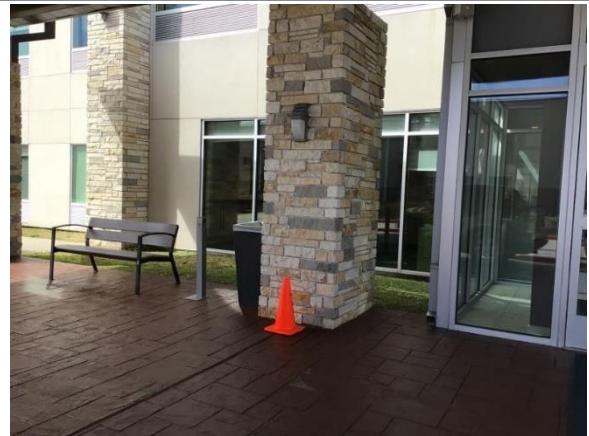
SME noted that no cones were placed and fixed the issue while on site. The EDS photos show the cones in place.
